COAST GUARD RESEARCH AND DEVELOPMENT CENTER GROTON CT F/G 13/10
AIR CUSHION VEHICLE (ACV) ICEBREAKER TEST AND EVALUATION PROGRA--ETC(U)
JUL 78 J BUCK , C W PRITCHETT DOT-C6-81-1856
UNCLASSIFIED CGR/DC-12/78-VOL-1 USCG-D-21-79-VOL-1 NL

1. Report No. CG-D-21-79	2. Government Accession No. ① 18 USCG	3. Recipient's Catalog No. ① 11 ② 39	
4. Title and Subtitle Air Cushion Vehicle (ACV) Icebreaker Test and Evaluation Program. Volume I. Executive Summary.		5. Report Date July 1978	6. Performing Organization Code CGRDC-12/78-VOL-1

15. Supplementary Notes This report is an Executive Summary of the work reported in Volume II, "Operational and Engineering Analysis: ACV Icebreaker Test and Evaluation Program."

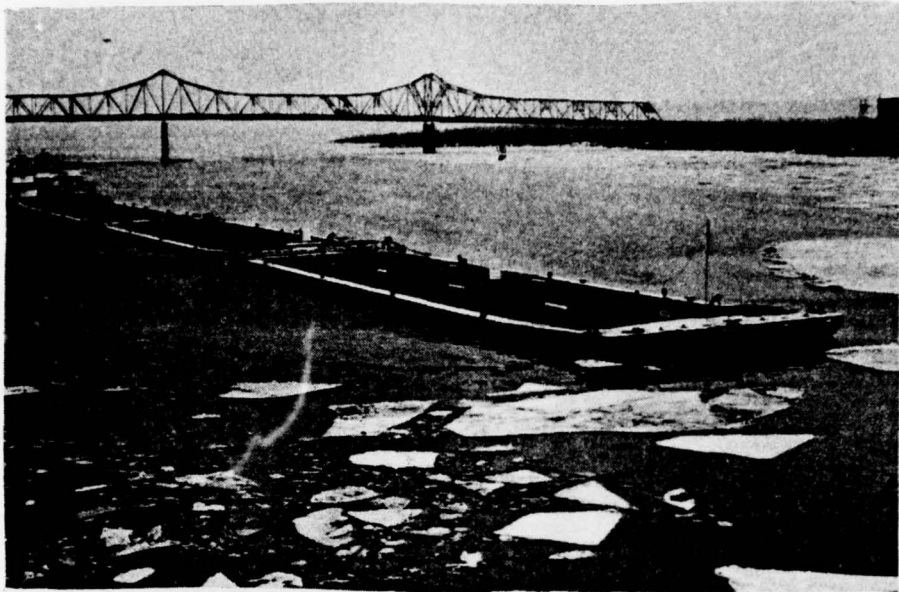
TYPICAL TOWBOAT TRAFFIC IN
OPEN WATER AND PLATE ICE

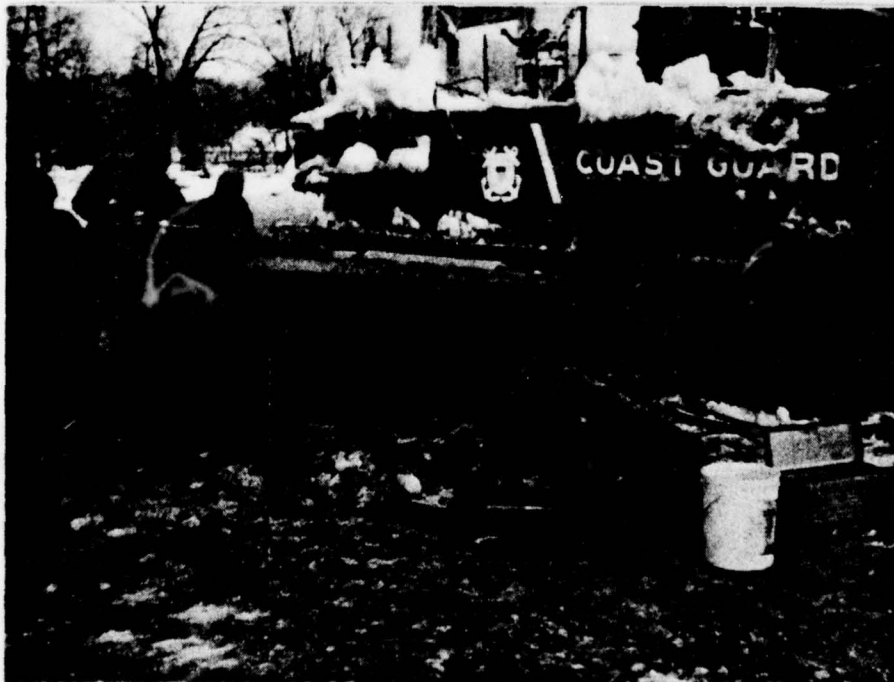
MACKACE SEGMENT REPAIR

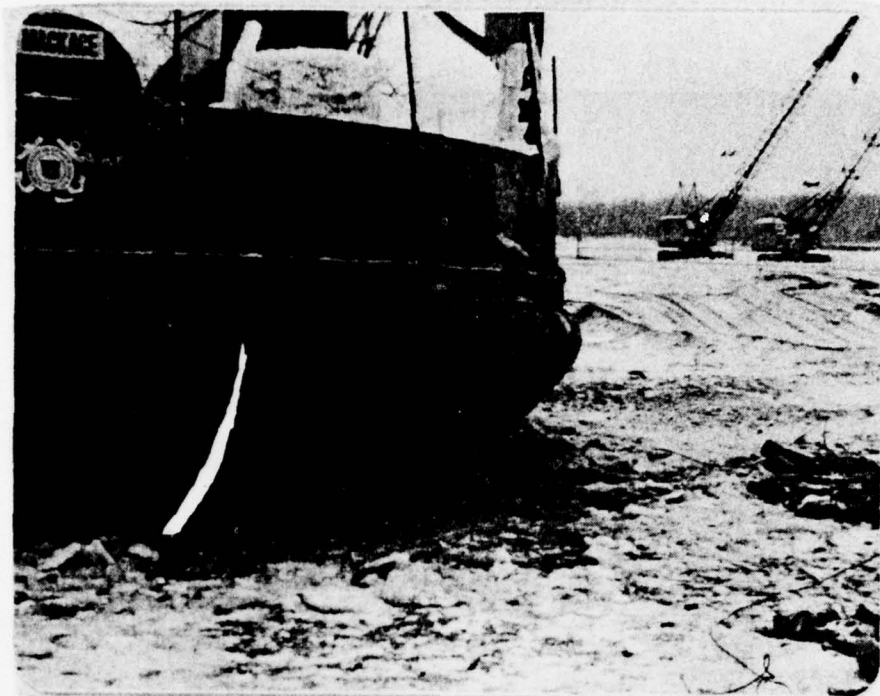
MACKACE ON HOVER SHOWING RIP IN SEGMENT

Of the many design criteria developed through the test and evaluation program, one of the most important was the determination of the type of skirt fabric that can best withstand the impact of river ice. The 60 oz. per sq. yard single weave, nylon fabric bonded with natural rubber that was used on the MACKACE ACV was unable to survive the ice environment. The LACV-30 used a two-ply material of several different weights, including 60 oz. per sq. yd., which was considerably more durable than the single-weave fabric.

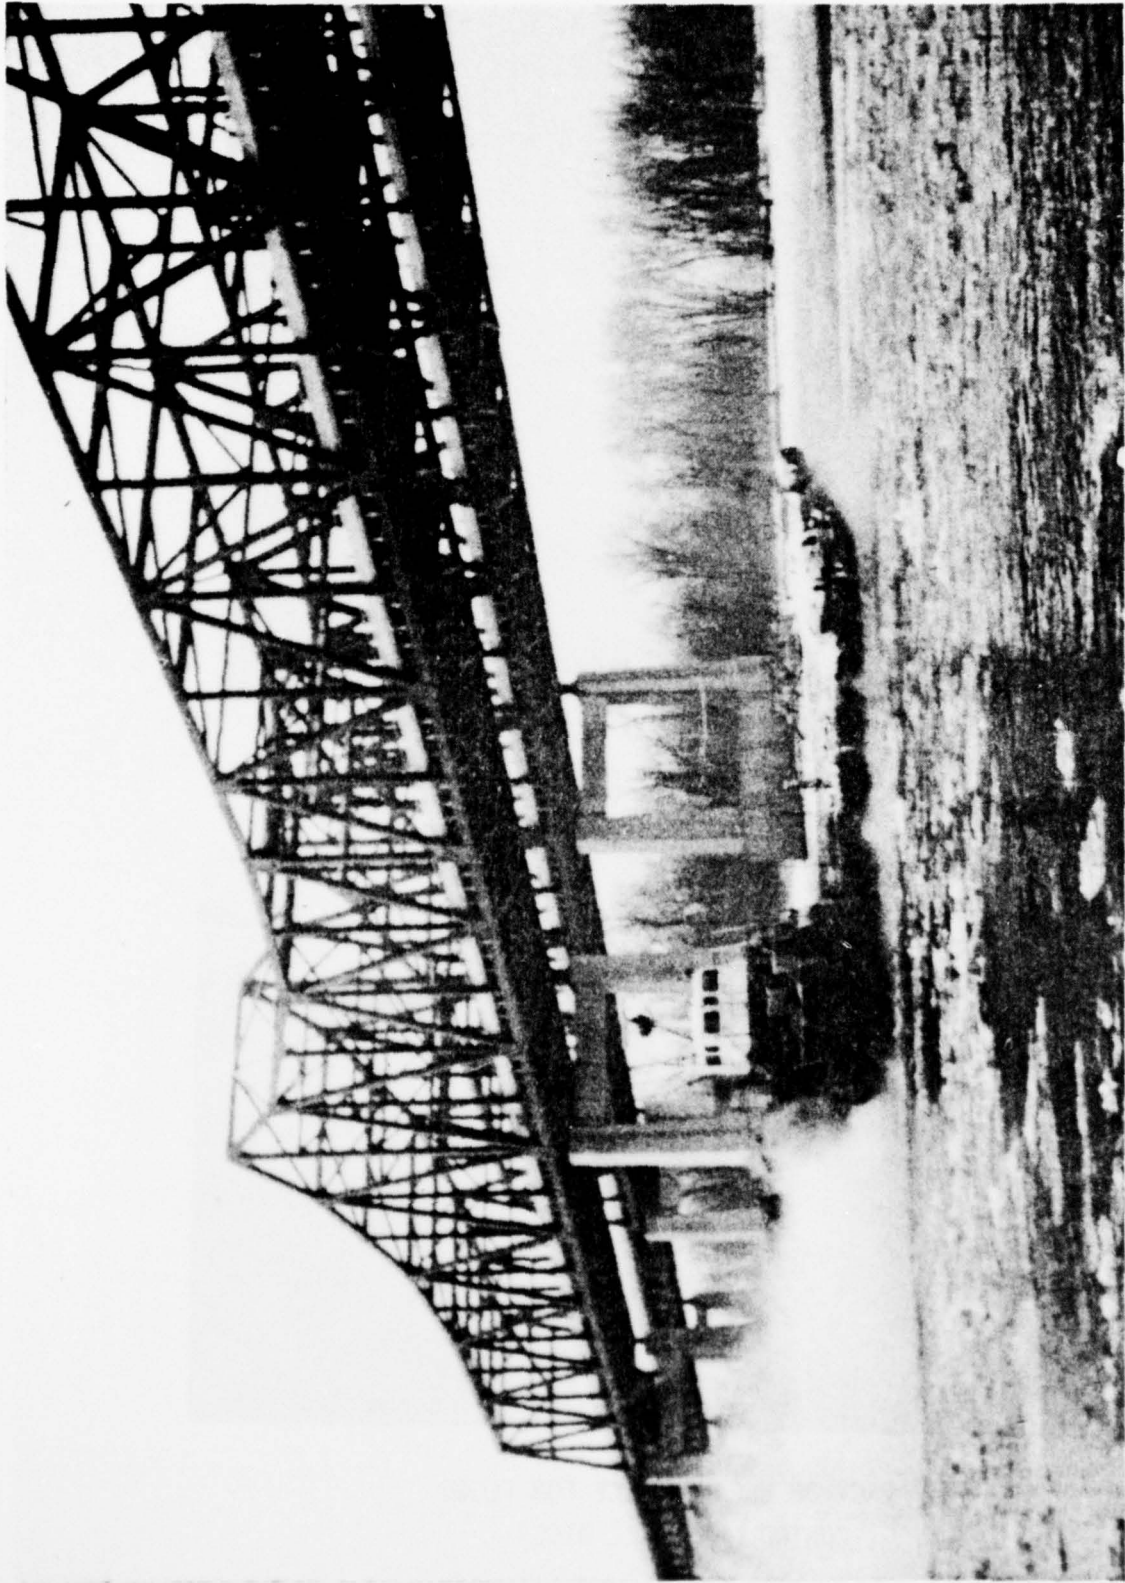
LACV-30 ICEBREAKING OPERATIONS
ILLINOIS RIVER

air management system is powered by a 140-horsepower auxiliary power unit (APU) manufactured by Alturdyne Corporation. The air management system provides filtered, positive pressure air for the engines. The system includes an axial fan, moisture separators, and filters. Figure 3-2 gives the general characteristics of the craft.
