2
RADC-TR-79-98
Final Technical Report
May 1979

ALTERNATIVE METHOD FOR THE EVALUATION OF FUSED GLASS-TO- METAL SEALS

General Electric Company
GA

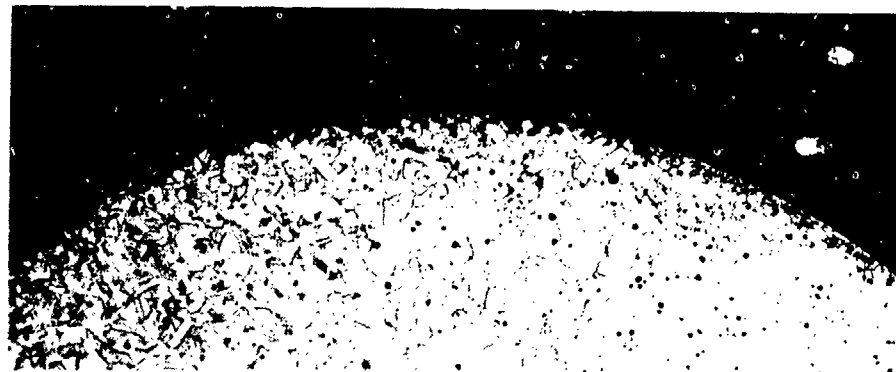
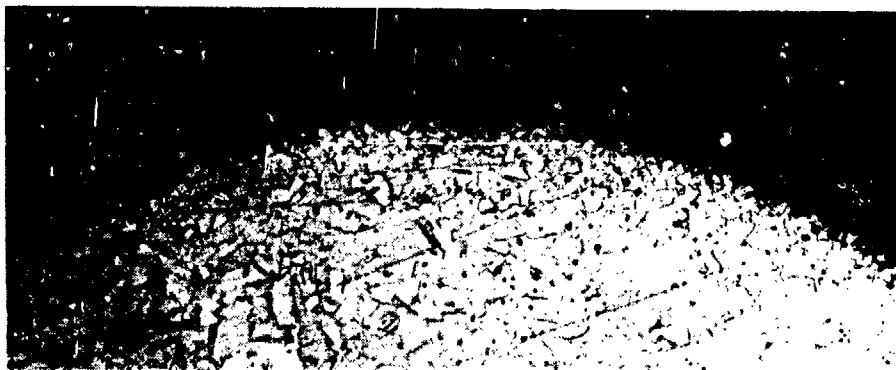
Fig. 2 Oxidation of Kovar @ 1500°F in Air

3 min

6 min

9 min

12 min

This Table shows that the ratio of intergranular oxide to oxide scale can be relatively high during the early stages of oxide formation. As total oxide content increases, the intergranular oxide-scale oxide ratio is more nearly consistent at about 1.5:1.

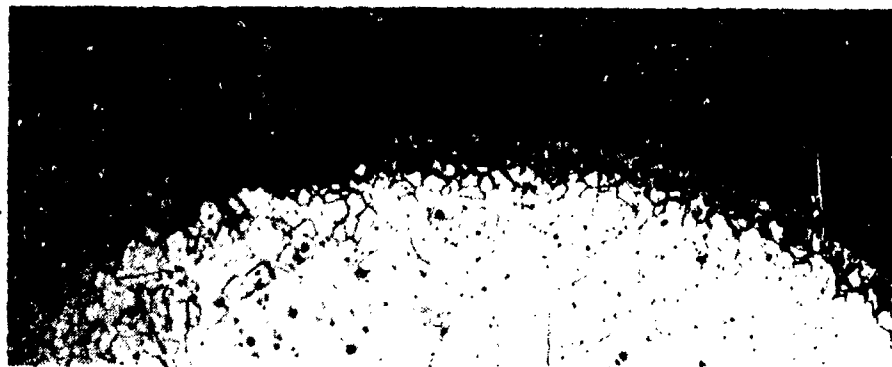
Fig. 3 Oxidation of Kovar @ 1700°F in Air

3 min

6 min

9 min

12 min

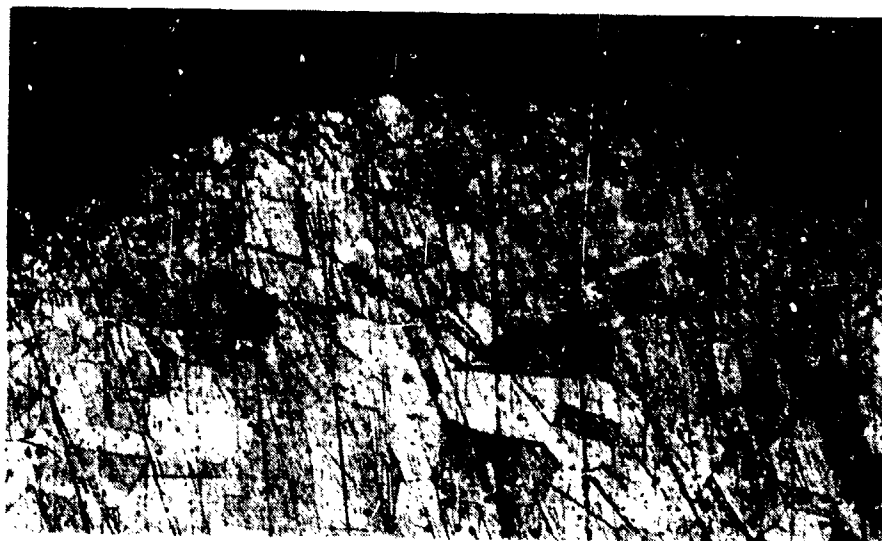
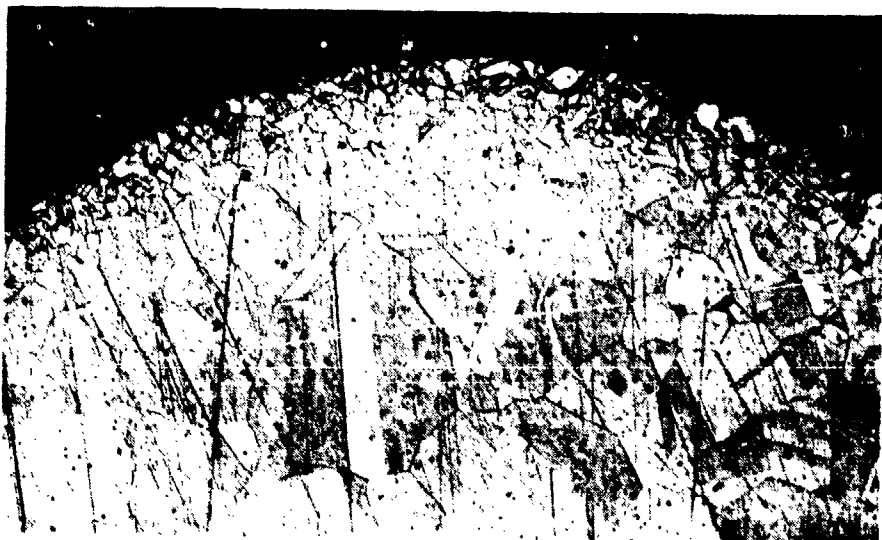
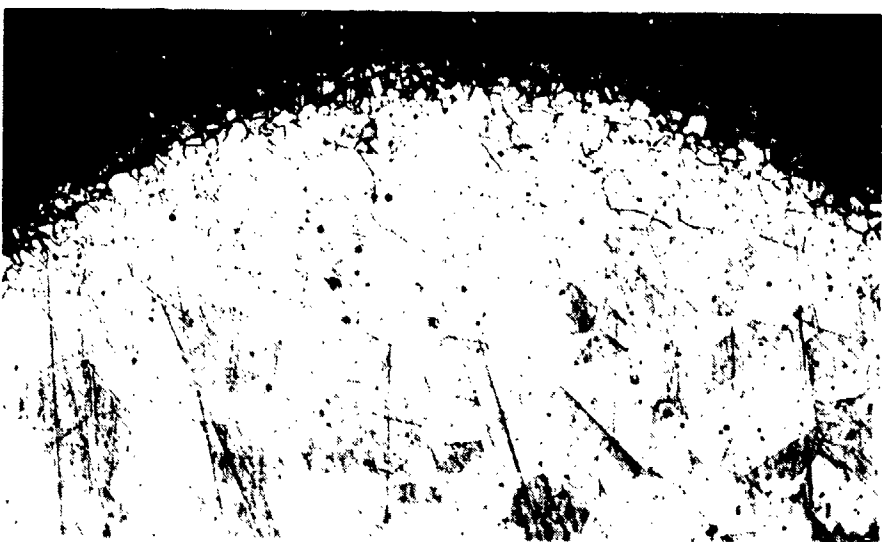
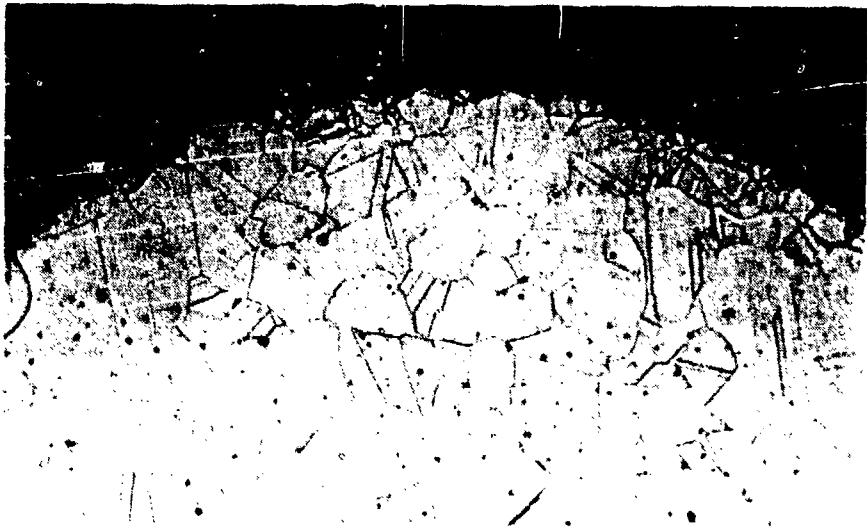
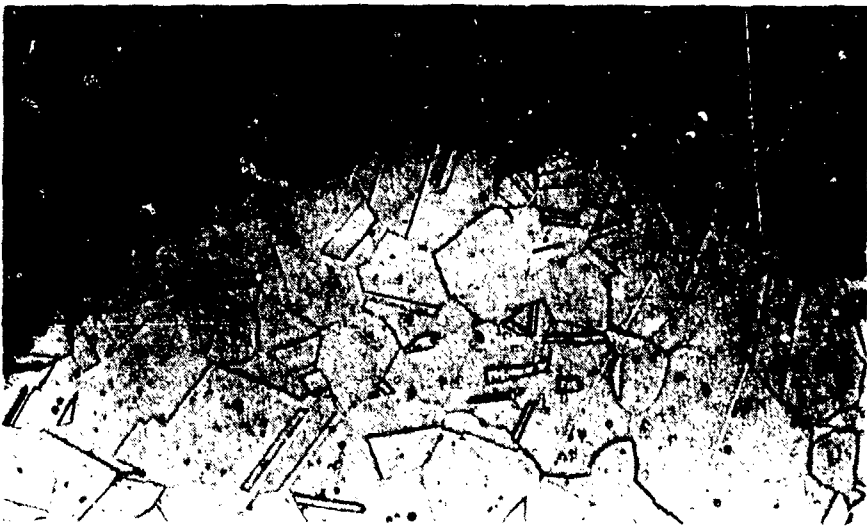
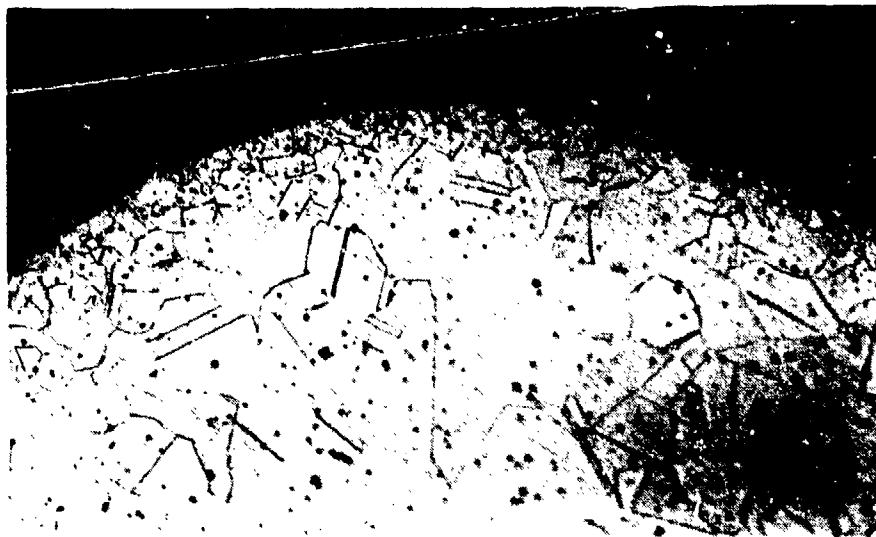
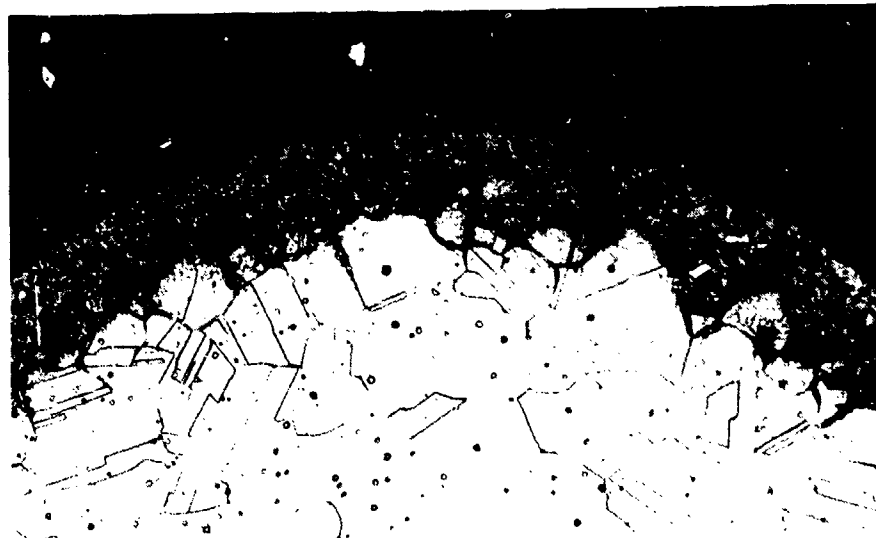
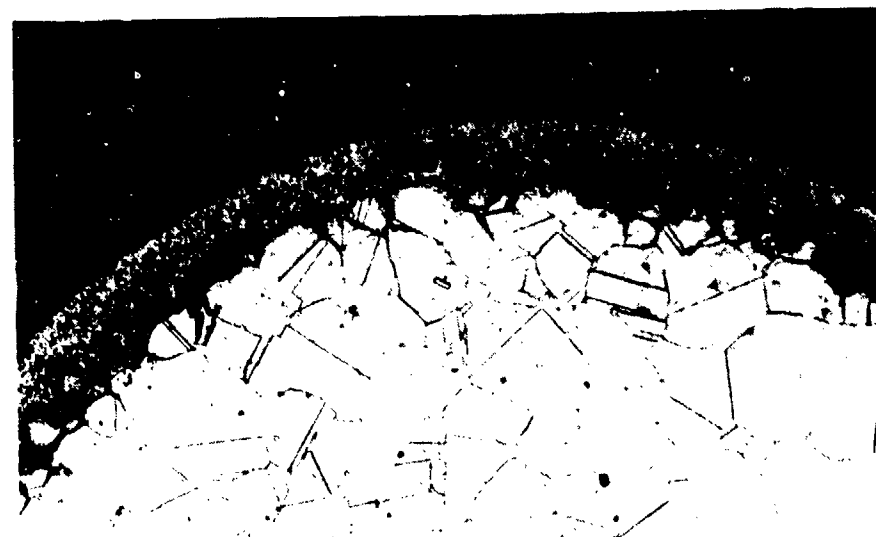
Lot 1 - Vendor A Oxidized #184 400X 5% Nital

Lot 2 - Vendor A Oxidized #185 400X 5% Nital

Lot 3 - Vendor A Oxidized #186 400X 5% Nital

Production Furnace Oxidation

Lot 3R - Vendor A Oxidized #278 400X 5% Nital

Lot 4 - Vendor A Oxidized #177 400X 5% Nital

Lot 4R - Vendor A Oxidized #179 400X 5% Nital
Fig. 6 (cont'd) Production Furnace Oxidation

Lot 4RR - Vendor A Oxidized #279 400X 5% Nital

Lot 5 - Vendor A Oxidized #178 400X 5% Nital

Lot 5R - Vendor A Oxidized #180 400X 5% Nital
Fig. 6 (cont'd) Production Furnace Oxidation

used. As can be seen from these results, the target amount of intergranular oxide appears somewhat difficult to achieve. This despite assurances by the supplier that the specified targets would offer no particular difficulty. The indication is that the production pre-oxidizing process contains more uncontrolled variables than is generally realized. From the need for repeated attempts to attain a target oxide quantity, and the general variations from target by most lots, and from some variation within a lot, it appears that much closer pre-oxidation control than is apparently presently practiced will be necessary if imposed criteria are to be met.

As was found in the laboratory oxidation experiments, the production tests also show that intergranular oxidation occurs more rapidly than scale oxide formation during initial stages of oxidation.

In later stages of oxide growth, the ratio of intergranular oxide to scale oxide again approaches 1.5:1, as it did for samples processed in the laboratory.

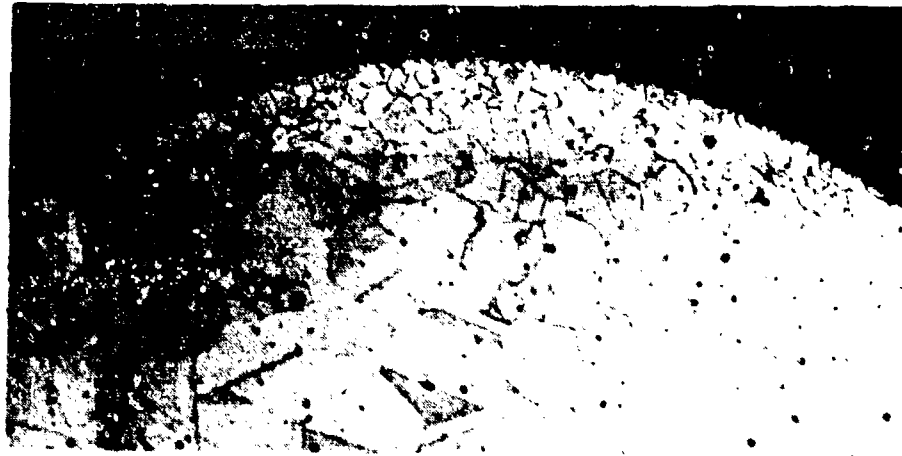
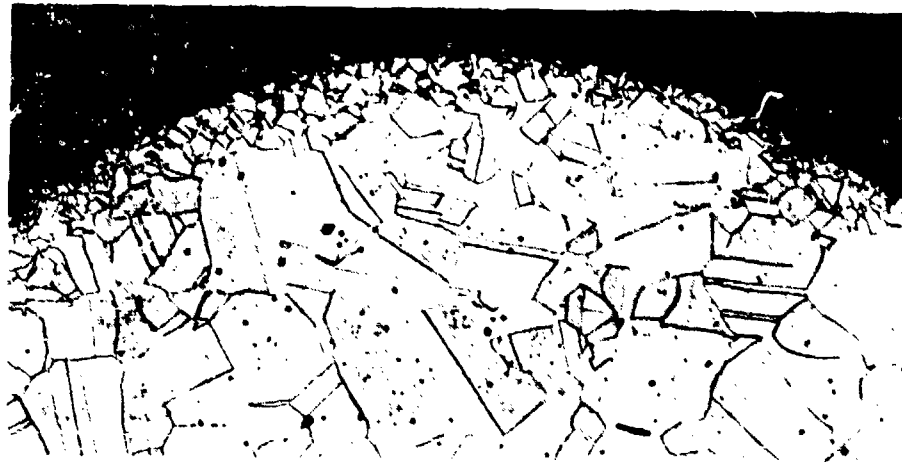
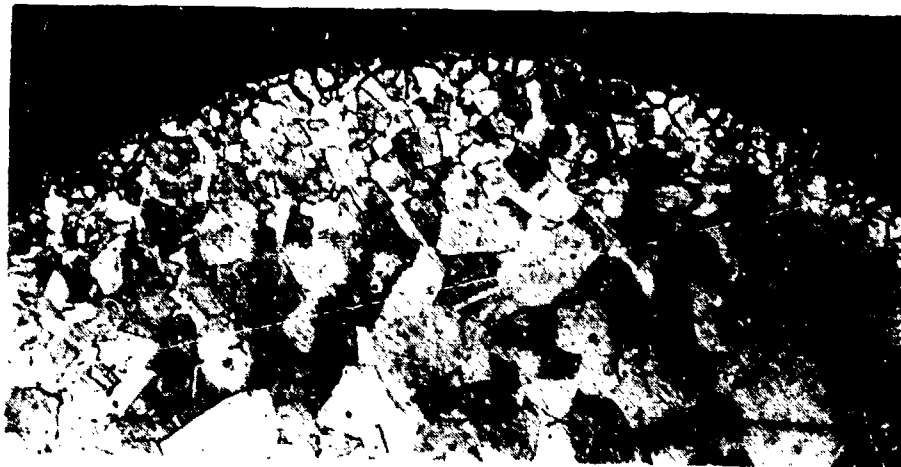
Fig. 9 Residual Intergranular Oxide; Lots 1, 2, & 3

Lot 1 Sealed #187 400X 5% Nital
Vendor A $2.5\mu\text{m}$ Residual Intergranular Oxide

Lot 2 Sealed #188 400X 5% Nital
Vendor A 3.5 μm Residual Intergranular Oxide

Lot 3 Sealed #189 400X 5% Nital
Vendor A 7.5 μm Residual Intergranular Oxide

The effect of the intergranular oxide is to roughen the metal surface at the glass-metal interface. This effect is hardly perceptible at residual intergranular penetration of less than $2.5\mu\text{m}$, and is readily perceptible at over $3.5\mu\text{m}$ of residual intergranular oxide. At $7.5\mu\text{m}$, the intergranular oxides approach a magnitude such that surface damage can result in reduced lead integrity (bend fracture or SCC).

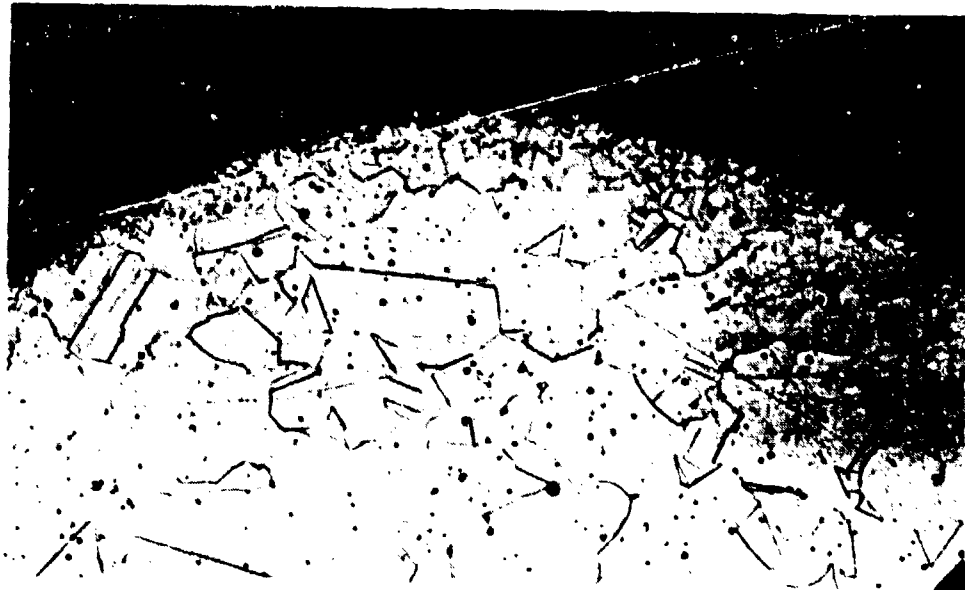
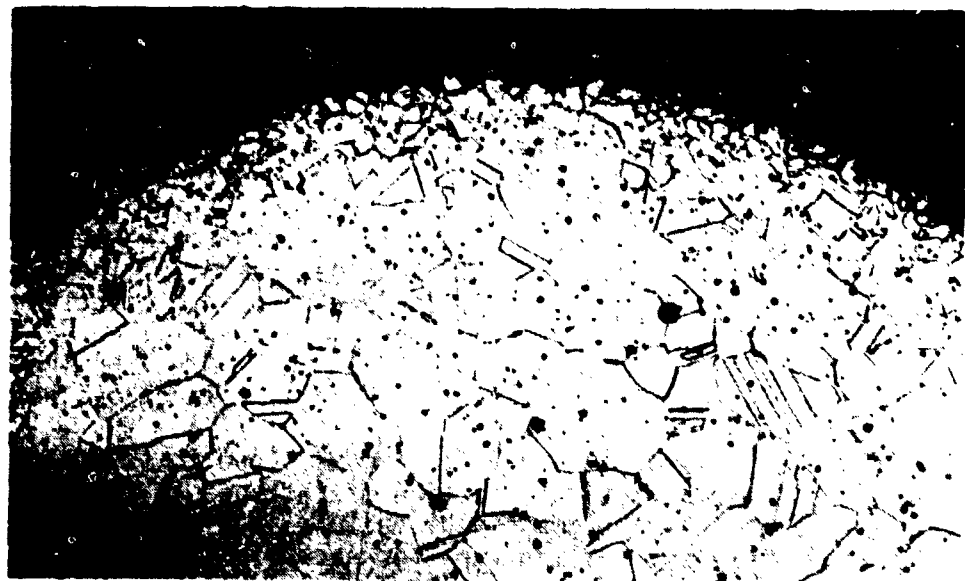
Fig. 9 (cont'd) Residual Intergranular Oxide; Lots 4 & 5

Lot 4 Sealed #270 400X 5% Nital
Vendor A 1.2 μ m Residual Intergranular Oxide

Lot 5 Sealed #266 400X 5% Nital
Vendor A 5.5 μ m Residual Intergranular Oxide

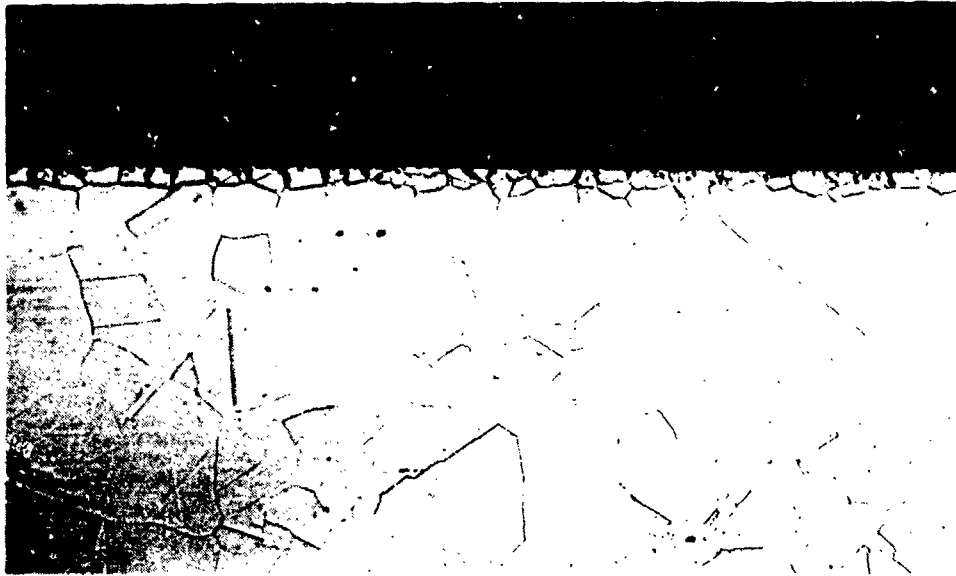
Fig. 13 Lot 8, Hermetically Tight Seals

Lot 8
Vendor C

Pin
6.5 μ m Residual Intergranular Oxide,
Longitudinal Section

Eyelet
2.5 μ m Residual Intergranular Oxide,
Longitudinal Section

Lot No. 8 parts are also representative of large production quantities of a T0-5 type package. In this case, the normal failure rate is 1%, but this lot passed hermeticity 100%. The residual intergranular oxide is within the desired range; gas quantity, size and distribution are acceptable, and there are no foreign materials at the glass-metal interface.

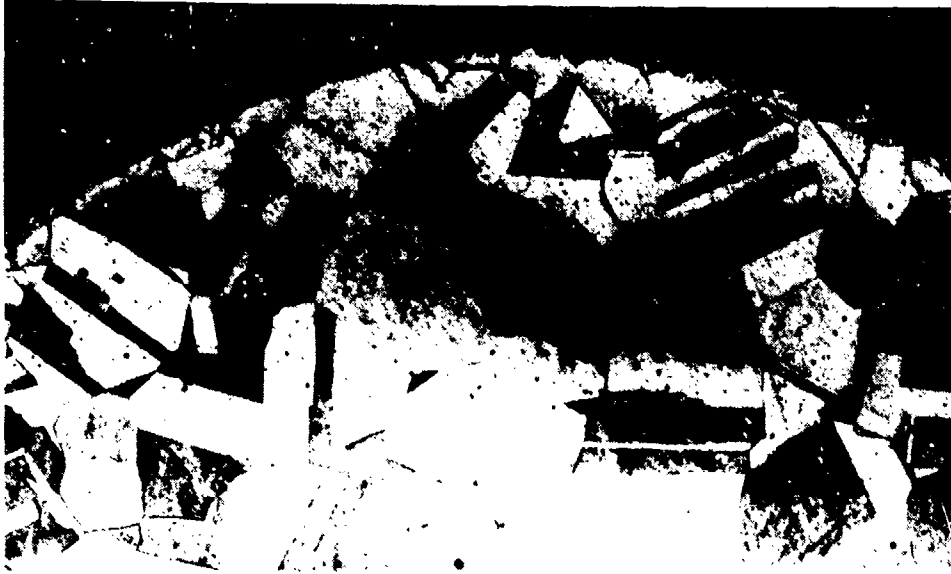
Fig. 15 Lot 10, Hermetic Failure

Lot 10 Pin #619 400X 5% Nital
Vendor D 5.0 μ m Residual Intergranular Oxide

Lot 10 Eyelet #618 400X 5% Nital
Vendor D 25.0 μ m Residual Intergranular Oxide,
Saturated Glass, Glass Cracked

Lots 9 and 10 parts are feed-thru terminals similar to those in Lot No. 6. Lot No. 9 showed a relatively high leak rejection rate due to the effect of excess oxide residuals which caused degradation and cracking of the glass with excessive void formation. Lot No. 10 exhibited a lower failure rate. Most of the metal members were in the acceptable range for residual oxide. Several eyelets were heavily oxidized, resulting in some glass degradation.
