AFFDL-TR-78-206
VOLUME I

FASTENER HOLE QUALITY

Structures Design Department
General Dynamics Fort Worth Division
Fort Worth, Texas 76101

Technical Report AFFDL-TR-78-206, Volume I
Final Report June 1976 - October 1978

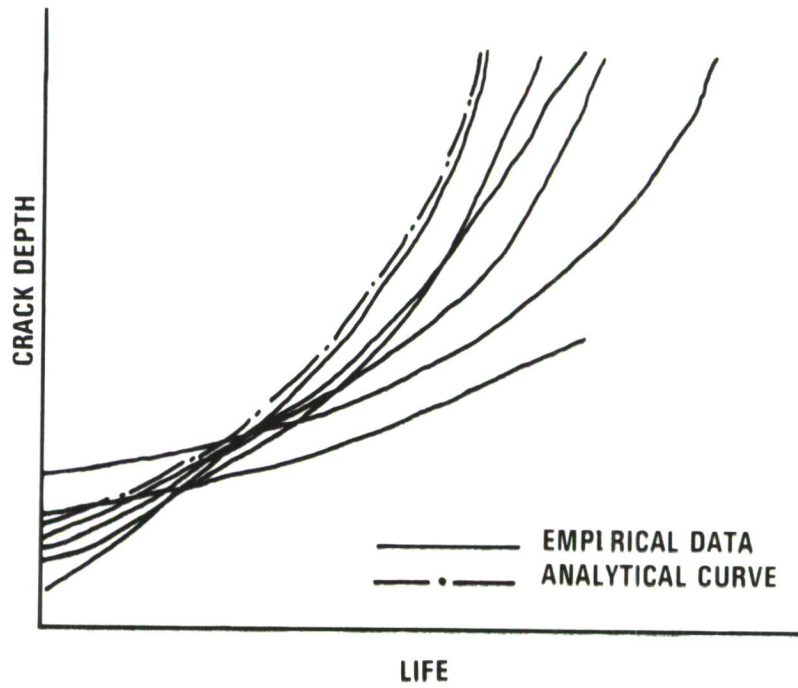
Figure 2-7 Selection of a Single Analytical Curve for a Sample of Fractographic Crack Growth Histories

Selection of a simple analytical curve for determination of individual EIFS values for each specimen was made using well-defined criteria. An analytical curve was grown so as to define a conservative bound, as seen in Figure 2-7, to the fastest growing crack in a sample of specimens, over as large a range of crack depth as possible. The EIFS for each specimen was obtained by matching the analytical crack growth to each fractographic crack growth history using regression analysis to obtain the best fit. The analytical and fractographic curves were matched between crack depths of 0.01 - 0.05 inch. The crack depth value of the analytical curve, corresponding to time zero for each fractographic crack growth history, was the EIFS value for that fastener hole. An EIFS value was obtained for every specimen in a sample.
