*Final* Scientific Report  
to  
United States Air Force  
Air Force Office of Scientific Research  
*AFOSR-76-3087*  
Wear of Homogeneous and Composite Materials  
Under Conditions of Repeated Normal and Sliding Impact  
Stephen Rice and Roman Solecki

4. TITLE (and Subtitle) <b>WEAR OF HOMOGENEOUS AND COMPOSITE MATERIALS UNDER CONDITIONS OF REPEATED NORMAL AND SLIDING IMPACT.</b>	5. TYPE OF REPORT & PERIOD COVERED <b>FINAL Rept.</b> 30 Jun 76 - 31 Aug 79	<del>6. PERFORMING ORG. REPORT NUMBER</del>

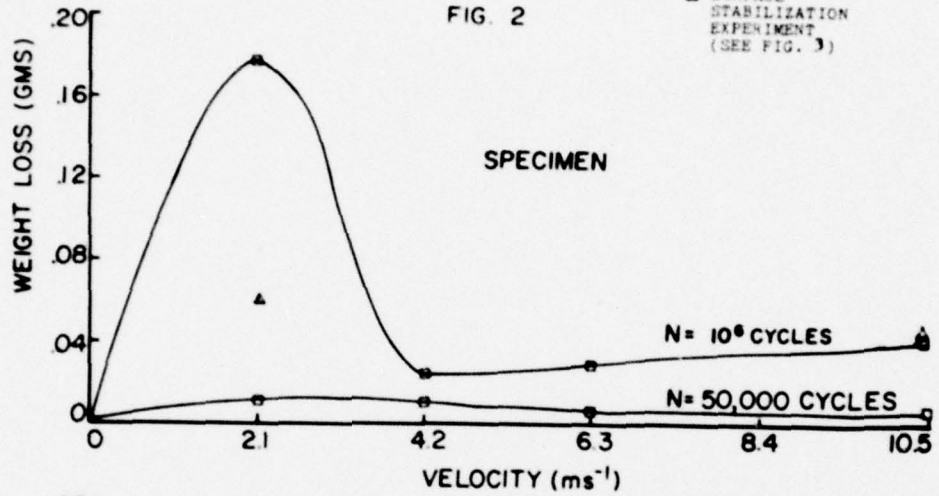
FIG. 2

EXTENDED CYCLE TESTING  
TITANIUM ALLOY RMI 5522S

$\sigma = 18.6 \text{ MPa}$

△ SURFACE  
STABILIZATION  
EXPERIMENT  
(SEE FIG. 3)

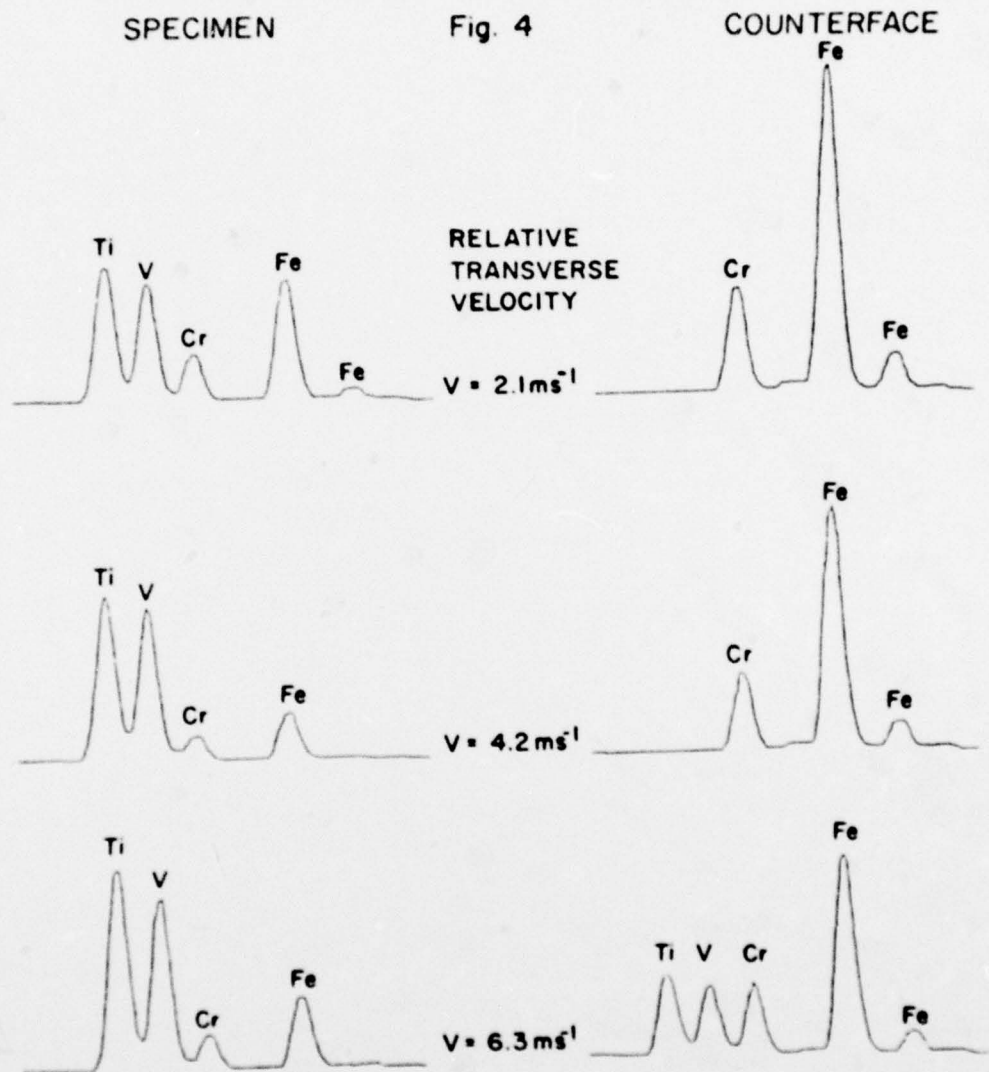
ENERGY DISPERSIVE X-RAY RESULTS

RMI BETA TITANIUM

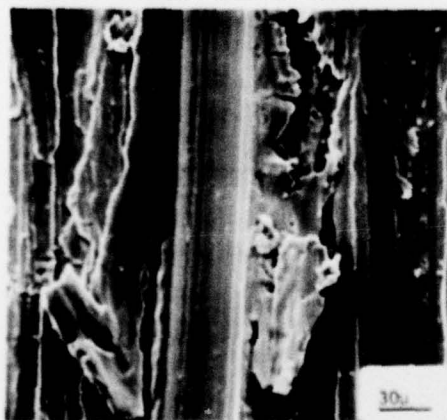
FIGURE 8 Micrograph (SEM) of RMI 5522S, worn surface. ( $V=2.1 \text{ ms}^{-1}$ ,  $\sigma=18.6 \text{ MPa}$ ,  $N=10^6$  cycles).

Figures 8 and 9 are indicative of surface features following wear of the pair RMI 5522S titanium alloy specimen against 17-4 PH stainless steel counterface. Figure 8 shows the specimen; plowing grooves and lamellar wear sheets are clearly defined. Figure 9 shows the counterface, and the deposit of transferred material (with a characteristically layered morphology) over a previously plowed area. Note both Figures 8 and 9 illustrate worn surface appearance from a material pair tested at 2.1 m/s. The worn surfaces produced from experiments conducted at 4.2 m/s are decidedly different, as can be seen in Figures 10 and 11, showing specimen and counterface respectively. The difference between the worn surfaces produced at the two velocity levels underlines the significance of the combined effects of gross external variables (stress, velocity) and chemo-mechanical material processing which occurs in situ. From observation of oxide film formation with variation in color from bright blue to straw yellow, surface temperatures during testing are estimated to have reached roughly 800°C.

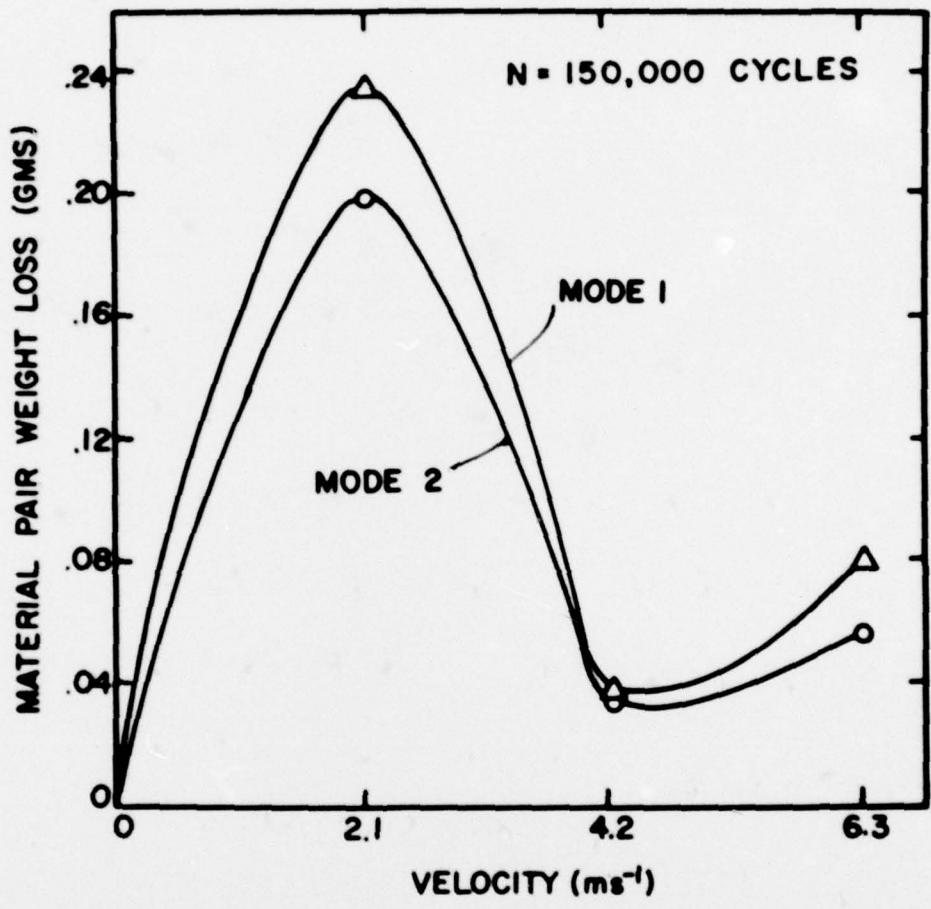
Fig. 13

COTAC (Co-10Ni-12Ta-.75C)

As is well known, fiber orientation is an important parameter not only in terms of strength but also in terms of wear [9,10,11]. Accordingly, two fiber orientation modes were utilized in impact wear testing, as described in Figure 12. Some weight loss data are presented in Figure 13 where results have been obtained for test durations of 150,000 repetitive load cycles at a fixed level of nominal peak normal impulsive stress (18.6 MPa). The velocity dependence is evident from these data, but the effect of fiber orientation is seen to be negligible.
