NAVAL MEDICAL RESEARCH INST BETHESDA MD  
OPERATION SNAPPER, NEVADA PROVING GROUNDS, APRIL-JUNE 1952, PRO--ETC(U)  
DEC 52 R H DRAEGER , M EICHER , T S ELY

AEC-WT-527

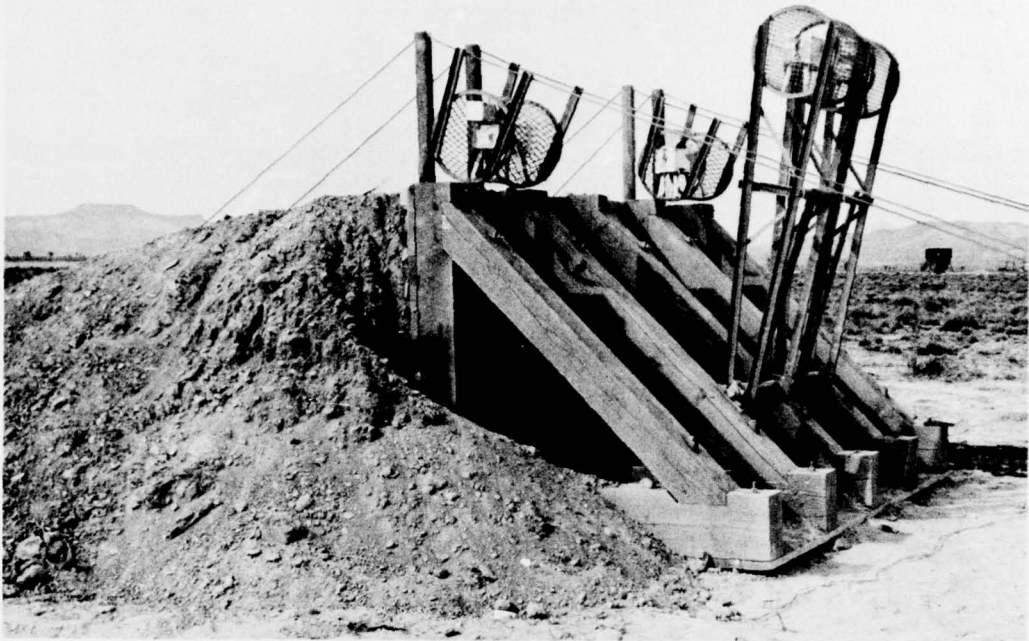
Fig. 1.1 Blast Barrier with Open Mesh Blast Exposure Cage, Side View

18 inches and length of 22 inches. The ends were reinforced by 1 x 2 inch steel channel welded to the wire mesh, one end having an 11 x 14 inch door.

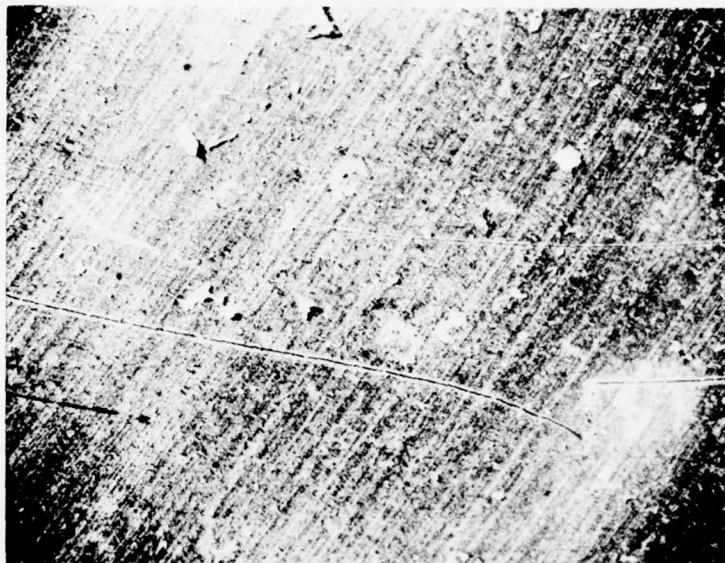
Fig. 1.15 Photomicrograph of Air Pressure Changes Mechanical Clock Recorder No. 12, 1114 Feet Ground Range, Shot 3, about 21x

In Shot 3 all pressure recorders were recovered undamaged from the five cylindrical exposure containers. The pressure data obtained are given in Table 1.3. In Shot 4 the first station was completely destroyed. The pressure recorders were recovered undamaged from the other four stations. The pressure data obtained are given in Table 1.4. Approximate phase relations for Shots 3 and 4 are given in Table 1.5. Selected photomicrographs of air pressure changes are given in Figs. 1.15 through 1.18.

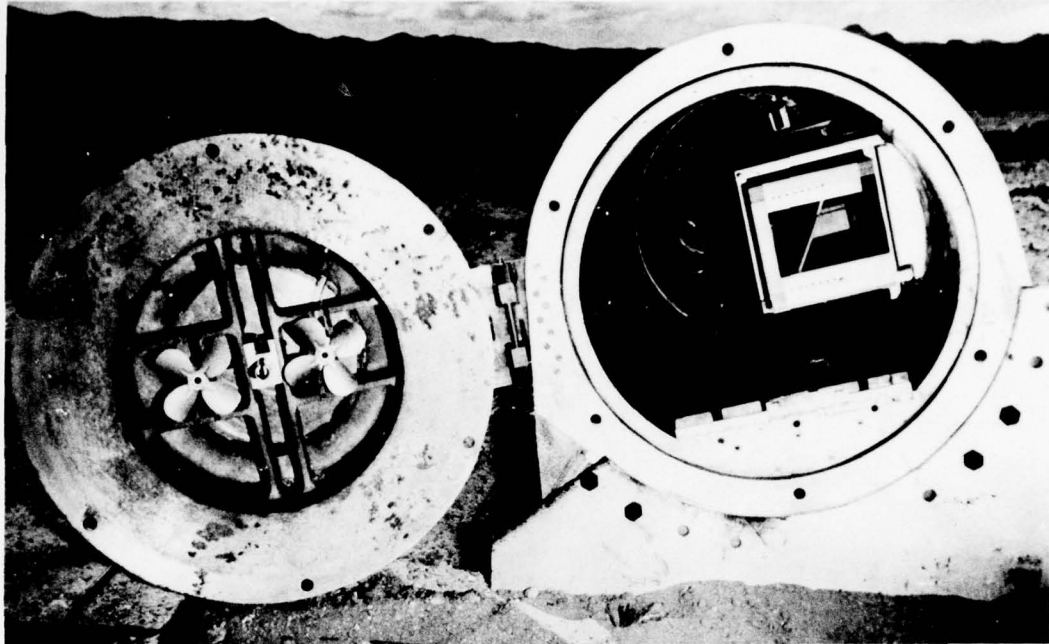
Fig. 2.8 Cylindrical Thermal Exposure Unit with Shutter Housings Open Showing Animal Container, Heater and Ventilation Fans

ventilation fans which maintained a moderate flow of air through the exposure container, Fig. 2.8.

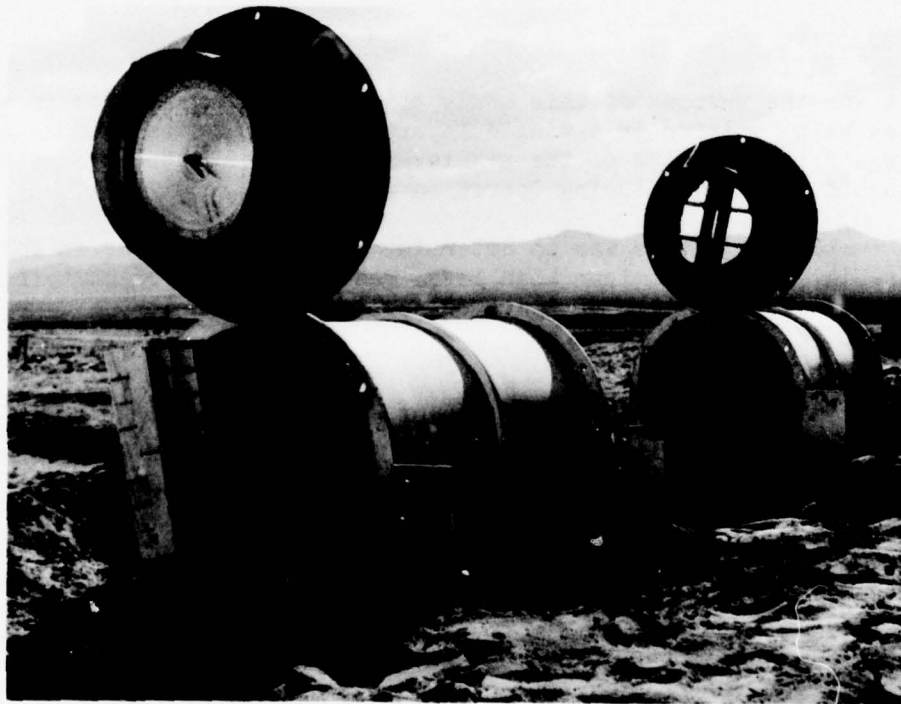
Operation GREENHOUSE cylindrical animal exposure containers mounted on timber skids as described in 1.4 were used for the exposure of single layered mouse cages, Fig. 3.1

These cages were constructed of 1/4 inch plywood having perforated metal covers. The cage was divided into 96 separate compartments arranged in eight rows and 12 columns each having inside dimensions of 2 x 2 1/4 x 3 inches.

Fig. 3.1 Single Layer Multicompart ment Mouse Cage Positioned in Animal Exposure Container

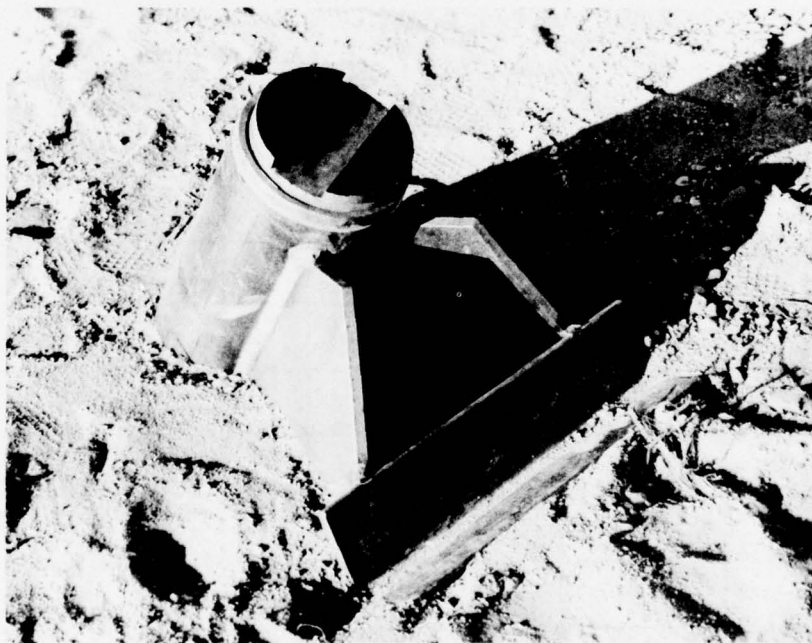
Fig. 3.2 High Level Radiation Exposure Container

In order to reduce the attenuation of radiation caused by the heavy steel walls of these containers they were redesigned and constructed entirely of aluminum. Vycor glass dosimeters were used to measure ionizing radiation.

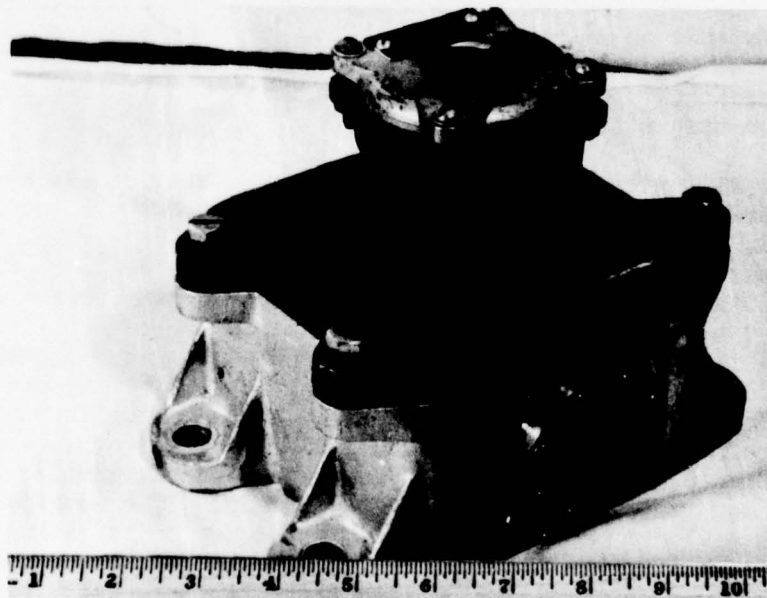
Fig. 4.1 Photoelectric Relay

Figure 4.1 shows the exterior appearance of the photoelectric relay. The housing was a heavy walled cast aluminum waterproof junction box, Navy issue number 17-B-29680. The circuit includes a small vacuum type phototube, a miniature cold-cathode thyatron, a subminiature sealed relay, and associated components, Fig. 4.2. All these components were potted in transparent plastic to improve waterproofing, and resistance to shock and handling. The power supply consisted of a 135-volt miniature B-battery. The potted unit and battery were housed in the junction box, and the reset button mounted on top. Light access was through a window in the side of the box and two pieces of fine metallic screen with a combined transmission of 4 per cent. The screen was necessary to prevent damage to the phototube by the high intensity flash and blocking by direct sunlight.

All units functioned properly. At the close-in stations, a hole was burned through the outer metallic screen but the phototube was not damaged. Since the area could not be entered for several hours the batteries were partially exhausted before the relay could be reset. This necessitated replacement of the batteries for successive tests.
