**PERFORMANCE TESTING OF TWIST DRILLS  
ON AISI 4140 ALLOY STEEL**

**TECHNICAL REPORT**

**DEPARTMENT OF MECHANICAL ENGINEERING  
MICHIGAN TECHNOLOGICAL UNIVERSITY**

**ENGINEERING DIRECTORATE  
ROCK ISLAND ARSENAL  
ROCK ISLAND, ILLINOIS 61299**

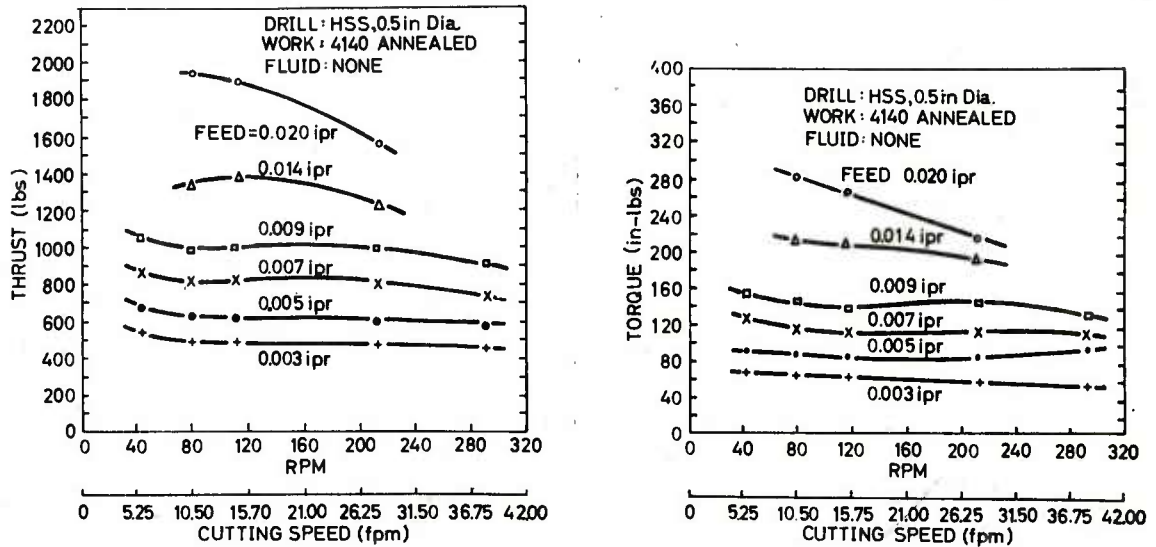
Investigations on the turning of carbon steel, shows that the cutting forces vary as the speed varies from low to high. The cutting speed at which the cutting forces are at a maximum peak, indicate greatest built-up edge formation.

Fig. 13: Drilling Forces at Various Drilling Speeds and Feed Rates

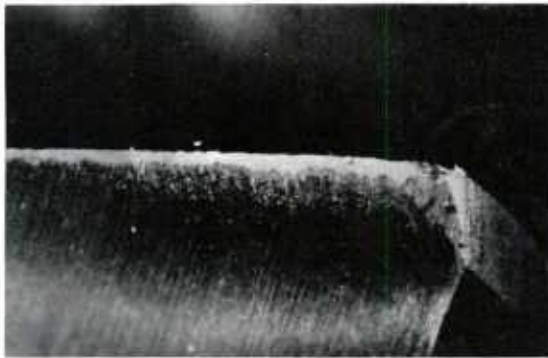
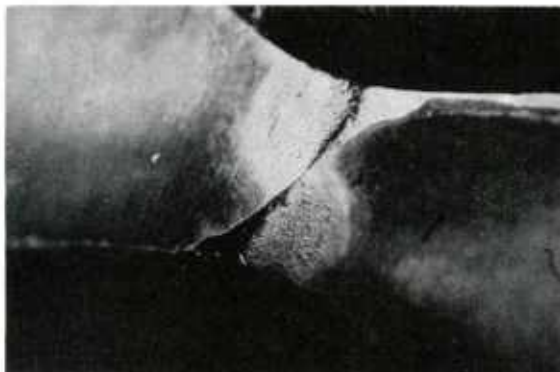
In Fig. 22 and Fig. 23a, the progress of wear on the drill can be seen by observing the increasing number of holes drilled, from 40 to 120. The cutting conditions were: RPM = 207, feed rate = 0.005 ipr, at penetration of 1.75 inch.

RPM = 207      f = 0.005 ipr

*Fig. 22: Progress of Wear on the Chisel and Lip*

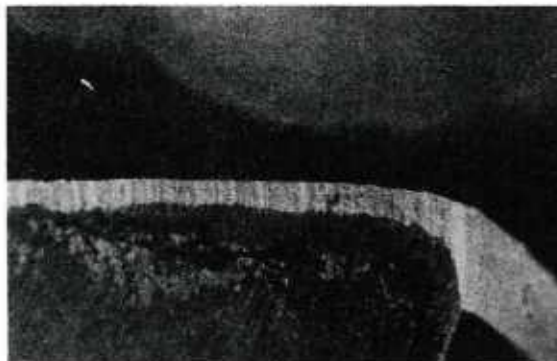
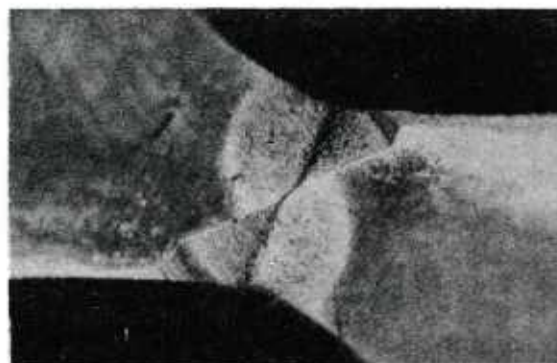
RPM = 207       $f = 0.005$  ipr

After 120 Holes

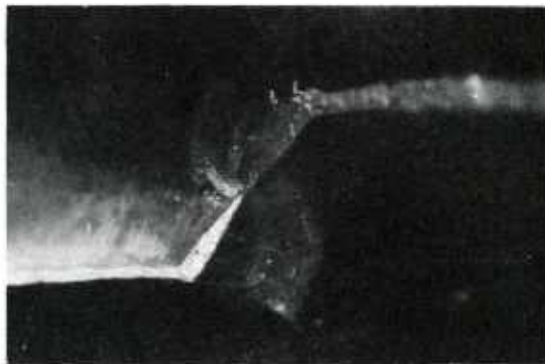
Using the greatest speed, RPM = 574 ( $V = 75$  fpm), it was distinctly noticeable that BUE was produced on the lip and chisel edge. Due to the protection afforded by the BUE, wear on the lip and chisel were small, even after 200 holes were drilled (Fig. 23b).

Fig. 23b: BUE Protects the Wear of Lip and Chisel

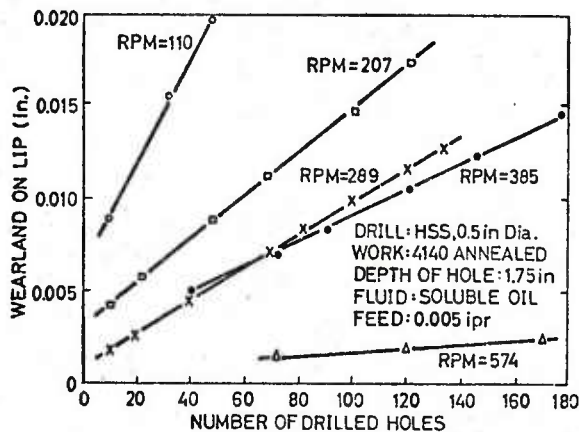
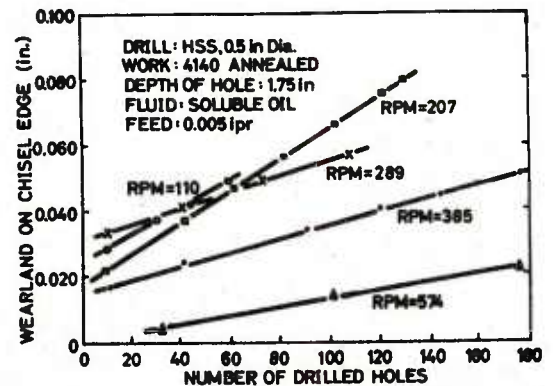
Based on the investigation, the wear land on the lip and chisel edge was tabulated and is plotted in Fig. 25 as a function of the number of drilled holes. The wearland on the lip developed almost proportionately with the increasing number of drilled holes. Also, the proportionality of wear on the chisel edge with the number of drilled holes is clearly indicated in the figure. As mentioned before, with the conditions: RPM - 574; feed rate  $f = 0.005$  ipr, BUE was developed, and in this figure, the maximum height of BUE is marked with the wearland on the lip.

Fig. 25: Wearlands vs Number of Drilled Holes

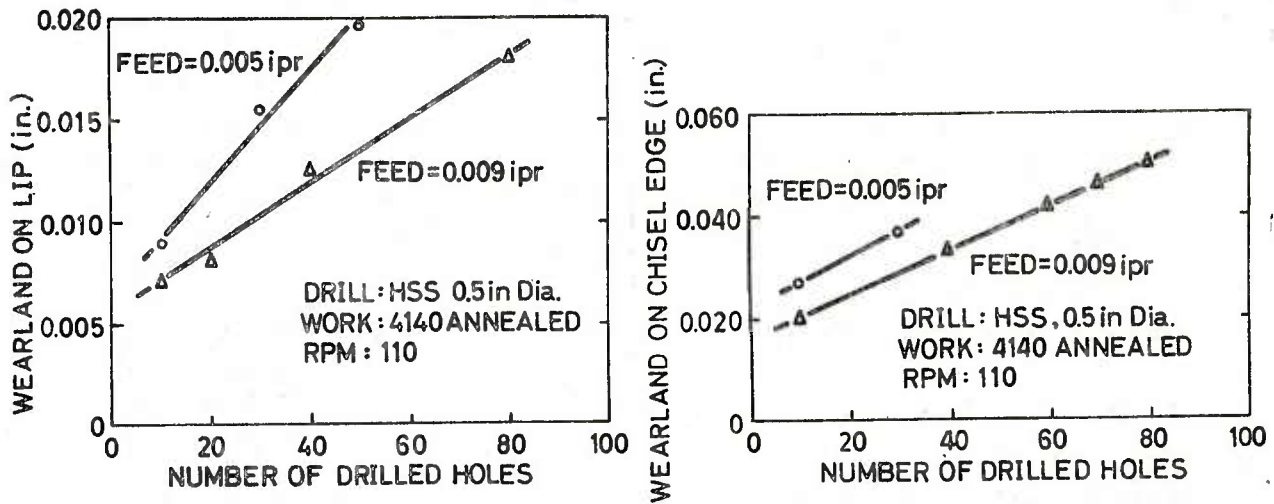
It was of interest to determine what effect feed rate had on drill wear. In Fig. 26 two different feed rates, 0.005 ipr and 0.009 ipr at 110 RPM, were compared in the progress of wear on both the chisel edge and lip. Increased feed rate showed definite decreased wear and also the actual cutting time was reduced. The reasons for this fact are the reduced cutting time, and the probability that increased drilling temperature will cause BUE occurrence which will decrease the wear on the drill.

Fig. 26: Effect of Feed Rate on the Drill Wear

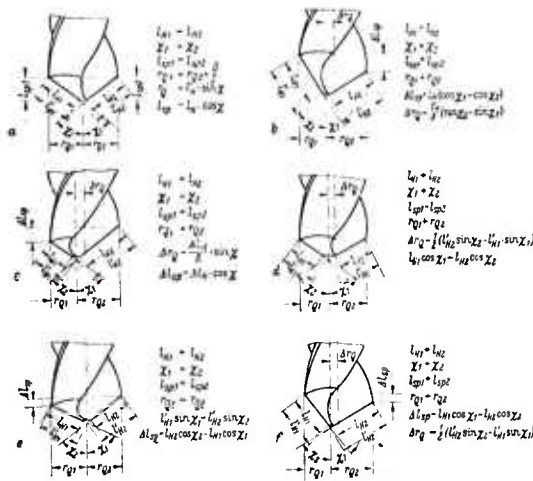
Both the drill manufacturer and user desire to have the drill ground with the highest accuracy possible. However, in practice, it is almost impossible to grind a drill perfectly. With accurately ground drills, regardless of the point angle, the angles of the two cutting lips,  $\chi_1$  and  $\chi_2$  should be equal. Similarly, the length of the two lips,  $L_{H1}$  and  $L_{H2}$  should be equal (Fig. 27a). The point should be symmetrical and the difference in relative lip height should be kept to an absolute minimum. According to

Fig. 27: Examples of Inaccurately Ground Drills (8)

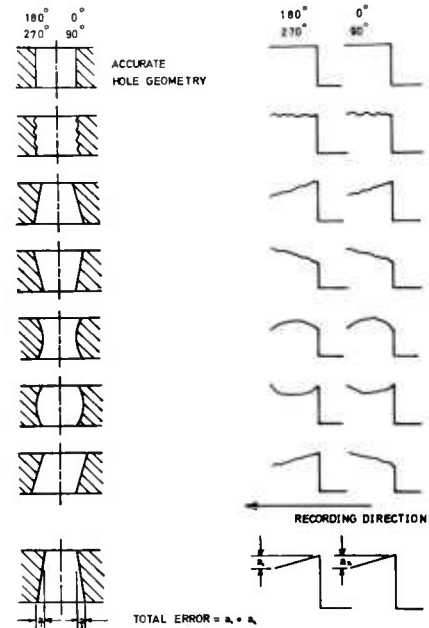
Fig. 38: Classifications of Error in the Hole Geometry after Drilling

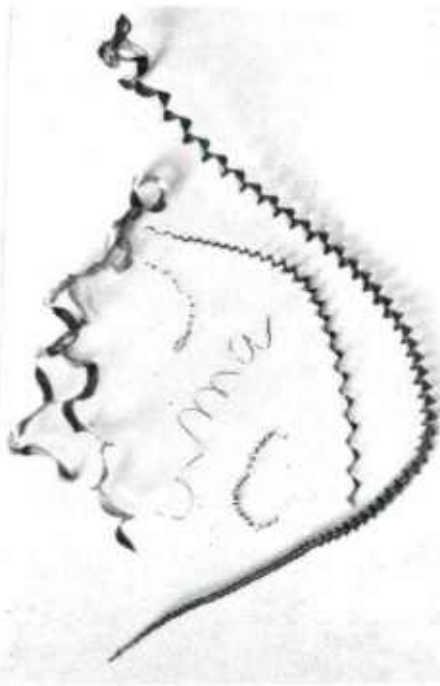
the drill is accurately ground (relative lip height is zero), both lips will remove the same thickness of chip. However, due to relative lip height not being zero, there will be some gap between the two lips which causes a difference in chip thickness during one rotation of the drill, i.e., one lip removes a thick chip while the other removes a thin chip. Naturally, the thin chip has a large fracture strain and this causes the long chip length.

Fig. 55: Chips Produced by Inaccurately Ground Drill

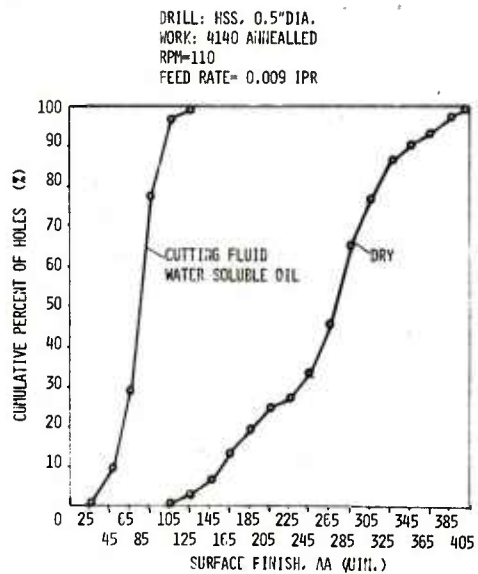
Fig. 61: Percentage Cumulative Frequency Comparing the Surface Roughness Effected by Cutting Fluid

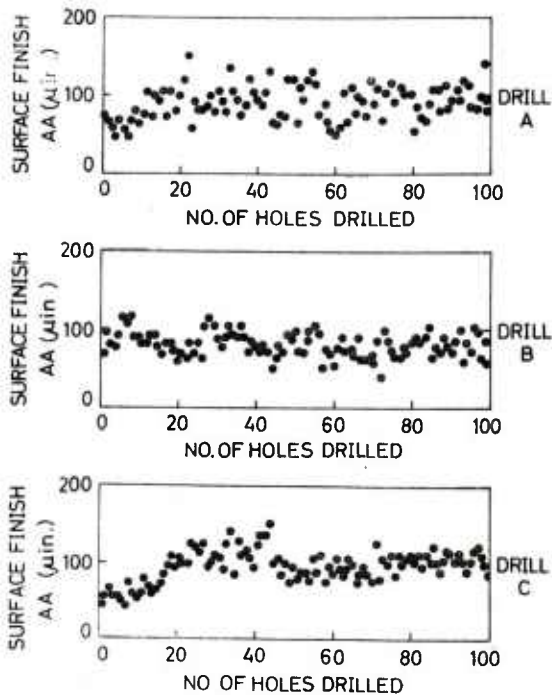
Fig. 63: Surface Finish Generated by Different Drills at Same Condition  
 Drill: 0.5 inch Work: 4140  
 RPM = 207  $f = 0.005$  ipr

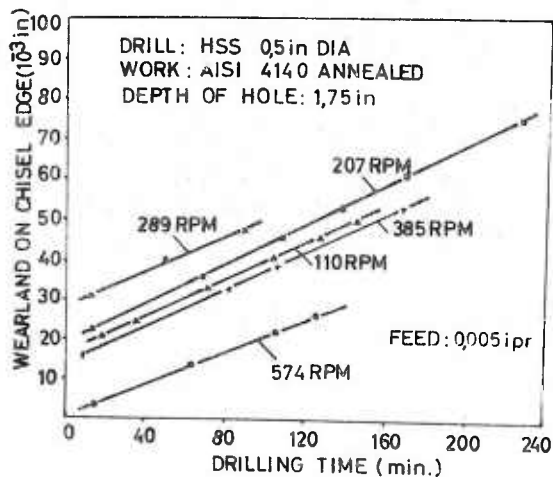
The curve giving the relationship between drilling length and drilling speed was established where the drill life criterion was chosen as a 0.040 inch wearland for the chisel edge. From this curve, it is noted that the drill life curve can be considered in two phases. At first the

Fig. 72: Relationship Between Wear on Chisel Edge and Drilling Time

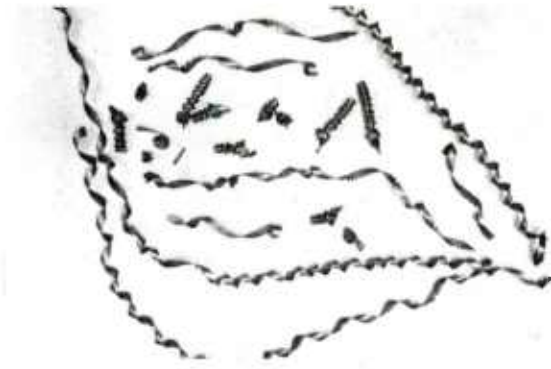
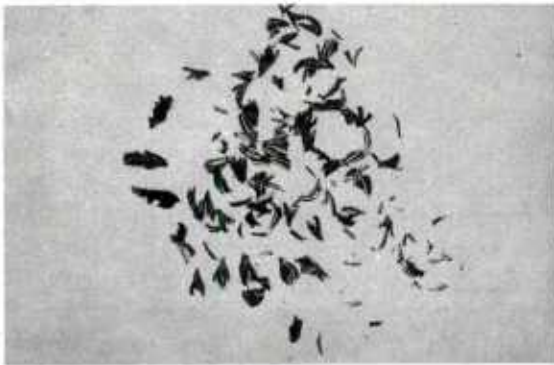
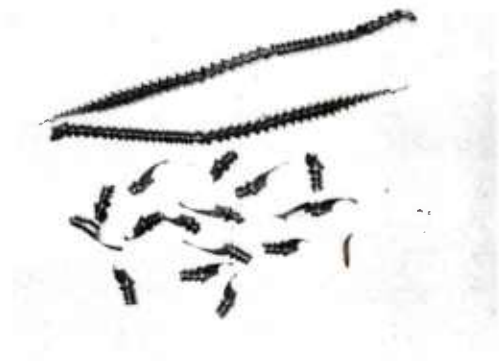
Fig. 77: Effect of Feed Rate on Chip Formation a) Helical b) Racon  
c) Pyrcon

In varying feed rates, each drill geometry produced a different length and form of chip as shown in Fig. 77 a, b, c, d, and e. This investigation involved the use of a coolant. For Regular, Helical, Pyrcon, Split, and V.K. points, the chip lengths decreased as the feed was increased. However, the Racon point showed an opposite trend: with a small feed rate, well broken small chips were observed. At a feed rate of 0.010 ipr, the length of the chips were similar to the length generated by other drills at 0.003 ipr. The reason can be deduced from the fact that the radial lip, which is round and larger than the lip of the other drill geometries, can cut the chip uniformly and easily. The chip removed by the round lip could not coil unless the feed rate was increased.

The reason for the more pronounced BUE formation on the Racon and the V.K. point is as follows: Due to the large lip of the Racon and the zero degree rake angle of the V.K. point, the cutting temperatures were higher, even though the thrust force was reduced by web thinning. Thus, the affinity for BUE formation was higher than in the cases of the other special drills.

$f = 0.005 \text{ ipr}$

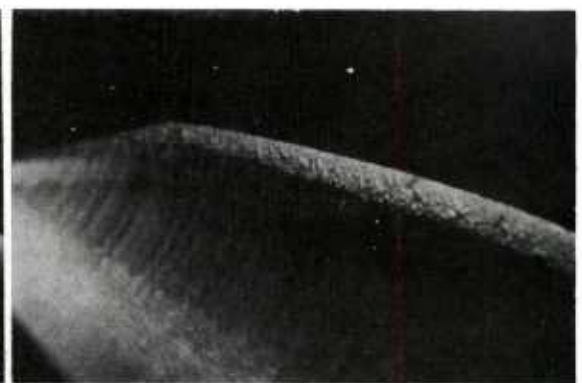
Using a coolant, wear took place on the lip and also on the chisel edge. Fig. 78a shows progress of the wear on the Helical drill. The wear on the lip formed as a slender

After 40 Holes  
RPM = 120  
f = 0.005 ipr

Fig. 78: Wear on Drills a) Helical b) Racon

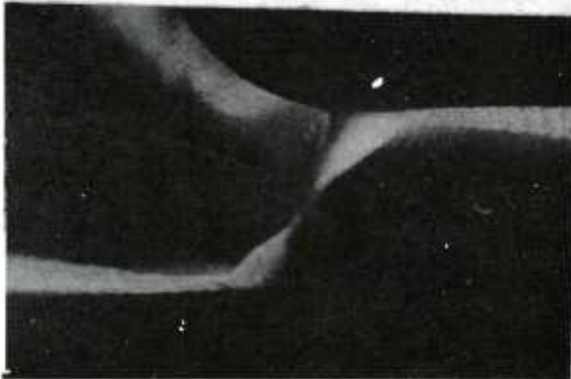
After 20 Holes  
RPM = 120  
f = 0.005 ipr

Fig. 78: Wear on Drills c) Pyrcor d) Split Point

The progress of wear on the Pyrcon drill is shown in Fig. 78c. The wear on both lips and the chisel edge shows similarity with that of the regular drill. It was noted that after 40 holes, the corner of the lip was damaged.

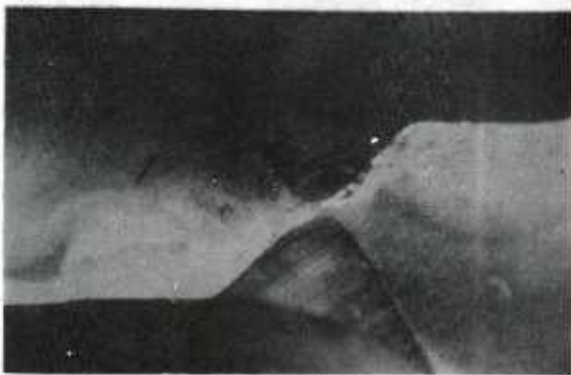
d)

After 20 Holes  
RPM = 120  
f = 0.005 ipr

Wear on the Split point can be seen in Fig. 78d, where its progress is indicated. After 5 holes, this drill was damaged on the lip closest to the chisel.

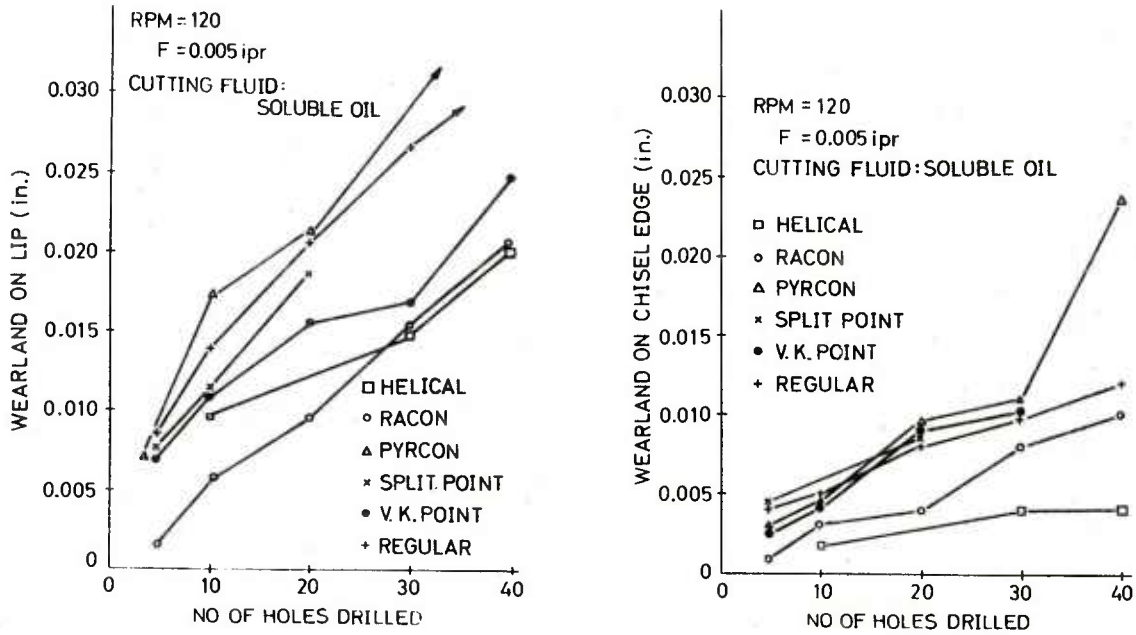
In Fig. 79 - the progress of wearland on the lip and chisel was plotted against the number of drilled holes. The largest lip wear was obtained by Pyrcon and the smallest was Racon drill. The largest chisel wear was by Pyrcon and the smallest was by the Helical drill after 40 holes. This figure was introduced only as an investigative example, because it is not desirable to determine drill performance in regard to drill life from this result. Reliable data can be obtained only after extensive investigation.

Fig. 79: Comparison of Wear in Different Special Drill Geometries

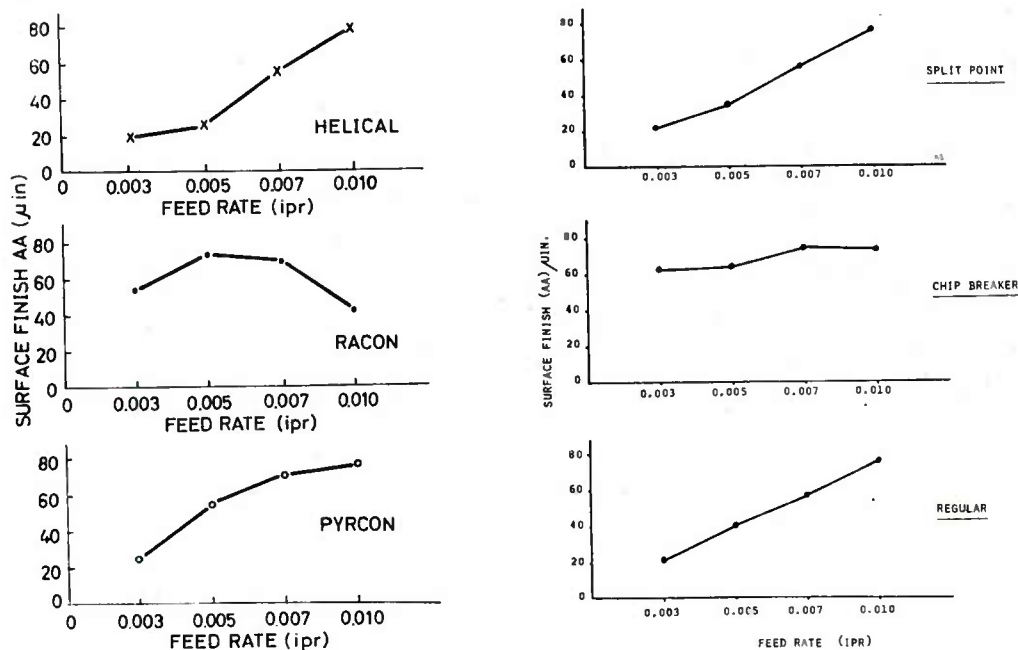
Fig. 80: Surface Finish Comparison of Different Special Drills
