OREGON STATE UNIV CORVALLIS SCHOOL OF OCEANOGRAPHY
EXPOSURE. A NEWSLETTER FOR OCEAN TECHNOLOGISTS. VOLUME 7, NUMBE--ETC(U)
NOV 79 R MESECAR

EXPOSURE

AXBT's For Oceanic Measurements

Electro- mechanical Swivel Termination

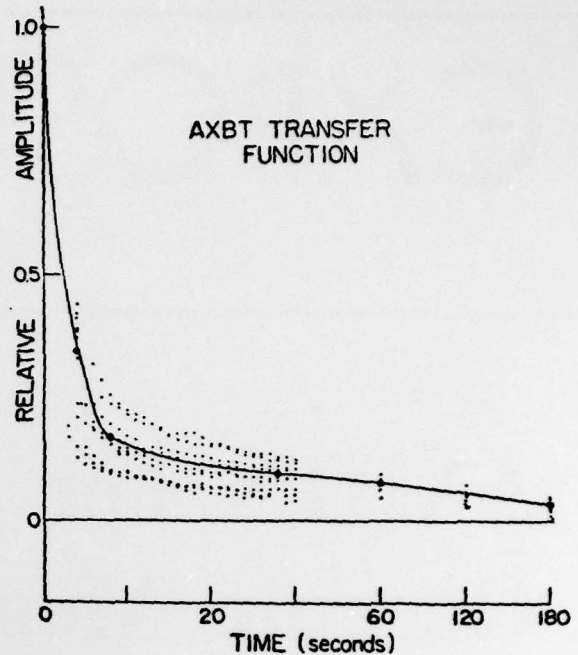
Experimental estimates of response of AXBT's to a step function temperature input. Data are for ten instruments from five different production lots. The heavy curve is the fitted transfer function.

constant of the probe assembly. New time-constant measurements yielded the results shown in Figure 2. Unfortunately, fairly large scatter in the data exists due to uneven coating of the individual thermistors. Since the probes contain pairs of thermistors in series, there can be large differences in each thermistor in the pair.

- 2) the inter- and intra-lot scatter amongst the units used in the time constant determination (Figure 2), or
- 3) the scatter in the observed times between probe release and the start of modulation (= transmission of temperature data), or
- 4) some combination of 1) to 3).
