Research
Paper
FPL 332
1979

Design, Fabrication, Testing, and Installation of a Press-Lam Bridge

Design, Fabrication, Testing, and Installation of a Press-Lam Bridge.

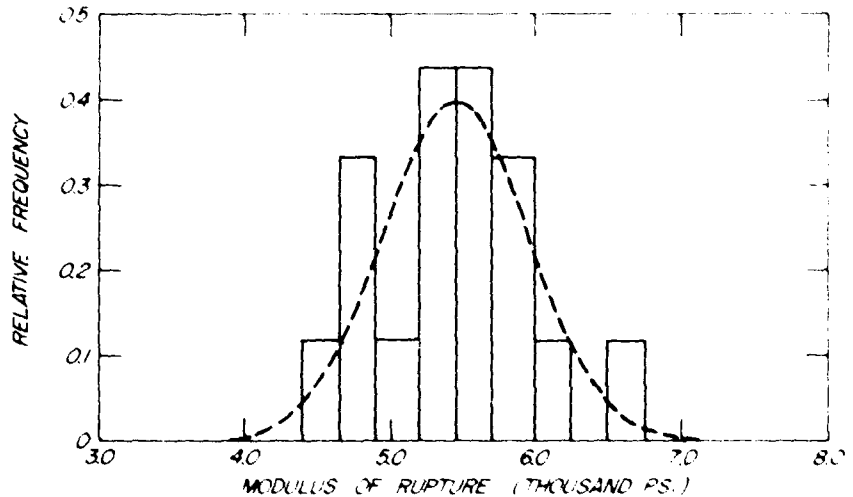
Figure 5 —Histogram of modulus of rupture data and assumed normal distribution for 18 bridge stringers

The average modulus of rupture for these 18 tests was 5,450 psi with a COV of 9 percent (fig. 5). The average modulus of elasticity for all 36 stringers was 1.71 million psi with a COV of 7 percent (fig. 6). Based on these tests and additional tests on treated material, an allowable bending stress of 2,000 psi was derived (Appendix B).

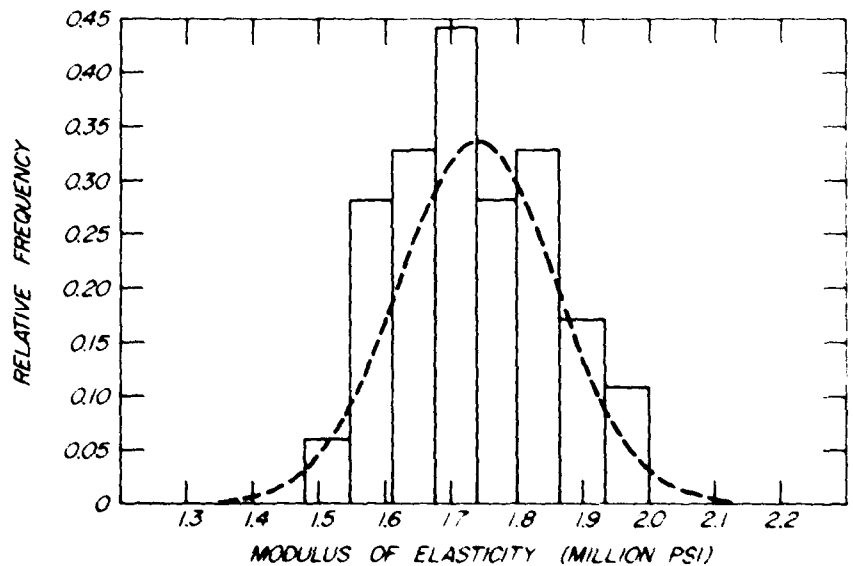
Figure 6 —Histogram of modulus of elasticity data and assumed normal distribution for 36 bridge stringers.

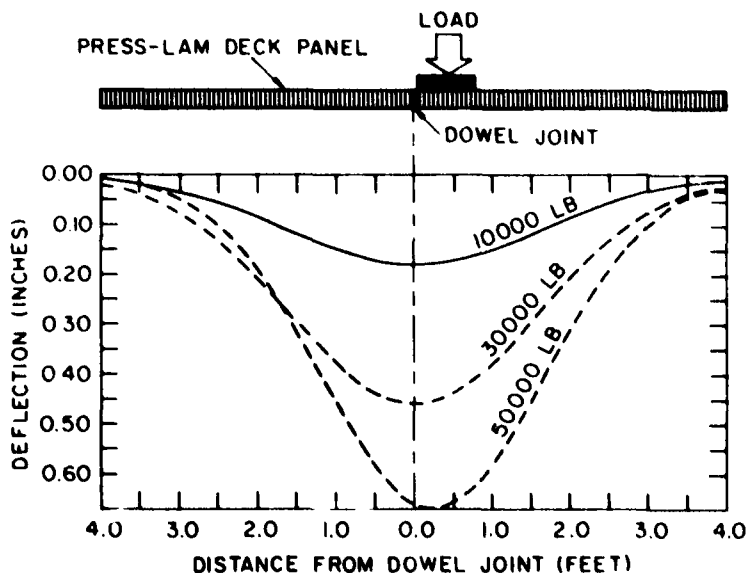
Figure 14. — Deflection profiles across dowel joint at three load levels

provided excellent load transfer with minimal differential displacement between panels (fig. 14).
