✓ RESEARCH AND DEVELOPMENT TECHNICAL REPORT
DELET-TR-80-2

**AUTOCLAVE TESTING OF PLASTIC ENCAPSULATED 400I CMOS
INTEGRATED CIRCUITS**

Richard Holevinski
ELECTRONICS TECHNOLOGY & DEVICES LABORATORY

January 1980

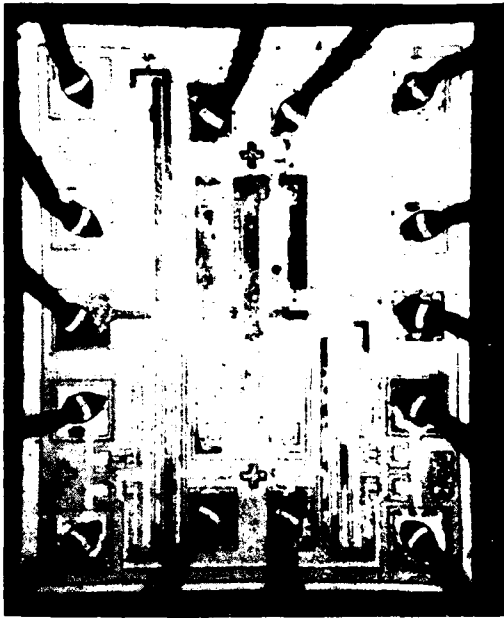
Figure 4. Micrographs of Type 4001 die from vendors C and D.

In Figures 2 through 5, the micrographs show various degrees of aluminum corrosion on some of the 4001-type circuits from the autoclave testing. These micrographs also show the wide range of vendor design layouts used for the circuit dice. Each vendor used his own layout and even these varied from older to newer date coded circuits. Only vendor B used the same layout for both date-coded circuits evaluated.

Type C1 biased for 96 hours

Type C2 biased for 144 hours

Type D1 biased for 120 hours

Type D2 unbiased for 1008 hours

All the decapsulated circuits were inspected with an optical microscope. The obvious failure mechanism of the PEDs was aluminum metal corrosion on the die.^{6,7,8} The greatest concentration of corrosion was found on the wire bonding pads where passivation is removed during processing of the circuits. (Aluminum corrosion of the intraconnects was found where glassivation pinholes or scratches existed.) Occasionally, some PEDs showed evidence of gold metal on the die surface caused by some of the gold bonding wire electroplating to the die surface under the influence of high moisture content and potential differences between bonding wires.

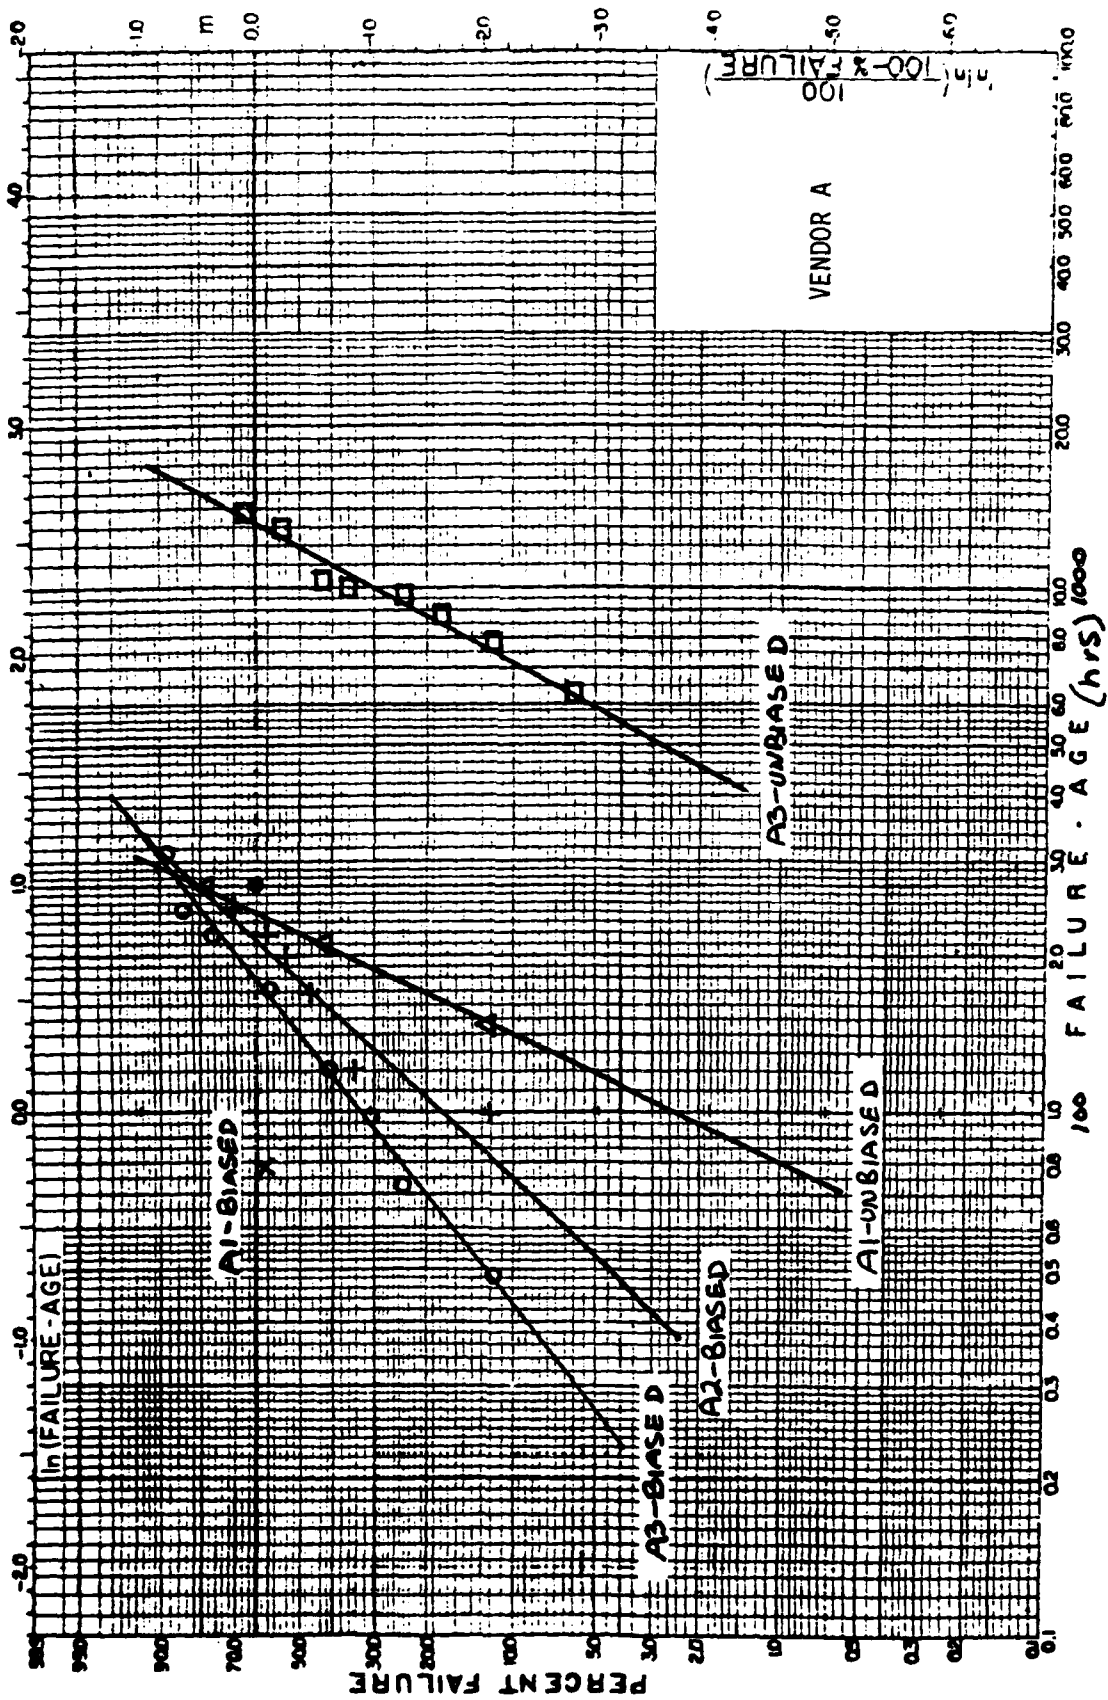
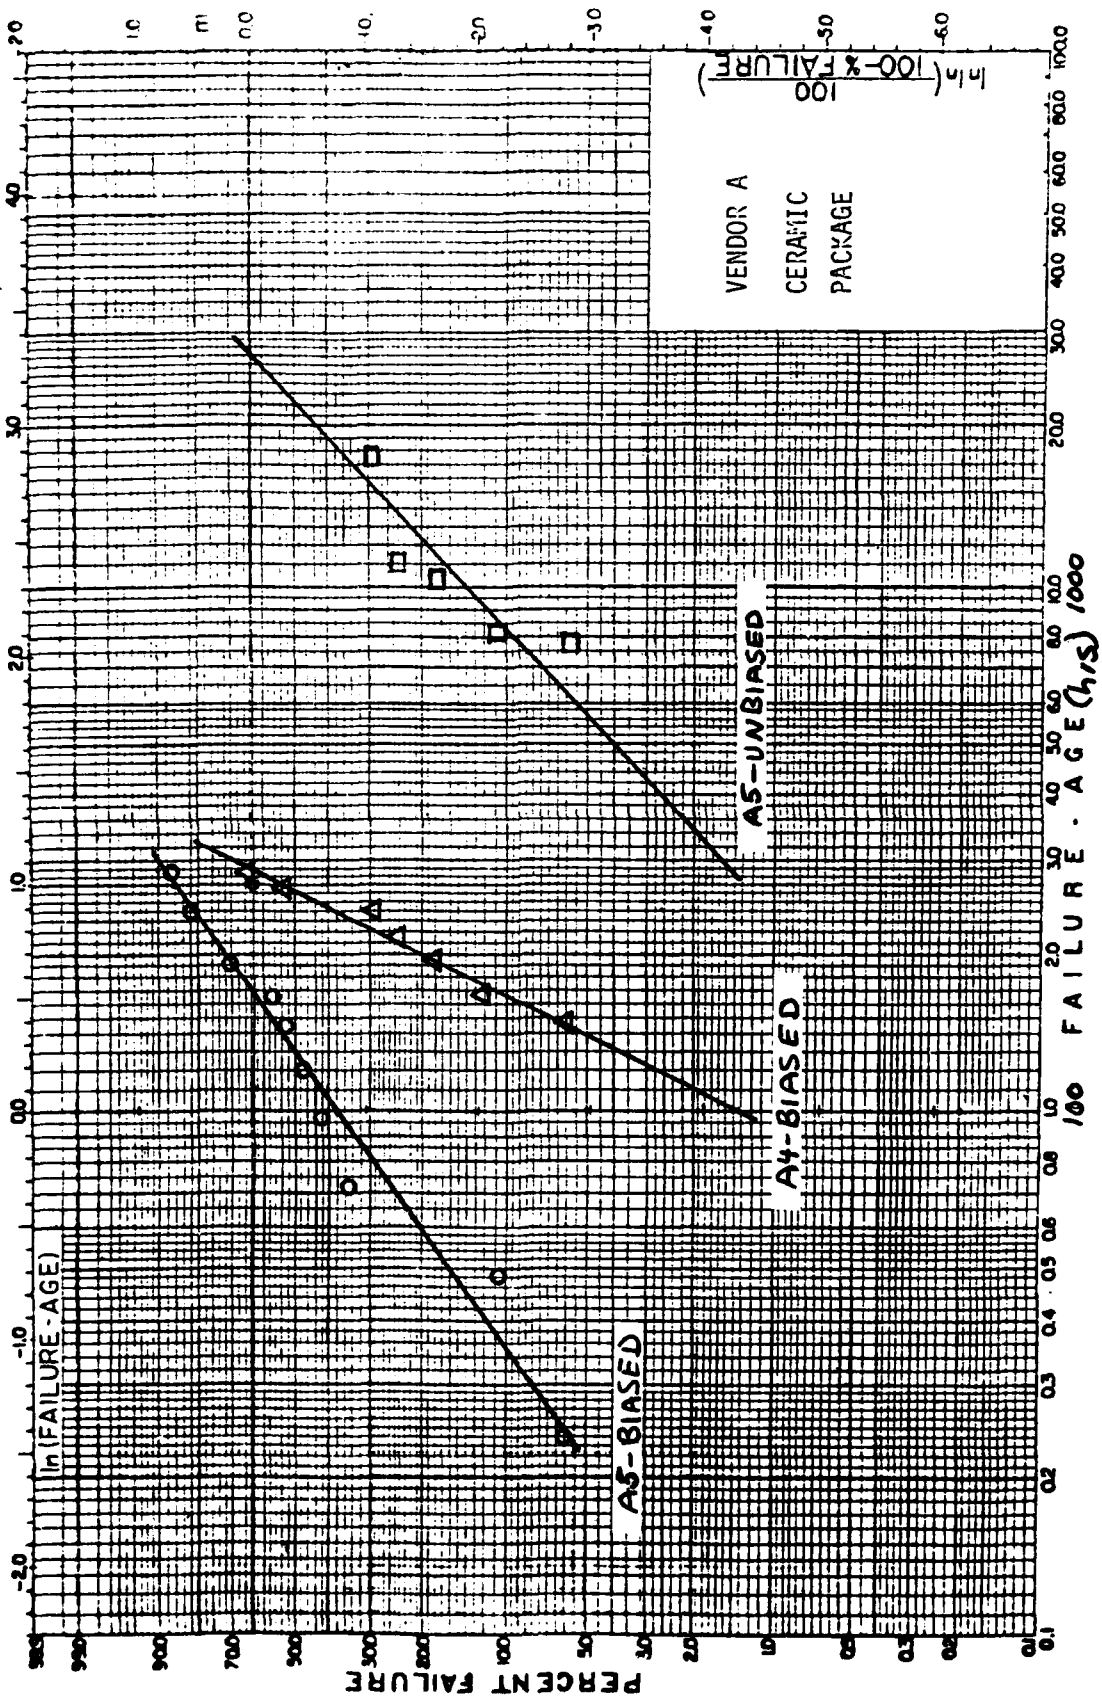
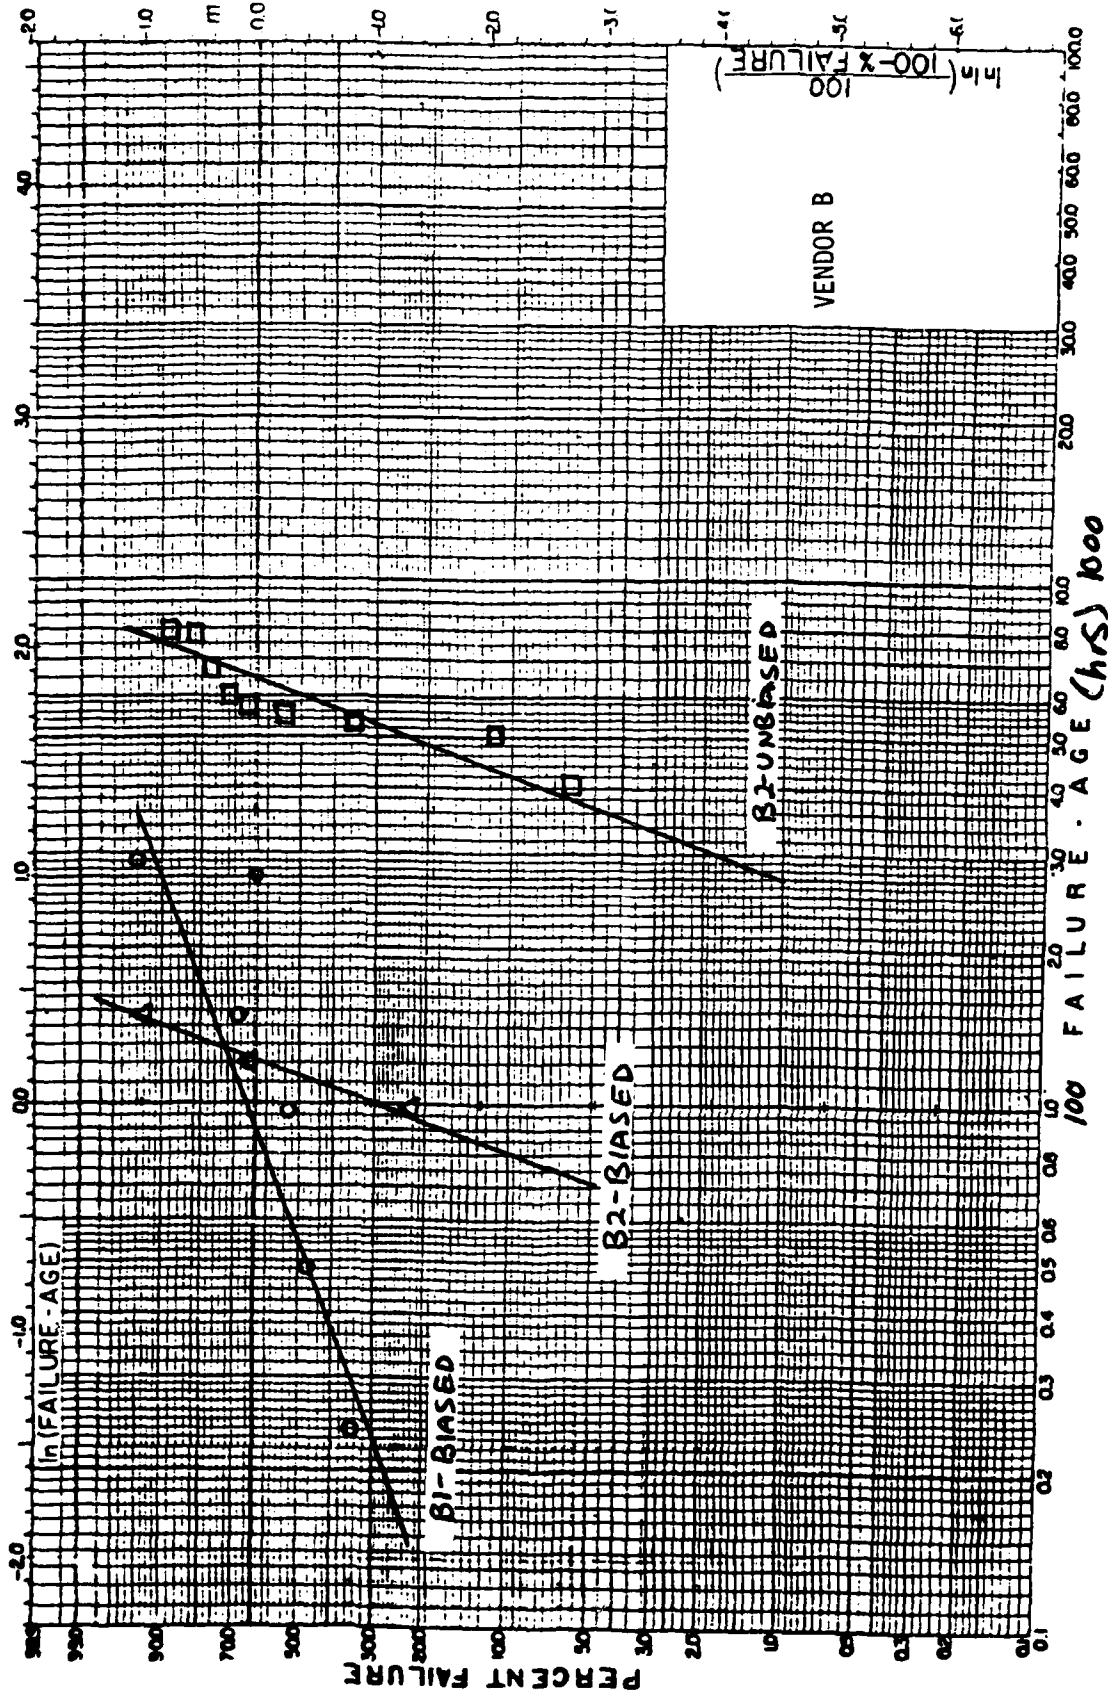
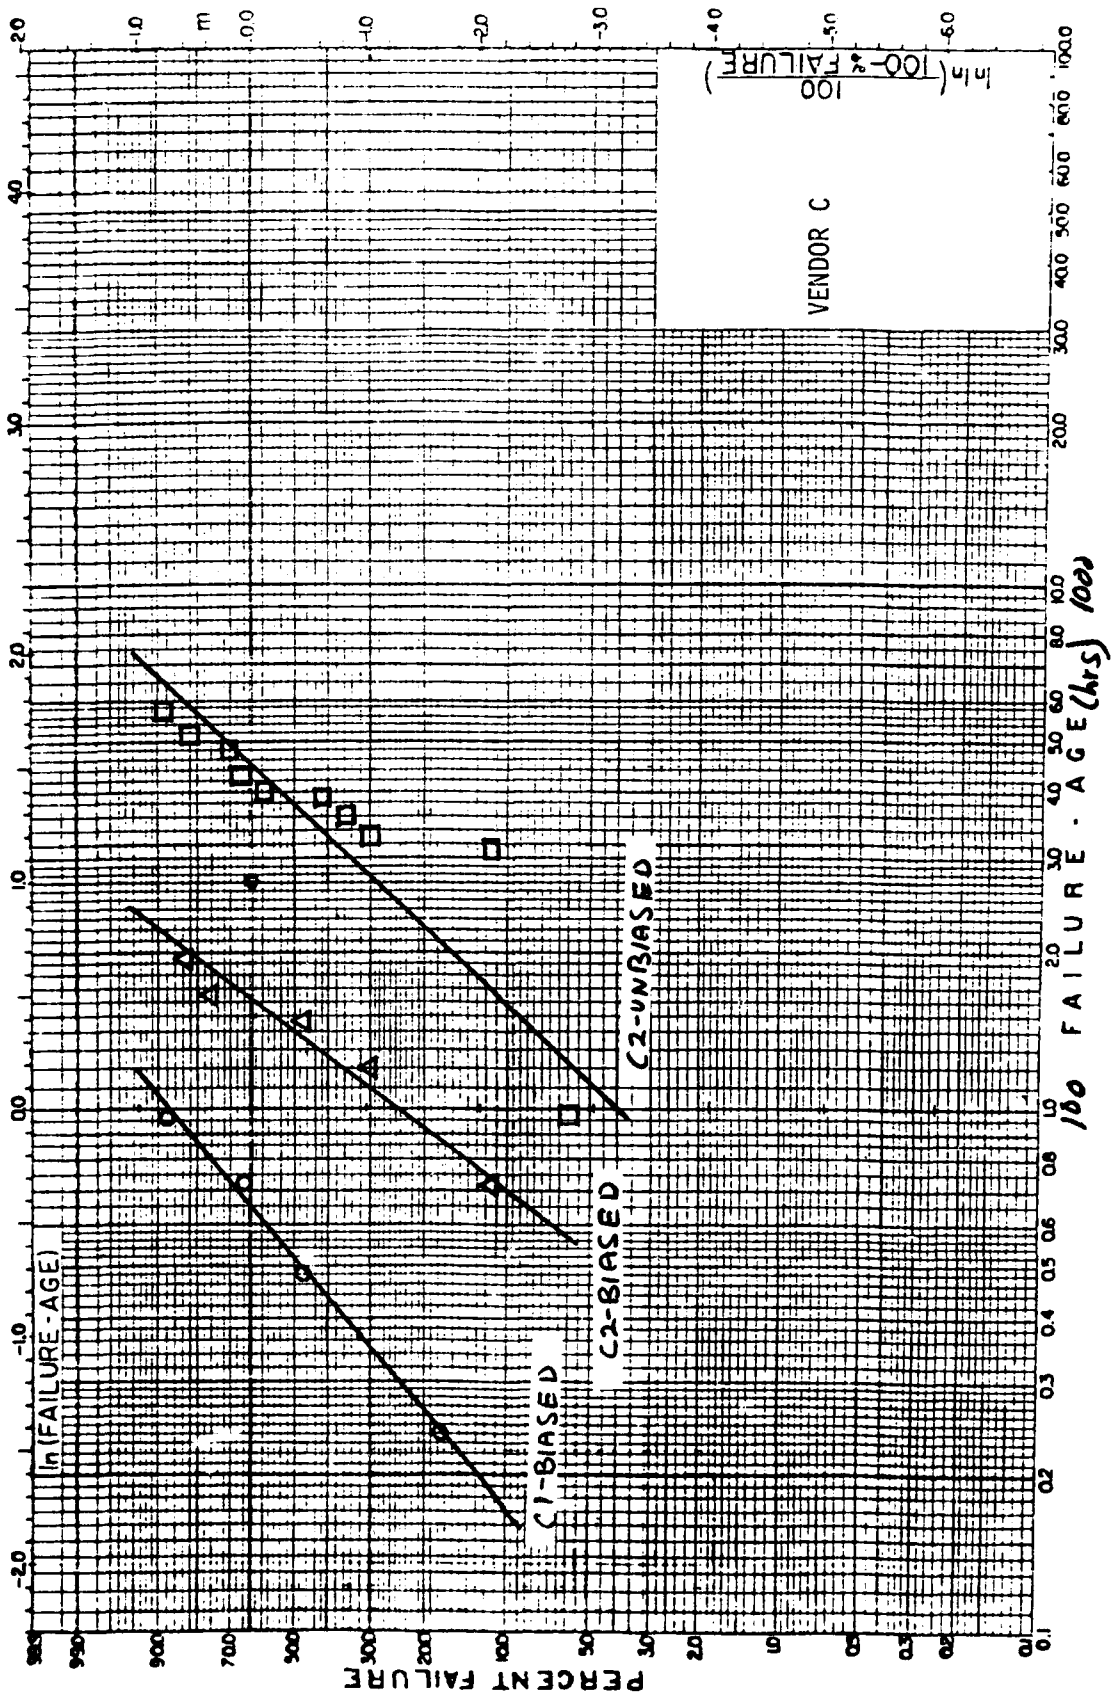
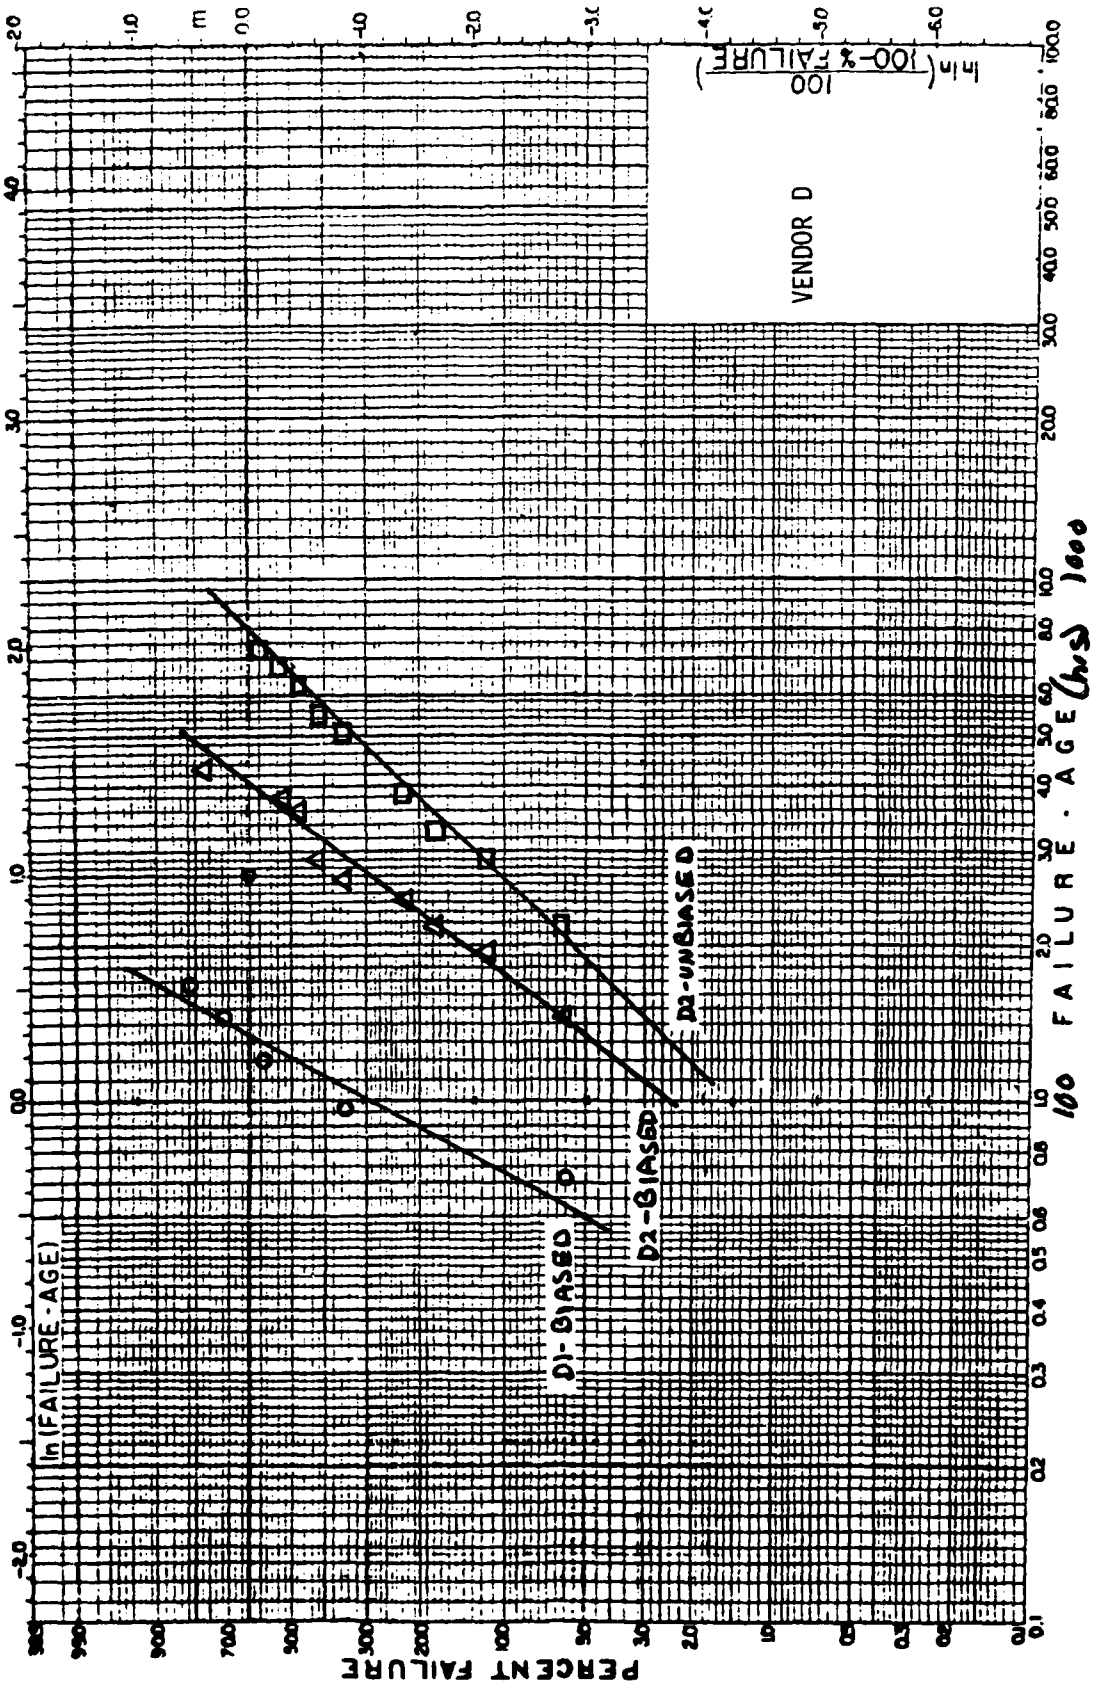
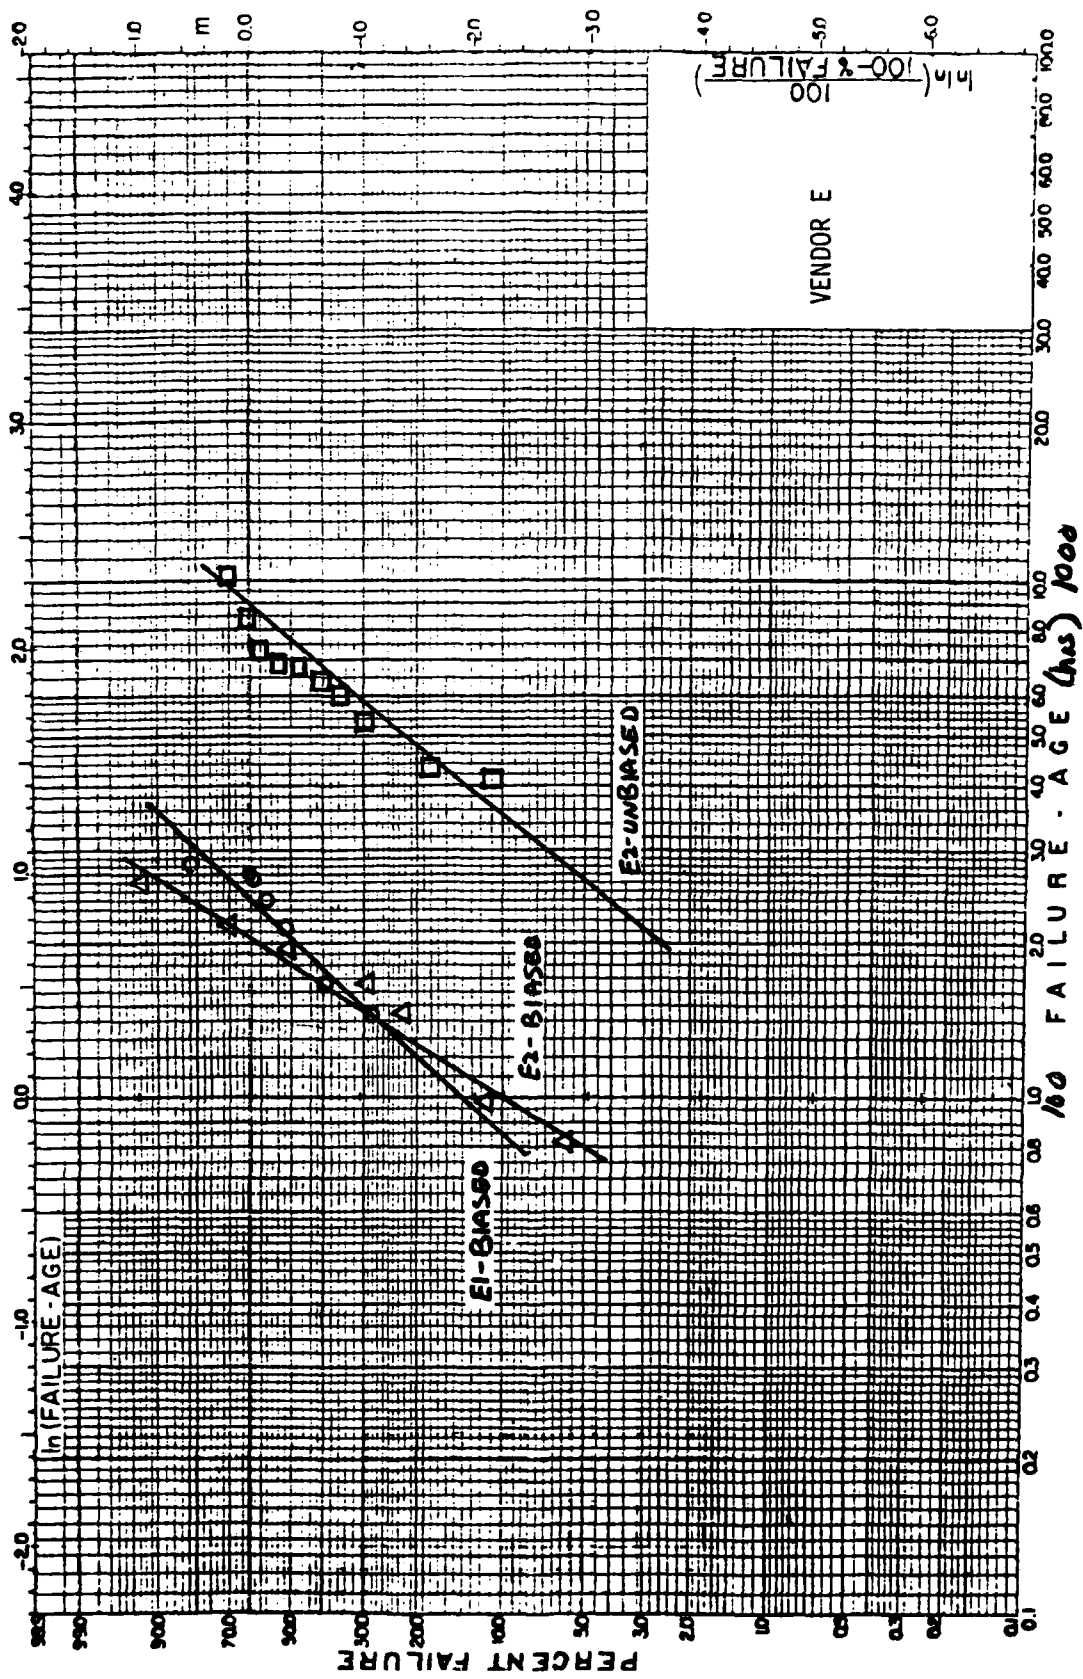
WEIBULL PROBABILITY DISTRIBUTIONS

Each vendor's test data was plotted on Weibull probability graphs and failure distributions were determined for each group. The Weibull graph is a plot of cumulative percent failure versus total test time. Appendix A shows a Weibull probability graph for each vendor group. From the Weibull graphs, the median life in hours, shape parameter or slope of the curve and the correlation coefficient of each curve was determined. In Table 3, this information is tabulated for the vendor groups which were biased at 5 volts in the autoclave. Table 4 contains the tabulated information for the unbiased groups. The consistently high correlation coefficients support the validity of applying the Weibull distribution to the test data.

The shape parameter, which is the slope of the Weibull curve, is a useful parameter because it gives a direct indication of the failure distribution. Shape parameters of <1.0 indicate dominant early-failures by parts having a high proportion of weak or marginal devices. Shape parameters of >1.0 indicate a wearout behavior by parts that fail within a short time span. The importance of the shape parameter is reflected by the results of vendor B. This vendor was the only one to use the same style die for both the older (B1) and newer (B2) date-coded parts. The data distributions for the biased autoclave test shows that the shape parameter changed from 0.7 to 5.5 with a corresponding increase in median life from 55 to 110 hours. This substantial effect on the shape parameter was promoted by a simple change of plastic encapsulant from silicone to an
