Report No. FAA-RD-80-28

## WEST COAST LORAN-C FLIGHT TEST

March 1980

Final Report

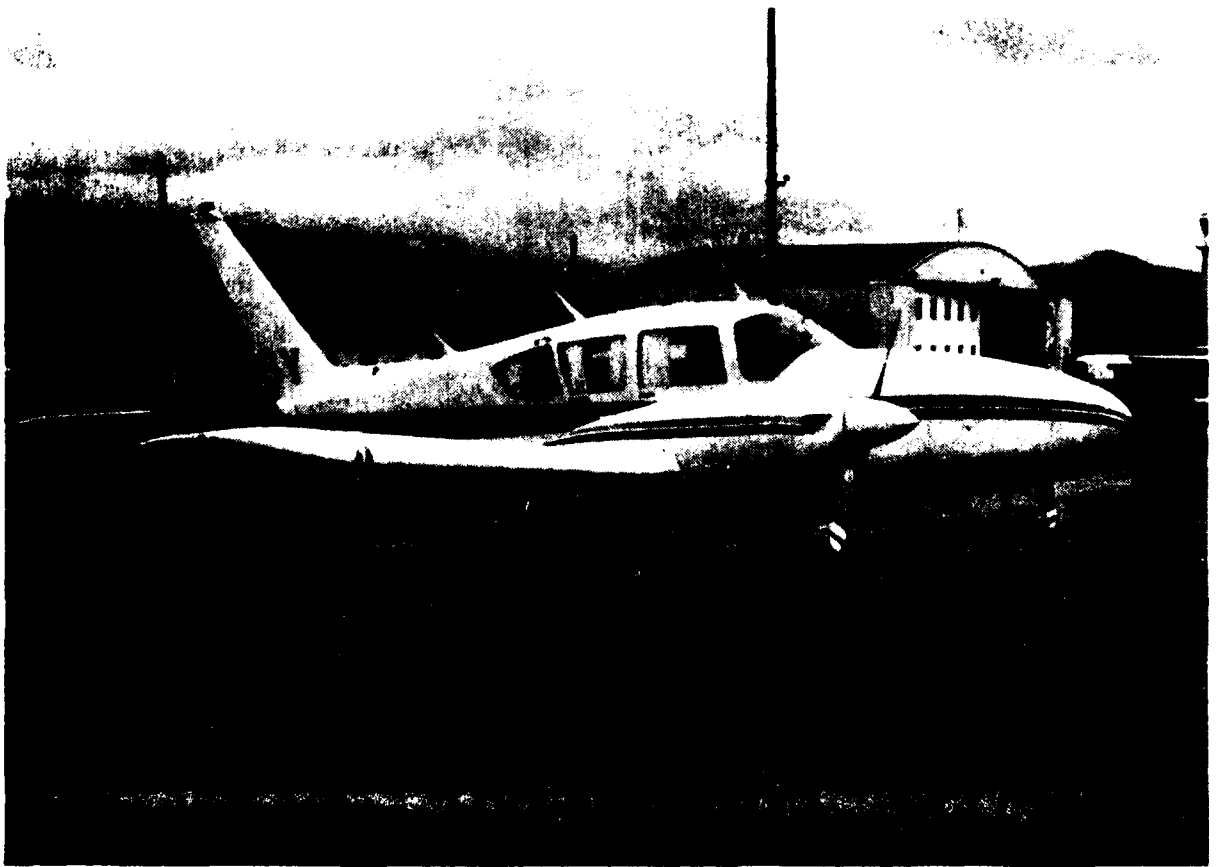
Figure 3.1 Flight Test Aircraft, N6686Y
