CIVIL ENGINEERING LABORATORY  
Naval Construction Battalion Center  
Port Hueneme, CA

DEVELOPMENT OF A SEAWATER HYDRAULIC VANE MOTOR FOR  
DIVER TOOLS

April 1980

An Investigation Conducted by  
WESTINGHOUSE ELECTRIC CORPORATION  
→ Oceanic Division  
P. O. Box 1488  
Annapolis, MD

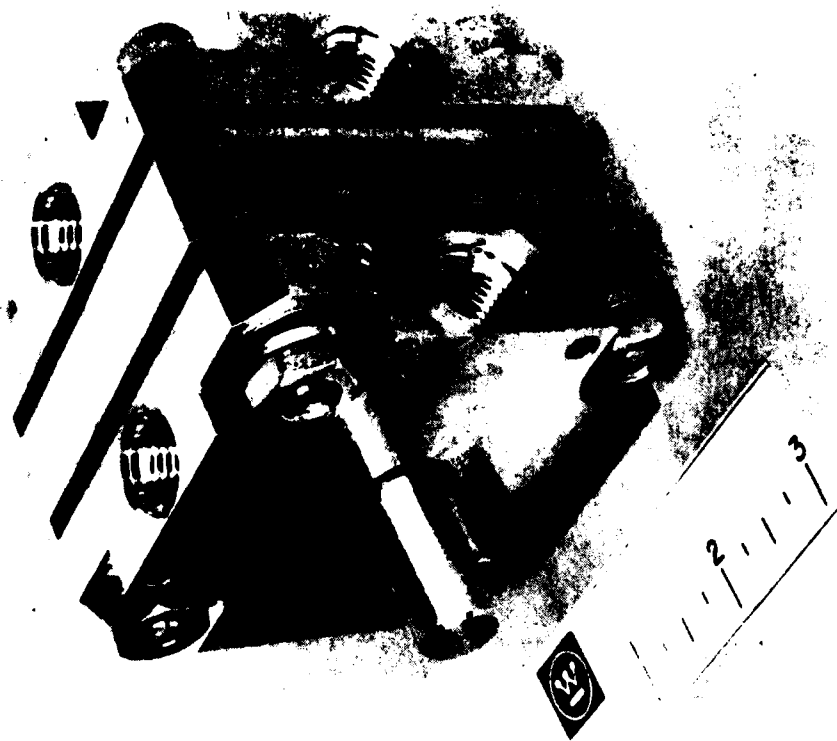
80036A03-9264-1

*Figure 5. Phase I Developed Engineering Model*

The seawater motor is shown assembled in Figure 5 and partially disassembled in Figure 6. Figure 7 shows critical parts after the motor was disassembled to replace springs during its 50-hour test.
