**THESIS**

THE INFLUENCE OF THERMOMECHANICAL PROCESSING  
AND HEAT TREATMENT ON THE FATIGUE RESISTANCE  
AND FRACTOGRAPHIC CHARACTERISTICS OF  
A HIGH-CARBON BEARING STEEL

Ik Sik Chung

December 1979

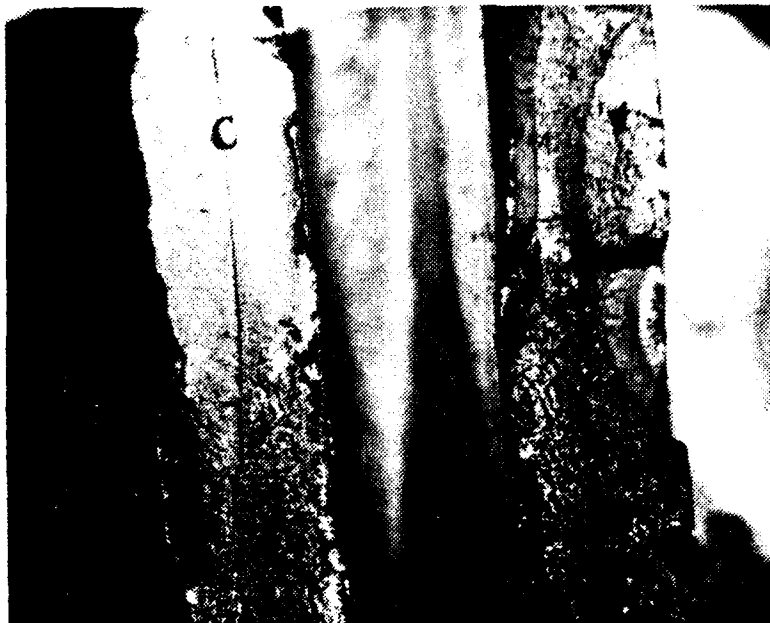
Figure 21. Macrophotograph of fatigue-fracture surfaces for specimen AR-2-1, fractured after 7,600 cycles at 100 ksi, showing several sites of fracture initiation. X10.

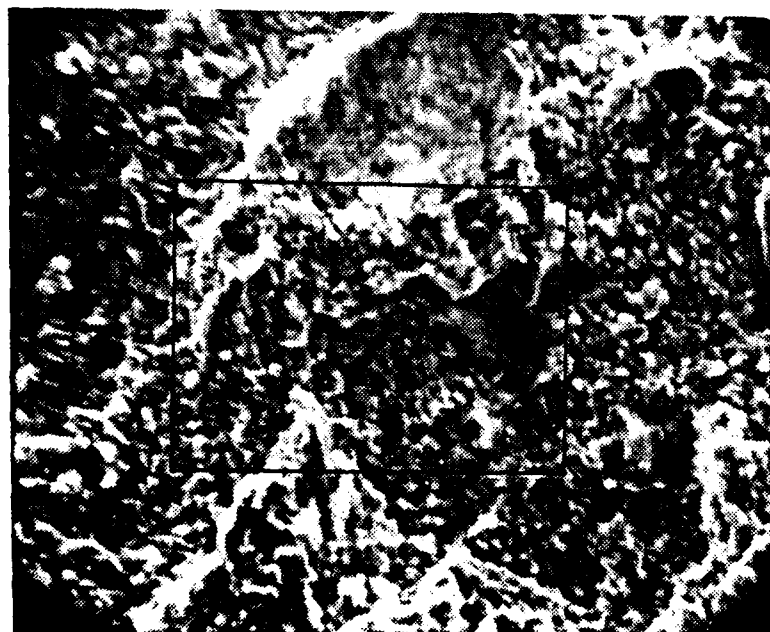
Figure 31. SEM fractograph of Fig. 30, in the fatigue zone, showing transgranular fracture and many secondary cracks. X1200.

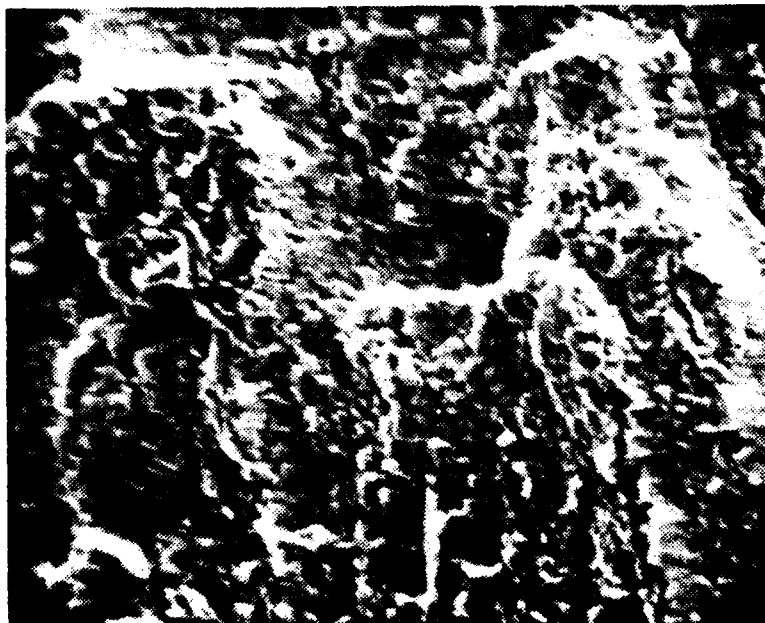
Figure 33. Higher magnification view of the fast fracture region B of Fig. 30, showing characteristic fracture surface of "lamella shape." X1200.

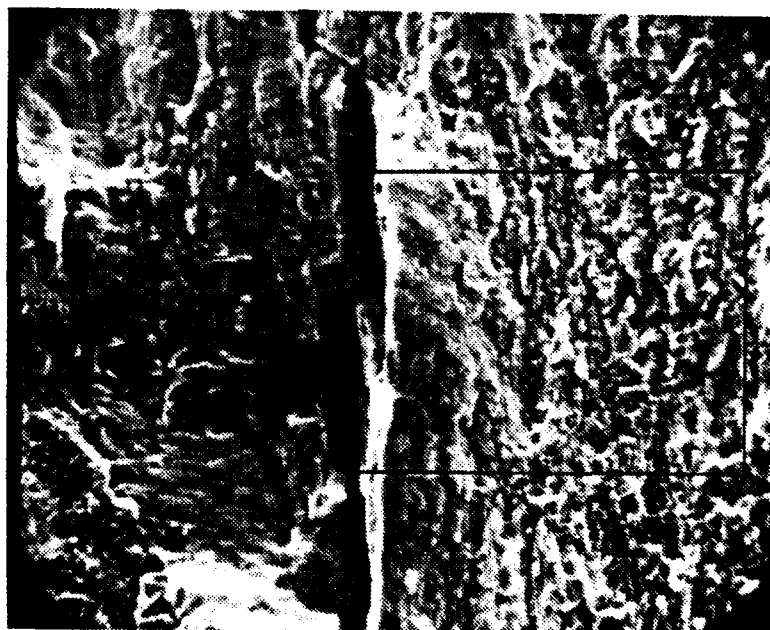
Figure 51. Fractograph on the boundary between the fatigue zone and fast fracture zone in the same specimen of Fig. 50. Quasicleavage with deep secondary cracks is evident. X1000.

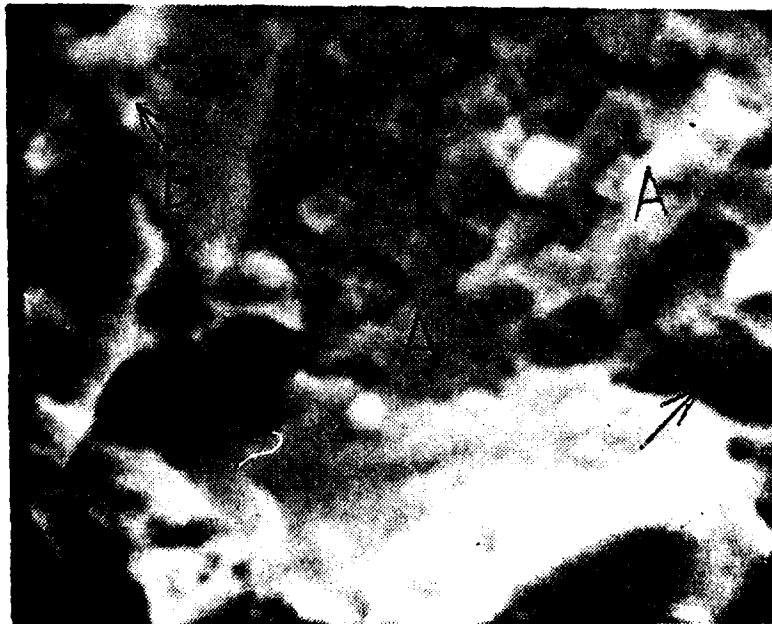
Figure 60. The area outlined by rectangle in fractograph Fig. 59, shown at higher magnification: brittle cleavage facets (marked A), deep secondary cracks (at arrow) and dimples (marked B) are evident. X5000.

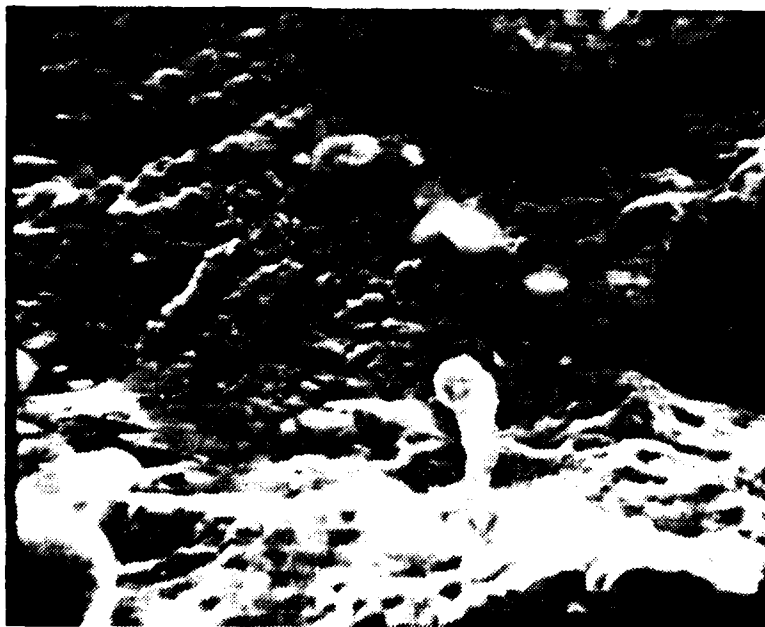
Figure 81. Higher-magnification fractograph of the specimen shown in Fig. 80 (RI-1-6) in the vicinity of fracture nucleus (lower right corner in Fig. 80). X2200.

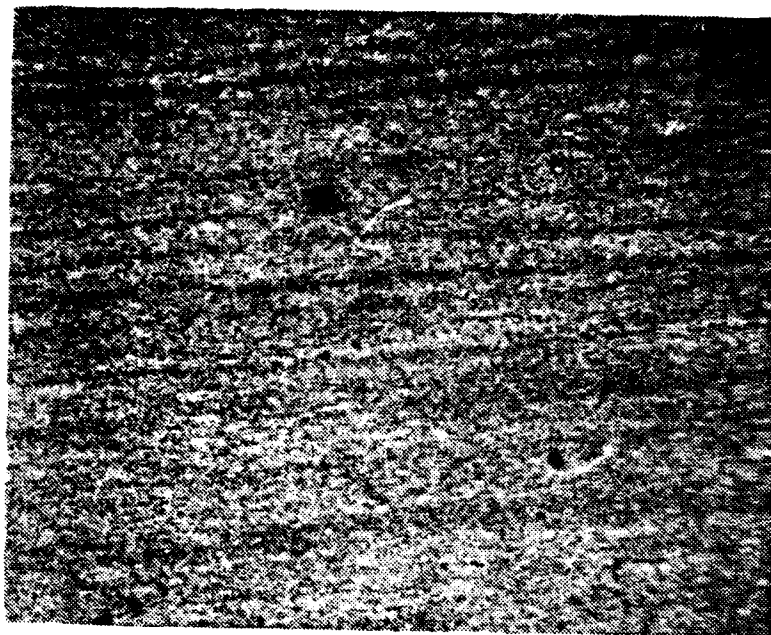
Figure 86. Microstructure of same specimen as in Fig. 85 (RI-1-6), etched in 2% nital + 2% picral solution for 10 seconds, showing banded carbide particles. X100.

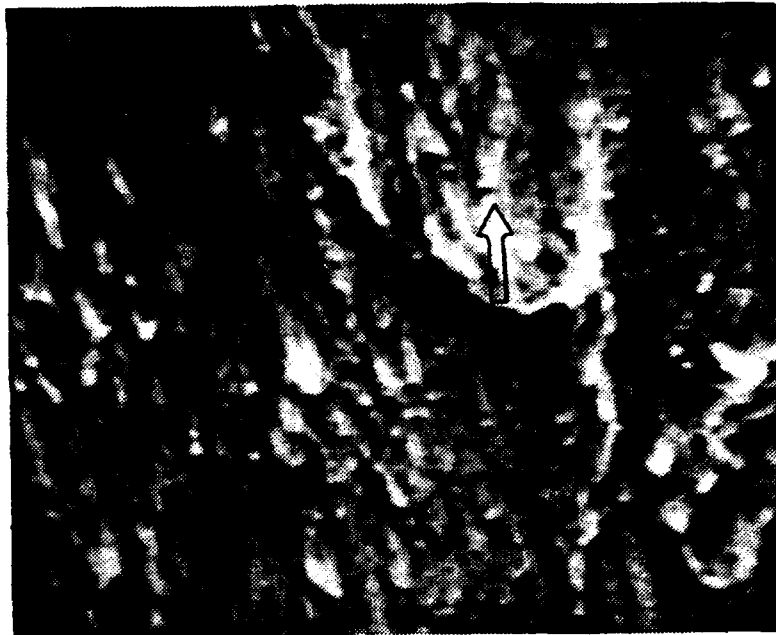
Figure 96. Area outlined by a hexagon, which is the fast fracture zone of Fig. 91 micrograph, showing radial marks which indicate the direction of fracture propagation (arrow). X2000.
