Report No. FAA-NA-80-9

FUEL FIRE HAZARD PENETRATION INTO A MODEL  
FUSELAGE AS A FUNCTION OF CIRCUMFERENTIAL  
DOOR LOCATION AND FUEL BED HEIGHT

Thor I. Eklund  
Joseph A. Wright

MAY 1980

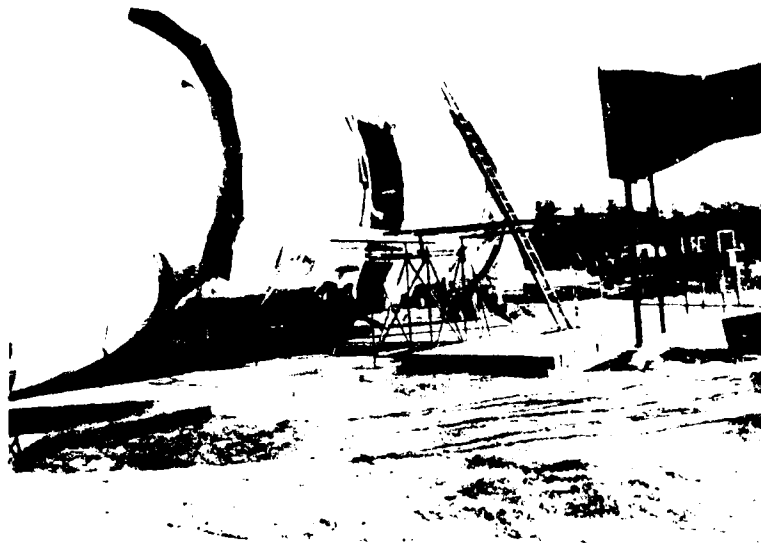
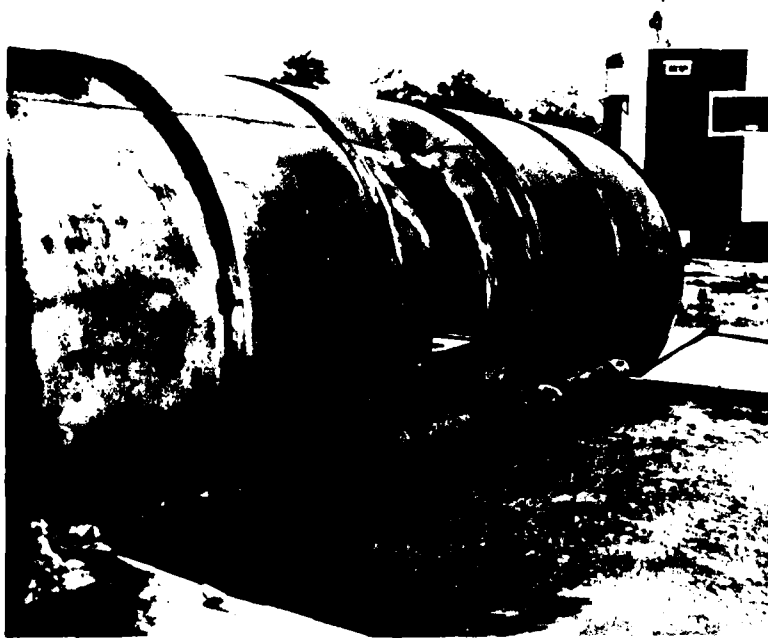
FIGURE 1. COMPARATIVE FULL-SCALE AND MODEL VIEWS (SHEET 1 OF 2)

FIGURE 1. COMPARATIVE FULL-SCALE AND MODEL VIEWS (SHEET 2 of 2)

At least three hypotheses have been advanced for this anomaly between the model and the DC-7. First, a simple geometric scaling of the fire scenario may not effectively reproduce the full-scale phenomena in all respects. Second, a possibility exists that the anomaly is caused by the different fire sources. For the model, the fuel fire was contained in a steel tray suspended approximately 2 feet above the ground. In the DC-7 project, the fuel fire was contained in a concrete basin at the ground level. This second hypothesis, if true, also has a bearing on the wide-body (C-133) project, which also employed raised fire pans. Finally, the fire penetration may be affected by the circumferential position of the doorway. The DC-7 doorway is approximately centered with respect to the top and bottom of the fuselage, while the model had a doorway placed higher on the fuselage side. The comparisons are photographically shown in figure 1.

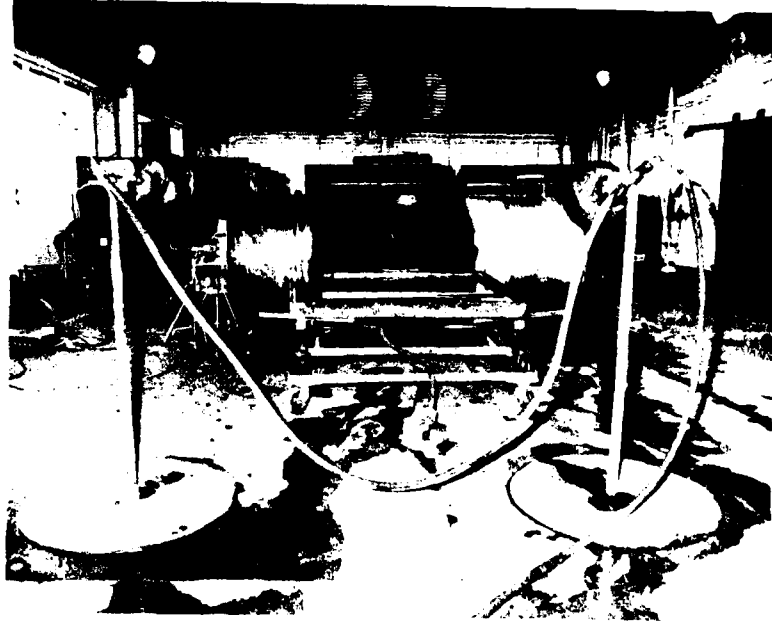
FIGURE 2. TEST BED FRONTAL VIEWS

Each end of the model had a cover fabricated in such a way that the cover could be detached while the model was rotated and thus maintain its vertical orientation. One cover held a large observation window through which the interior could be illuminated, viewed, and photographed. The other cover had a removable 10- by 12-inch glass window in its center. The removal of this window would simulate the opening of an additional door in a longer fuselage. Figures 2a and 2b show overall views of the test configuration, while figures 3a and 3b show test photographs with the two end covers visible.

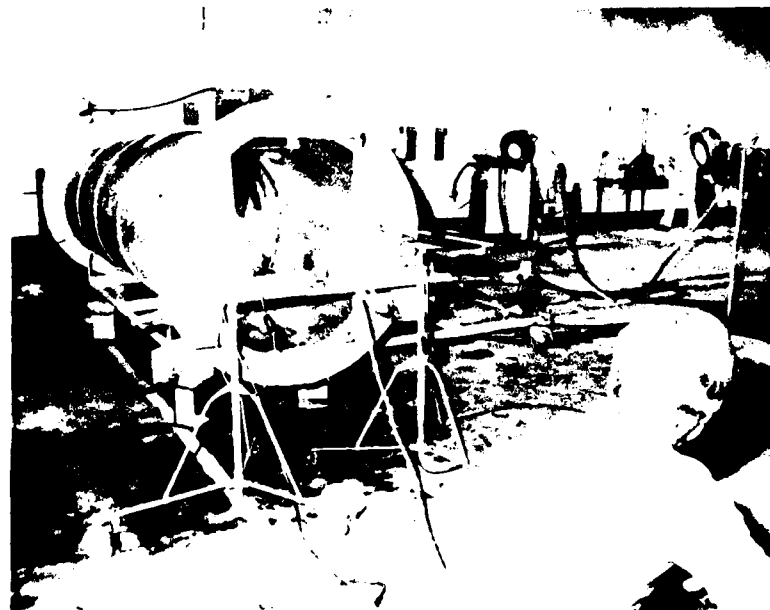
FIGURE 3. TEST BED SIDE VIEWS

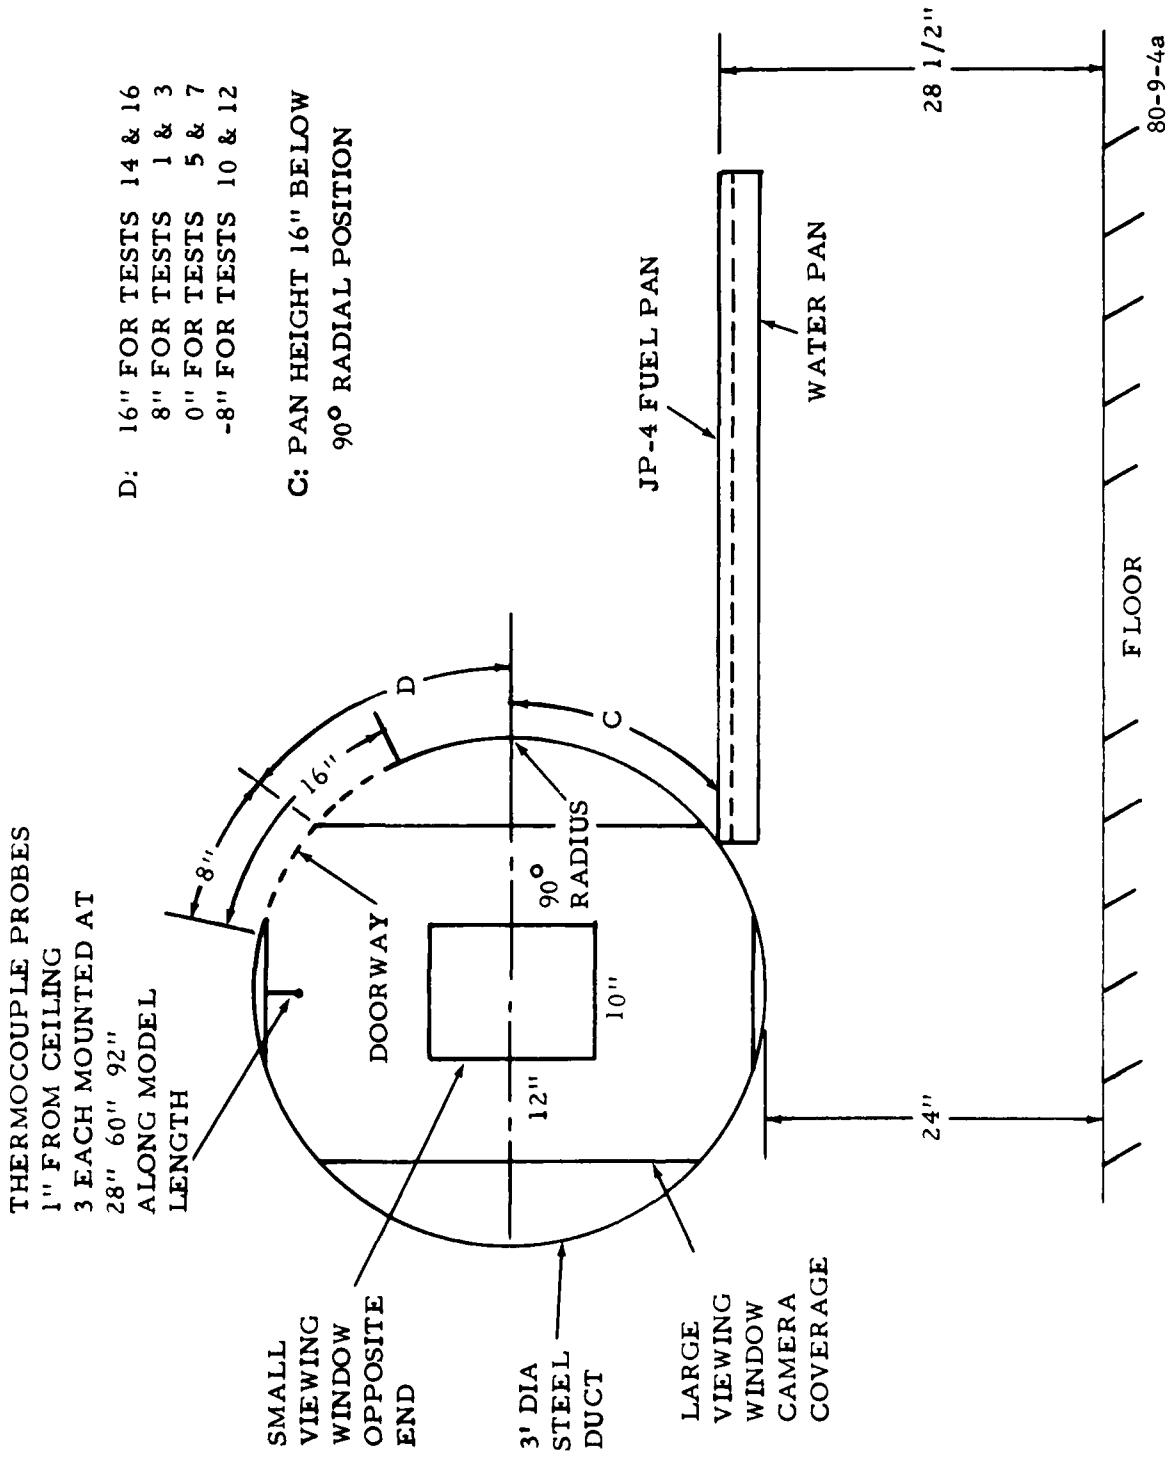
FIGURE 4. TEST CONFIGURATIONS (SHEET 1 OF 3)

THERMOCOUPLE PROBES  
 1" FROM CEILING  
 3 EACH MOUNTED AT  
 28" 60" 92"  
 ALONG MODEL  
 LENGTH

C: PAN HEIGHT = 8" BELOW  
 90° RADIAL POSITION  
 D: 16" FOR TESTS 18 & 20  
 8" FOR TESTS 22 & 24  
 0" FOR TESTS 26 & 28

\*\* Reference figure 4.

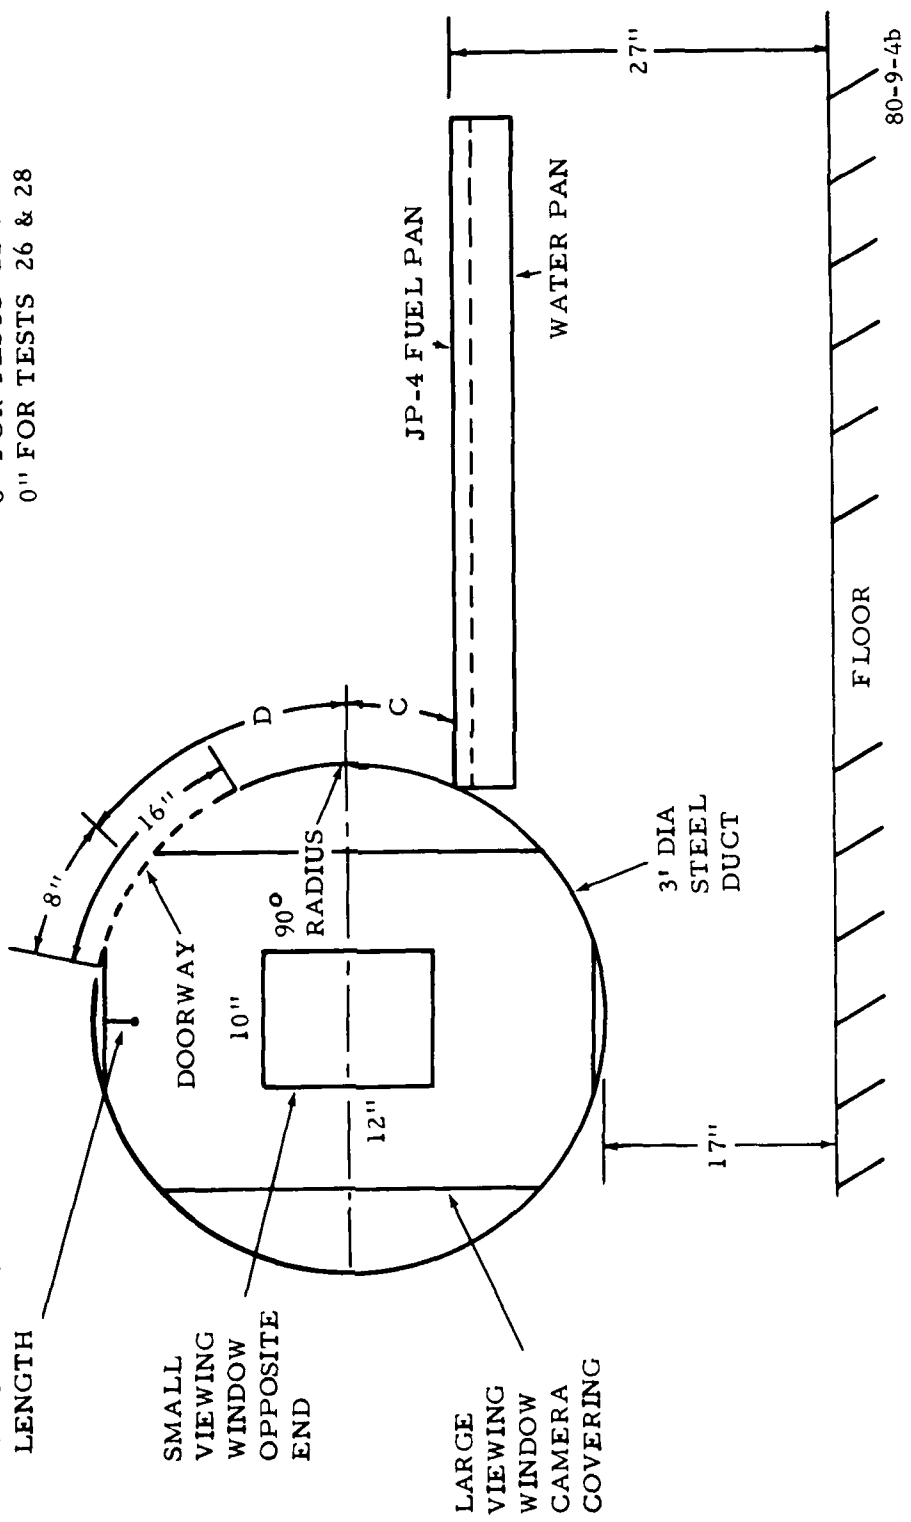
FIGURE 4. TEST CONFIGURATIONS (SHEET 2 OF 3)

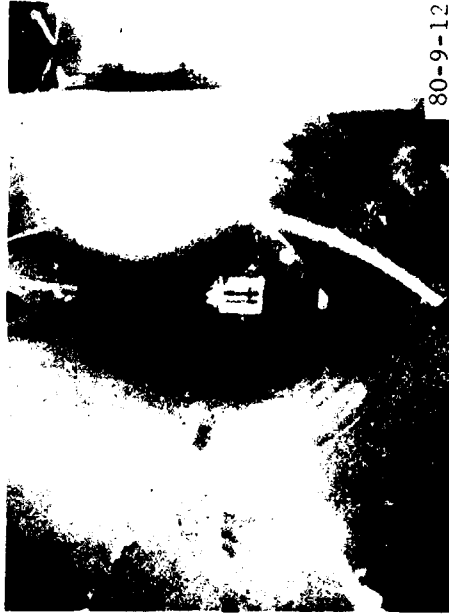
40 SECONDS  
 $\Delta T = 42 F^{\circ}$

60 SECONDS  
 $\Delta T = 151 F^{\circ}$

40 SECONDS  
 $\Delta T = 18 F^{\circ}$

60 SECONDS  
 $\Delta T = 69 F^{\circ}$

FIGURE 12. INTERIOR VIEWS (TESTS 30 AND 32)

Table 2 shows the type hazard at 40 and 60 seconds into the tests as noted by averaging the outputs of the two thermocouples closest to the model end covers. Also presented are comments developed from visual observations through the viewing window. Figures 5 through 13 show the corresponding

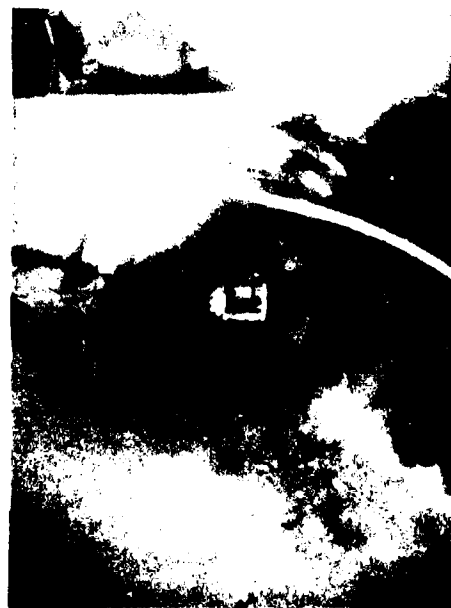
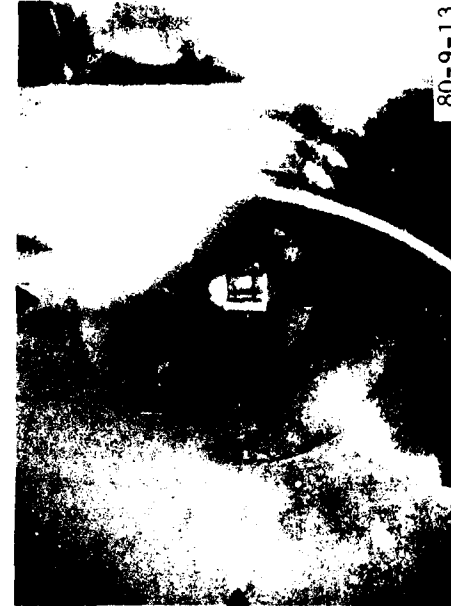
40 SECONDS  
 $\Delta T = 29 F^{\circ}$

60 SECONDS  
 $\Delta T = 97 F^{\circ}$

40 SECONDS  
 $\Delta T = 12 F^{\circ}$

60 SECONDS  
 $\Delta T = 58 F^{\circ}$

FIGURE 13. INTERIOR VIEWS (TESTS 34 AND 36)

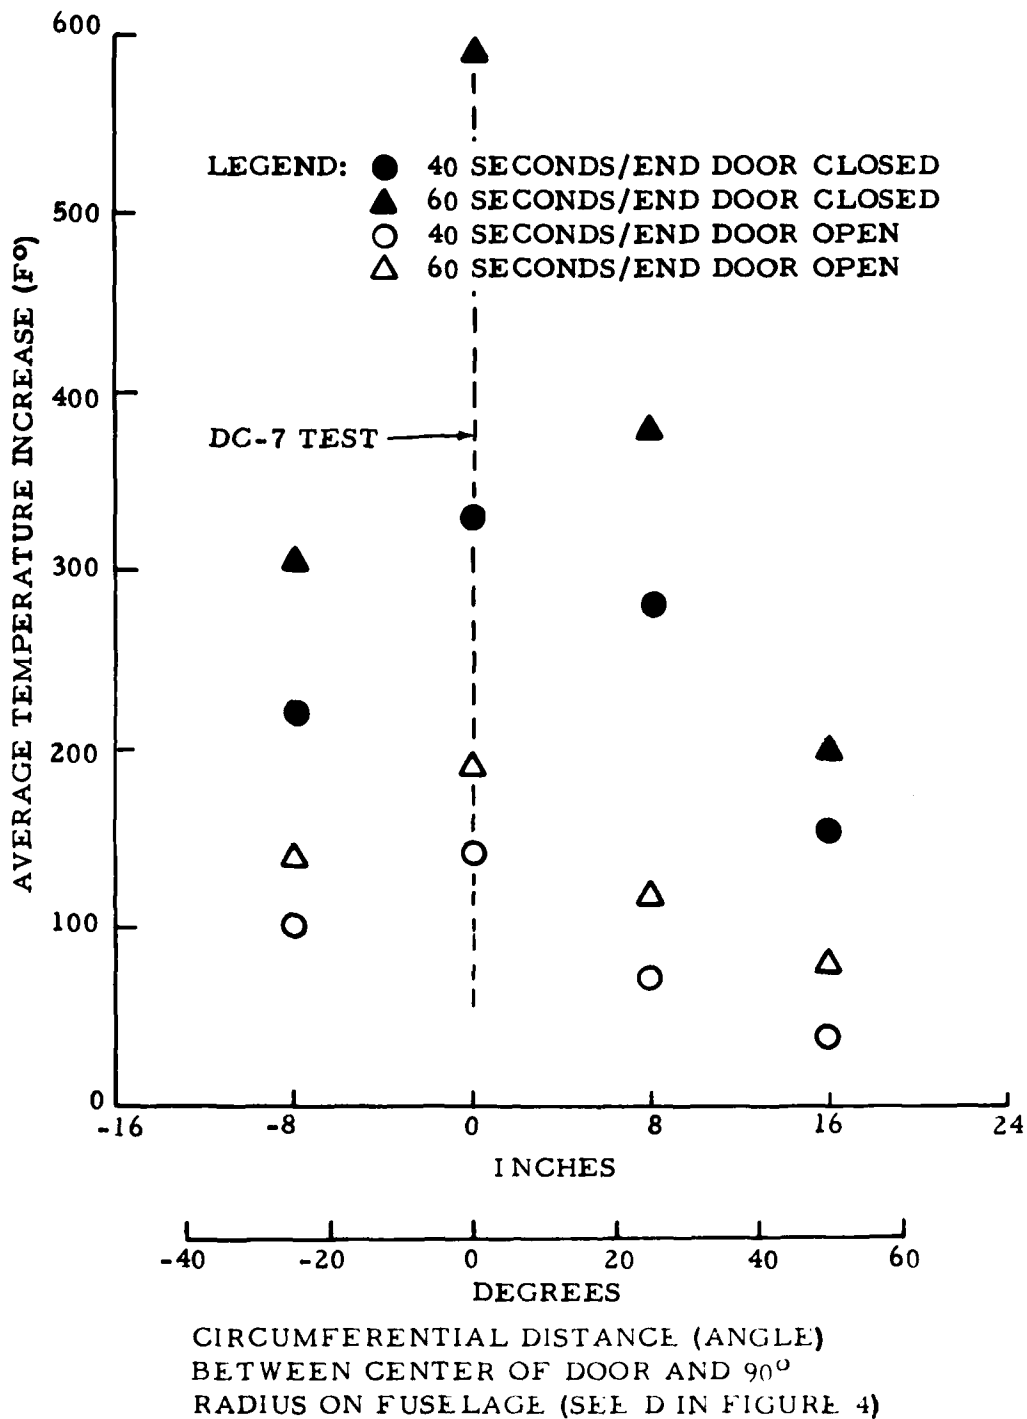
FIGURE 14. TEMPERATURE VERSUS DOOR POSITION (LOW FUEL PAN)

Figures 14 through 16 show plots of the 40- and 60-second ceiling temperature as a function of fuselage rotation for various fixed positions of the fire bed. Noted on these figures are the equivalent conditions found in the C-133 tests, the DC-7 tests, and the model tests. The general trend in evidence for these figures is that the hazard is worst when the center of the doorway is near the 90° position where 0° represents the top of the fuselage. (This is the location of actual doorways in most current transport aircraft.) The configuration equivalent to the DC-7 (tests 5 and 7) shows high temperature both when the end cover window is open and when it is closed. The C-133 and model configurations, on the other hand, show high temperatures when the end window is closed and low temperatures at 60 seconds when the end window is open.

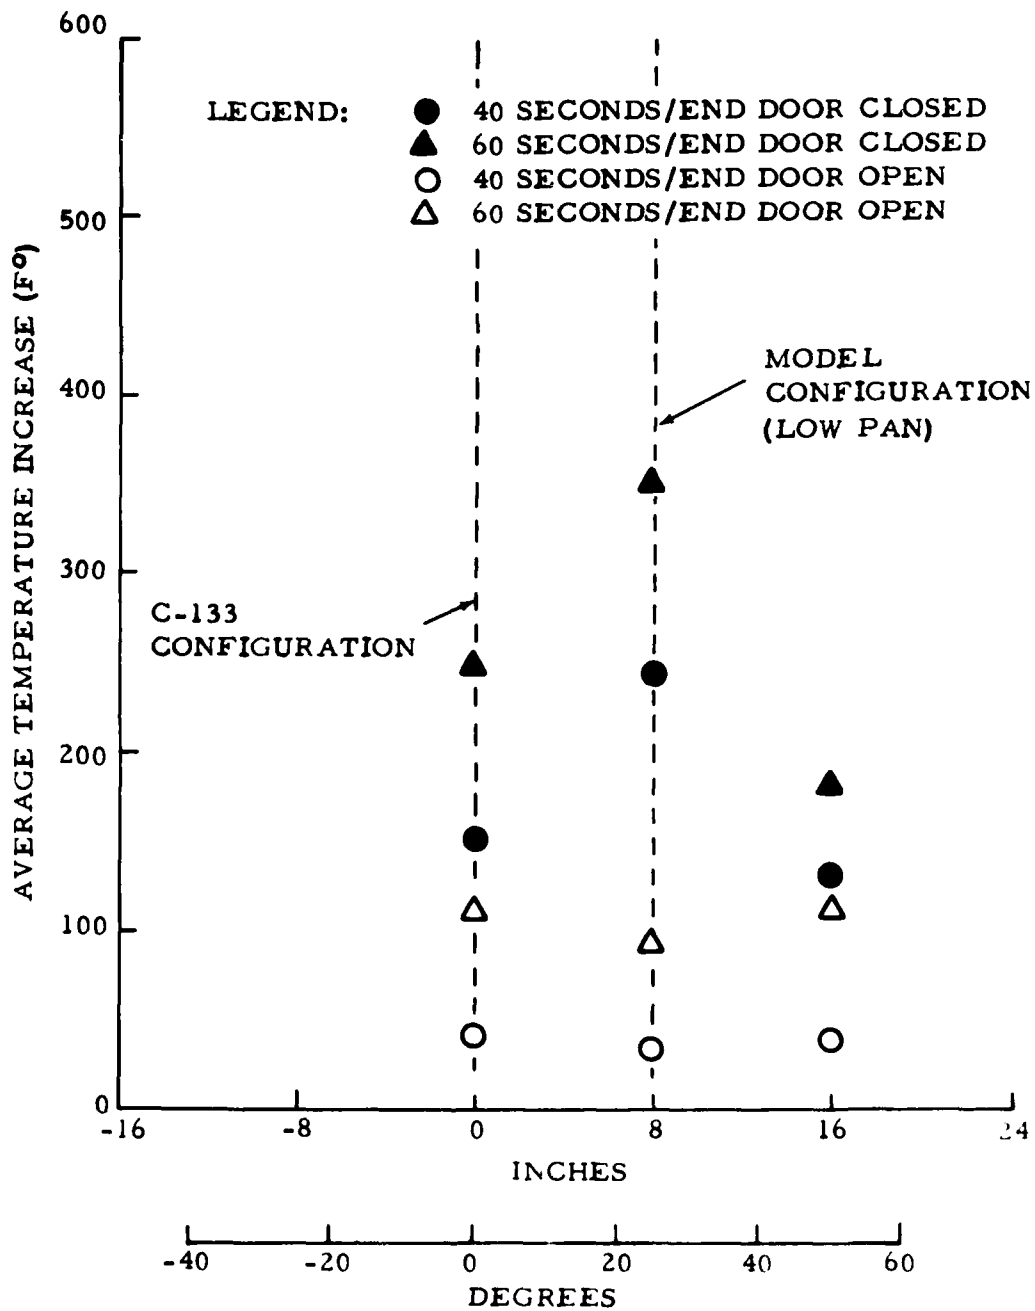
CIRCUMFERENTIAL DISTANCE (ANGLE)  
 BETWEEN CENTER OF DOOR AND 90°  
 RADIUS ON FUSELAGE (SEE D IN FIGURE 4)

FIGURE 15. TEMPERATURE VERSUS DOOR POSITION (INTERMEDIATE FUEL PAN)

The results in figure 15 predict that the C-133 would sustain significant heat and smoke from the external fuel fire if all doors other than the door facing the fire were closed.

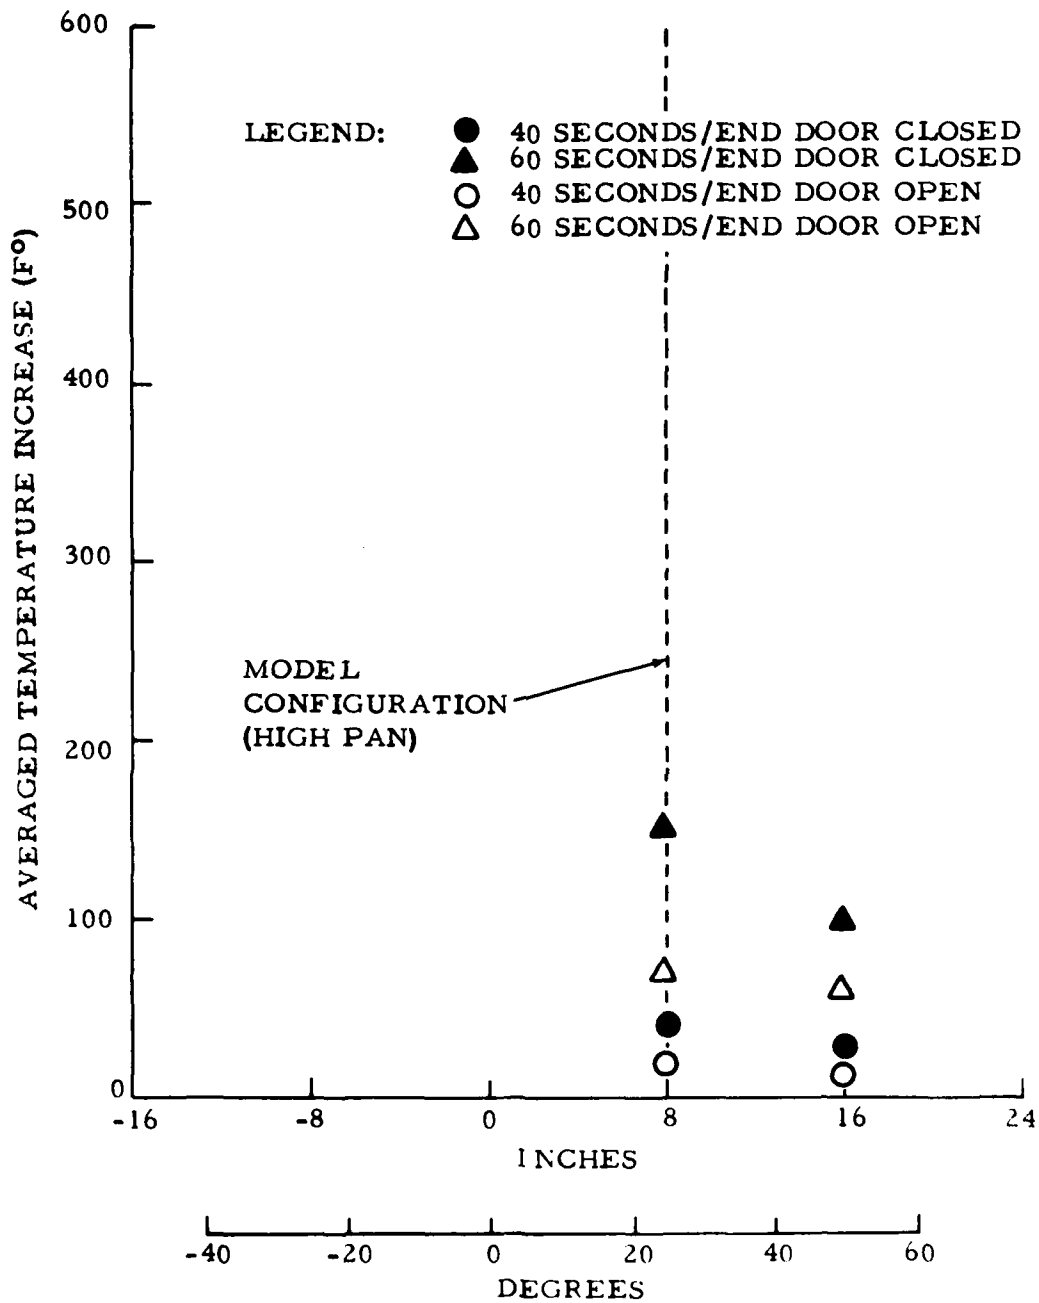
CIRCUMFERENTIAL DISTANCE (ANGLE)  
 BETWEEN CENTER OF DOOR AND 90°  
 RADIUS ON FUSELAGE (SEE D IN FIGURE 4)

FIGURE 16. TEMPERATURE VERSUS DOOR POSITION (HIGH FUEL PAN)

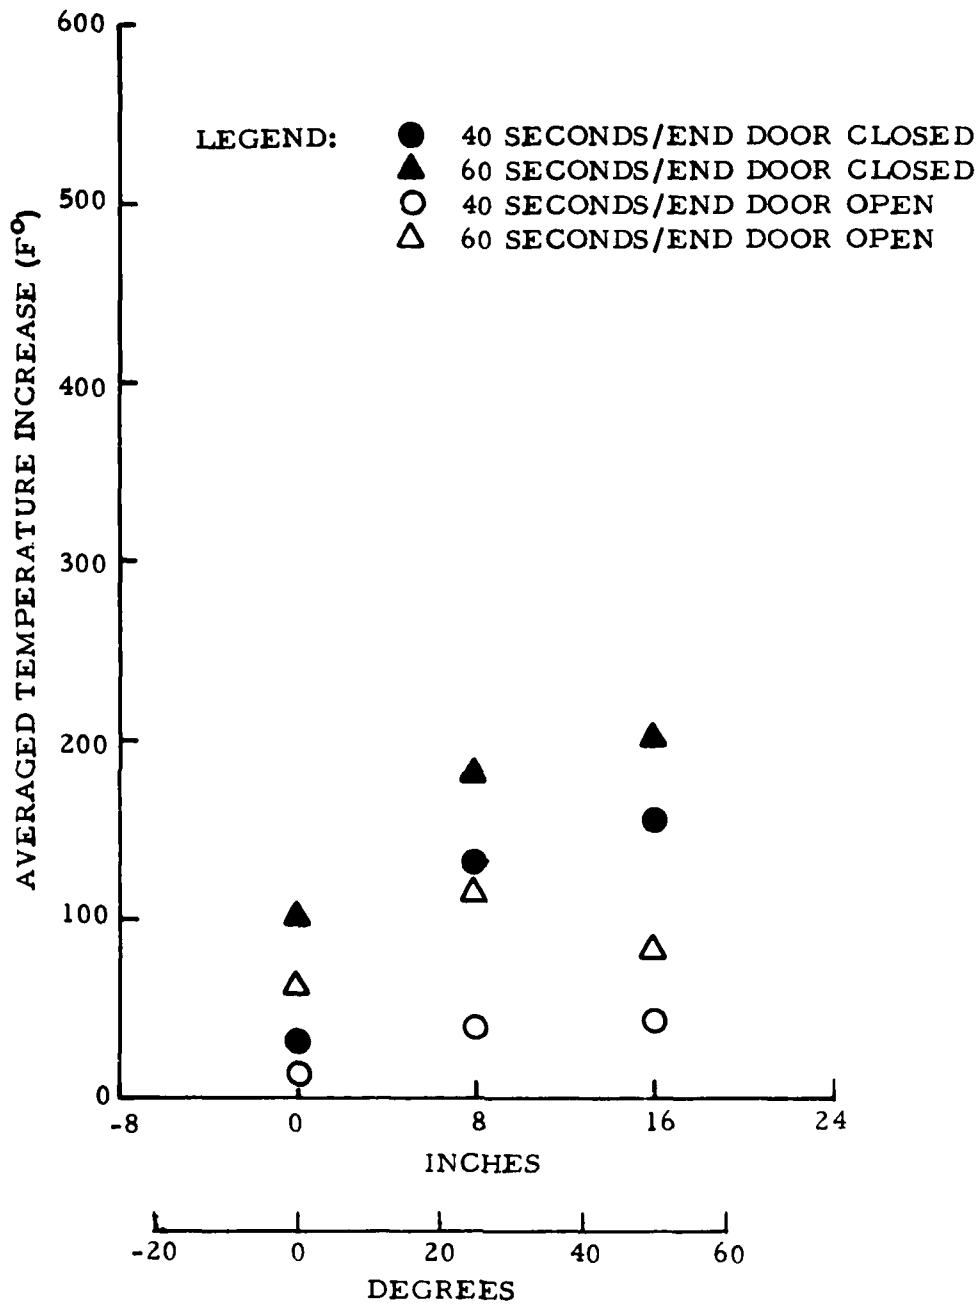
CIRCUMFERENTIAL DISTANCE (ANGLE)  
 BETWEEN TOP OF FUEL PAN AND 90°  
 RADIUS ON FUSELAGE (SEE C IN FIGURE 4)

FIGURE 17. TEMPERATURE VERSUS FUEL PAN HEIGHT (HIGH DOOR)

Figures 17 through 19 show the temperature buildup at 40 and 60 seconds when the fuselage rotation is invariant but the fuel pan is adjusted in height relative to the fuselage. It is apparent that as the fire base is moved upwards on the side of the fuselage, the hazard development within the fuselage subsides. Thus, the DC-7, which had the fire base on the ground, generated a much more severe environment than the C-133 which had the fire base at the height of the door bottom.

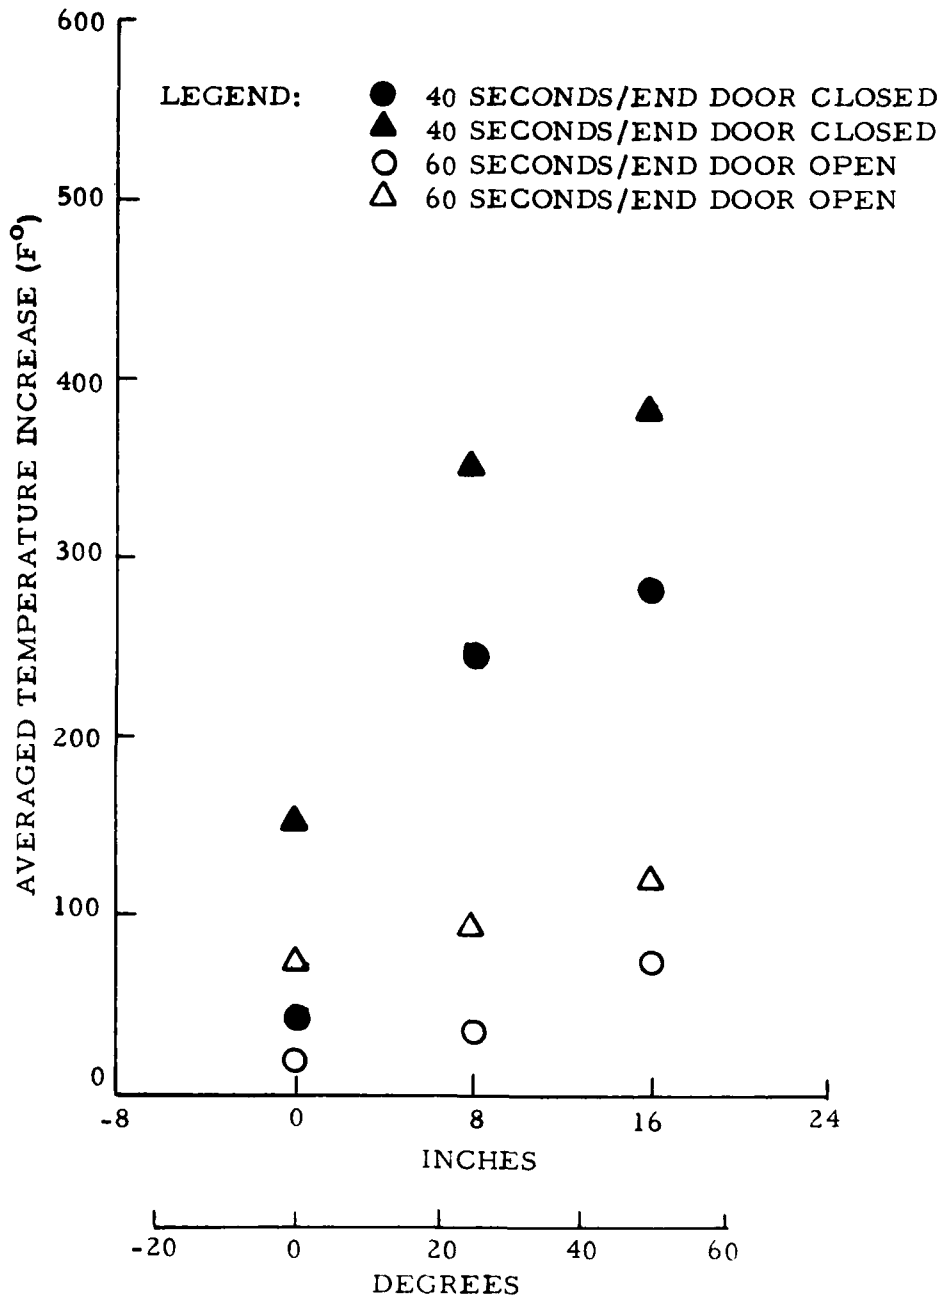
CIRCUMFERENTIAL DISTANCE (ANGLE)  
 BETWEEN TOP OF FUEL PAN AND 90°  
 RADIUS ON FUSELAGE (SEE C IN FIGURE 4)

FIGURE 18. TEMPERATURE VERSUS FUEL PAN HEIGHT (INTERMEDIATE DOOR)

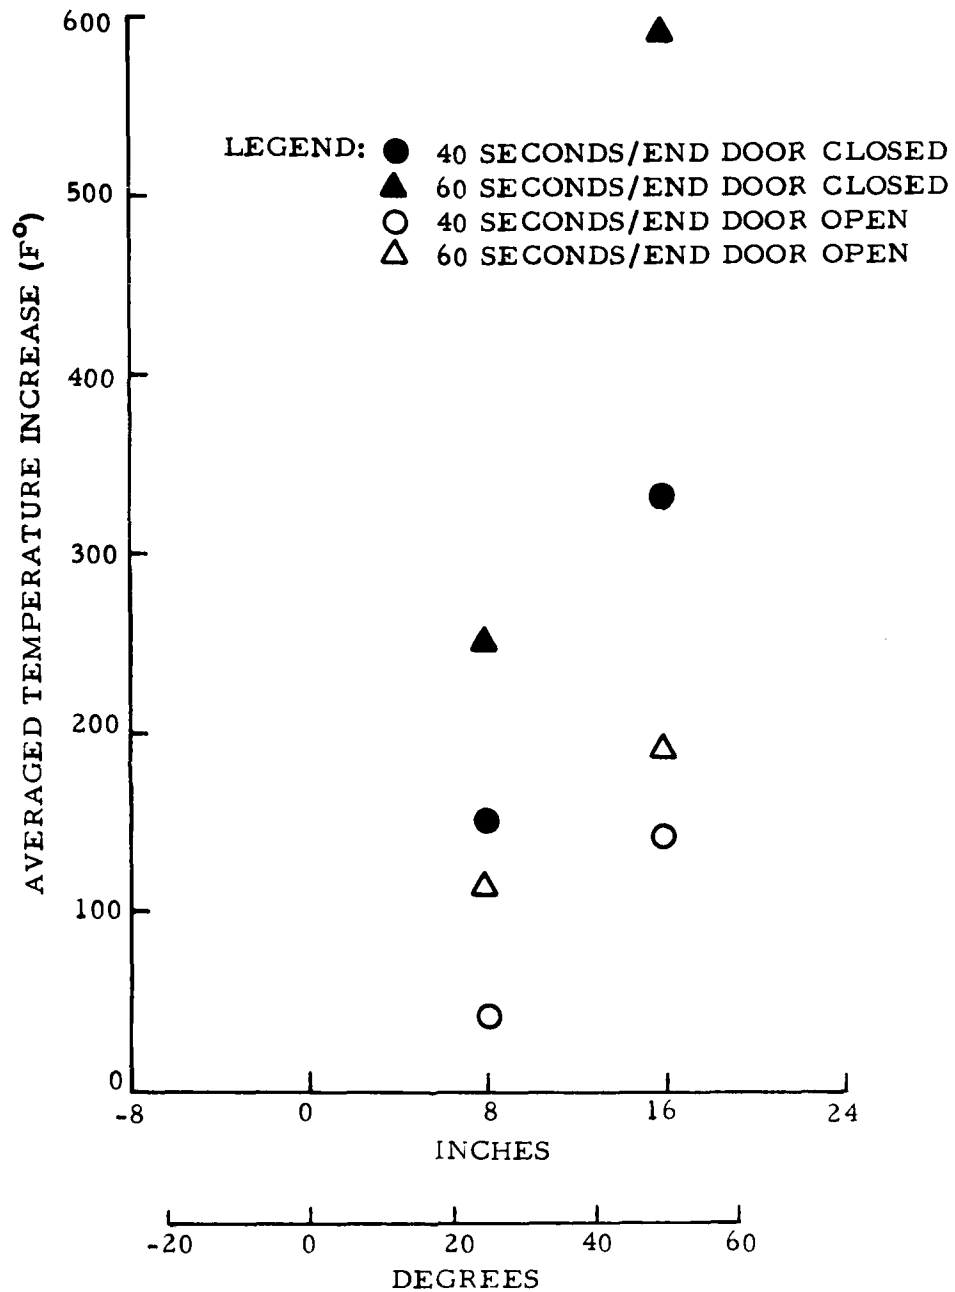
CIRCUMFERENTIAL DISTANCE (ANGLE)  
 BETWEEN TOP OF FUEL PAN AND 90°  
 RADIUS OF FUSELAGE. (SEE C IN FIGURE 4)

FIGURE 19. TEMPERATURE VERSUS FUEL PAN HEIGHT (DOOR AT 90° RADIUS)

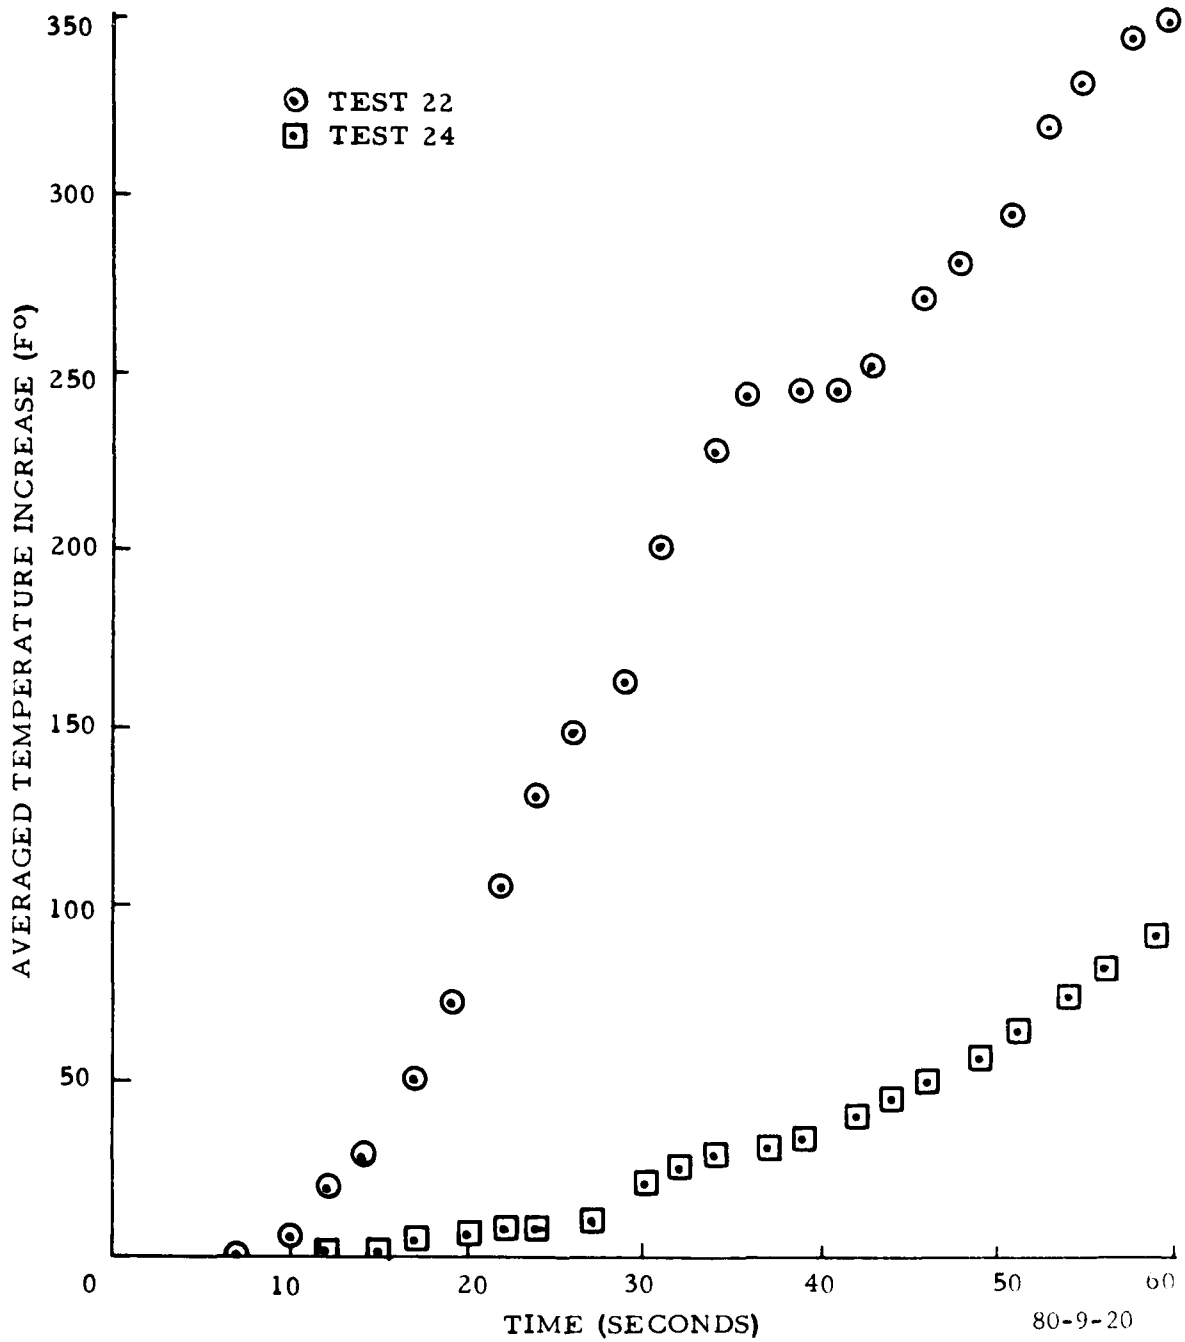
FIGURE 20. TEMPERATURE INCREASE (TESTS 22 AND 24)

Figure 20 shows a plot of temperature versus time for tests 22 and 24 to demonstrate the monotonic nature of the heat development. Even in test 24 which showed no smoke development at all, the ceiling temperatures would still rise noticeably during the test. This was due to two effects. First, the fire would radiate to the interior even when there was no documented flame penetration. Second, the model fuselage was not insulated. As a result, heat could be conducted efficiently through the wall and thereby heat the interior air. Nevertheless, these effects should have no effect on the conclusions developed.
