NAVAL RESEARCH LAB WASHINGTON DC

AUG 80 D J MICHEL, H H SMITH

NRL-MR-4282

## NEUTRON IRRADIATION EFFECTS ON FATIGUE CRACK PROPAGATION IN TYPE 316 STAINLESS STEELS AT 649°C

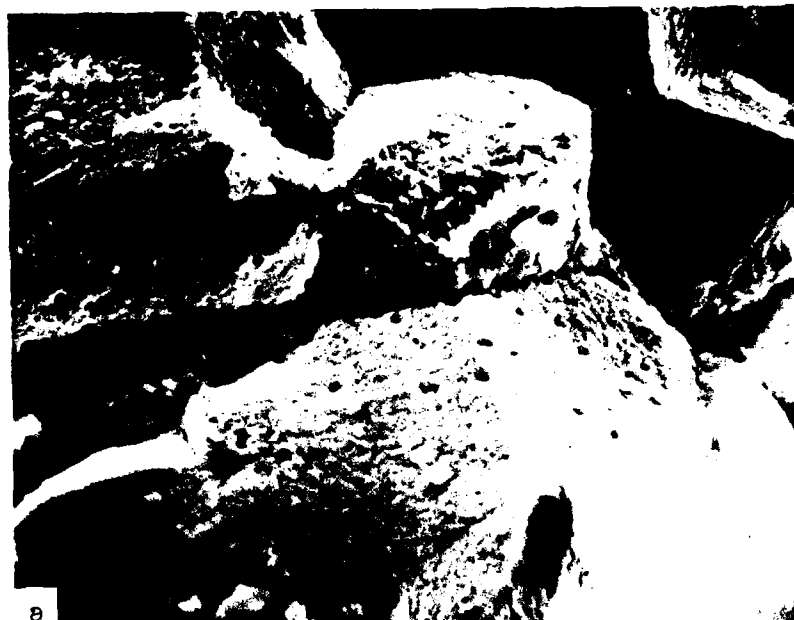
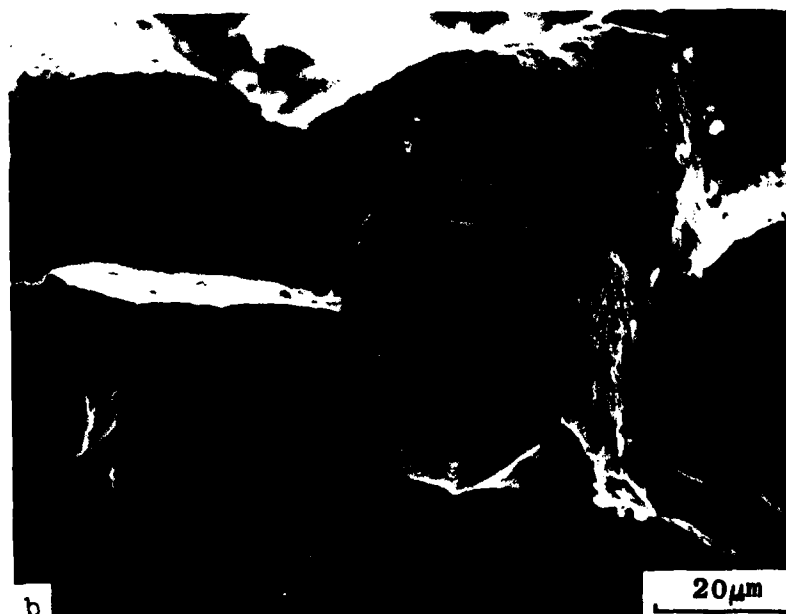
Fig. 8 — Scanning electron micrographs of intergranular cavities associated with precipitates in annealed Type 316 stainless steel irradiated to  $4.8 \times 10^{22} \text{ n/cm}^2$  at  $649^\circ\text{C}$  and tested with a two-minute hold time at  $649^\circ\text{C}$ .

Comparison of Figs. 5a, 5b and 6 clearly shows that the transgranular failure mode observed in the annealed, unirradiated steel at 649°C was not seen in the irradiated steel. This provides strong evidence that the intergranular precipitate mechanism operative in the unirradiated steel was influenced by the irradiation. Previous studies of 316 stainless steel irradiated to both low and high fluences at temperatures from 400 to 650°C have shown that the influence of irradiation on phase instability is quite pronounced, resulting in a variety of new precipitate phases [11-13] which include modified forms of the  $M_{23}C_6$  precipitate. Further, comparison of the results in Figs. 1 and 3 shows that the effect of irradiation on the crack propagation performance of the annealed steel was significant only when a hold time was included in the fatigue cycle. In particular, it is seen that the slope of the two minute hold time,  $da/dN$  vs  $\Delta K$  curve is identical to that for the one minute hold time result at 649°C despite the shift to lower values of  $K$  at equivalent values of  $da/dN$ . This suggests that the increased crack propagation rate for the hold time tests of the annealed, irradiated steel was the result of a failure mechanism which was different than that for the continuous cycling tests. This is supported by the SEM results which show that intergranular cavity formation occurred on the failure surface of the two minute hold time specimen, Fig. 8, but was
