TECHNICAL REPORT HL-80-10

# OCEANSIDE HARBOR AND BEACH, CALIFORNIA DESIGN OF STRUCTURES FOR HARBOR IMPROVEMENT AND BEACH EROSION CONTROL

Hydraulic Model Investigation

June 1980  
Final Report

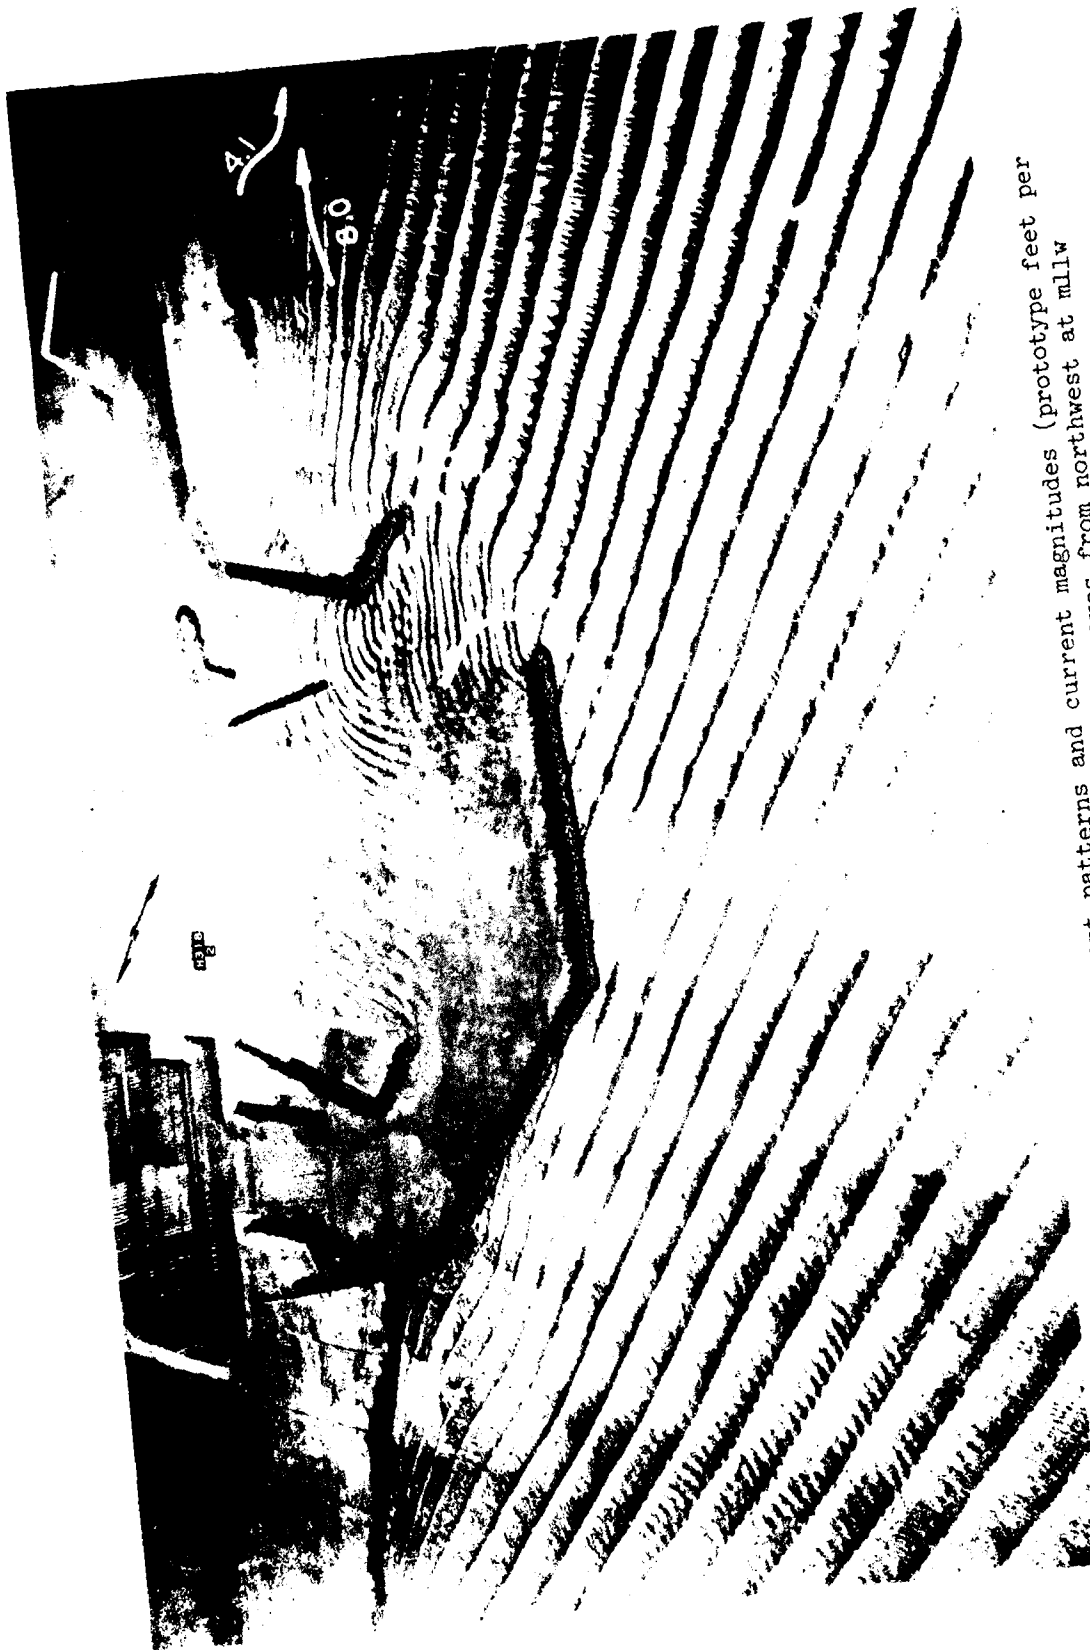
Photo 1. Typical wave and current patterns and current magnitudes (prototype feet per second) for existing conditions; 7-sec, 10-ft waves from northwest at mllw

38. Current patterns and magnitudes secured for existing conditions revealed that for waves from the northwest deepwater direction (Photo 1), strong longshore currents flowed along the north jetty, across the harbor entrance, and past the end of the south groin. For waves from the west deepwater direction (Photo 2), a convergence of longshore currents created rip currents at the shoreward terminus of the north jetty. Strong longshore currents were observed moving across the harbor entrance and past the south groin. For waves from the southwest deepwater direction (Photo 3), northerly longshore currents formed
