MISCELLANEOUS PAPER SL-80-10

# CONSTRUCTION OF TREMIE CONCRETE CUTOFF WALL, WOLF CREEK DAM, KENTUCKY

Terence C. Holland, Joseph R. Turner

September 1980

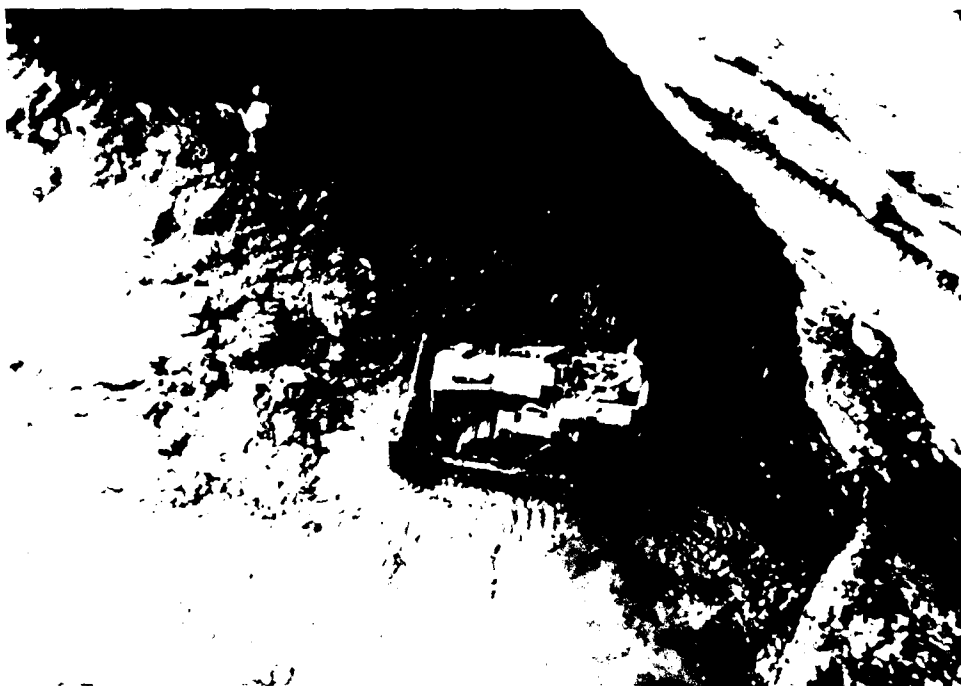
a. Note overhang left in place

Figure 2. Construction of cutoff trench (Continued)

b. Note width of trench

Figure 2. (Concluded)

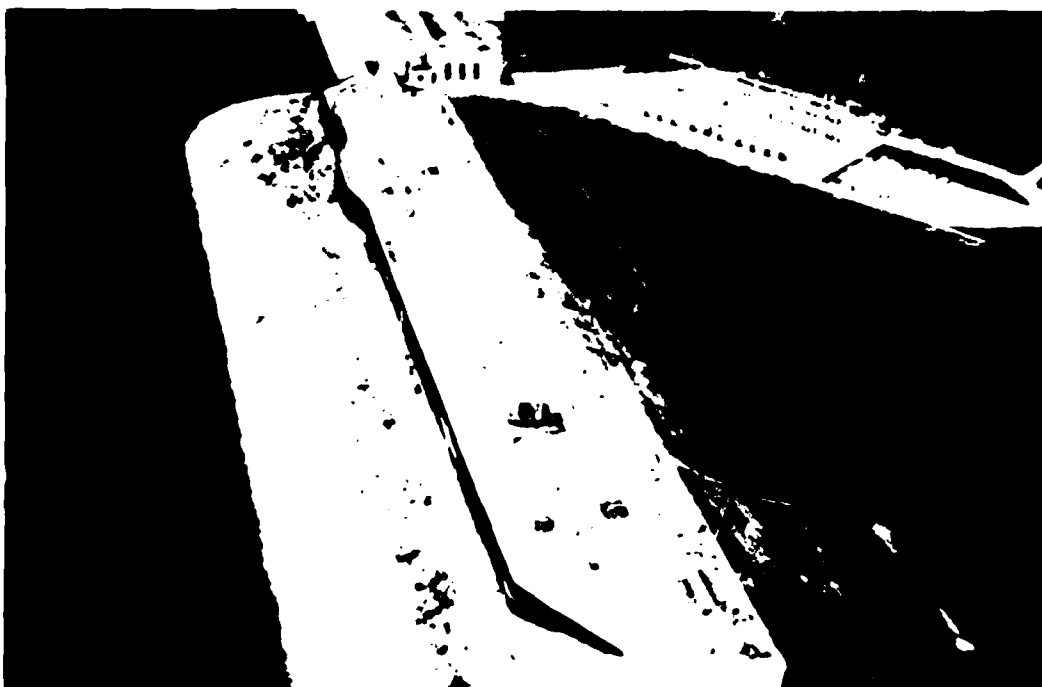
Figure 5. View of contractor's platform. This photo was taken during the first phase of the project adjacent to the concrete section of the dam

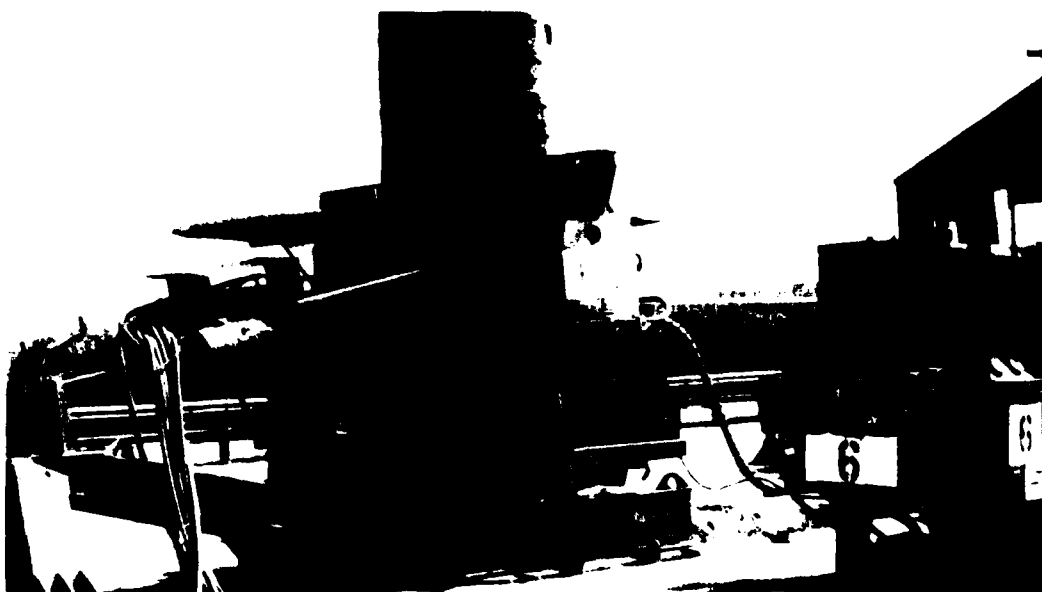
a. Casing handling machine. This machine both rotates and applies vertical force for casing installation or removal

b. Details of casing joint

Figure 6. Casing for primary elements

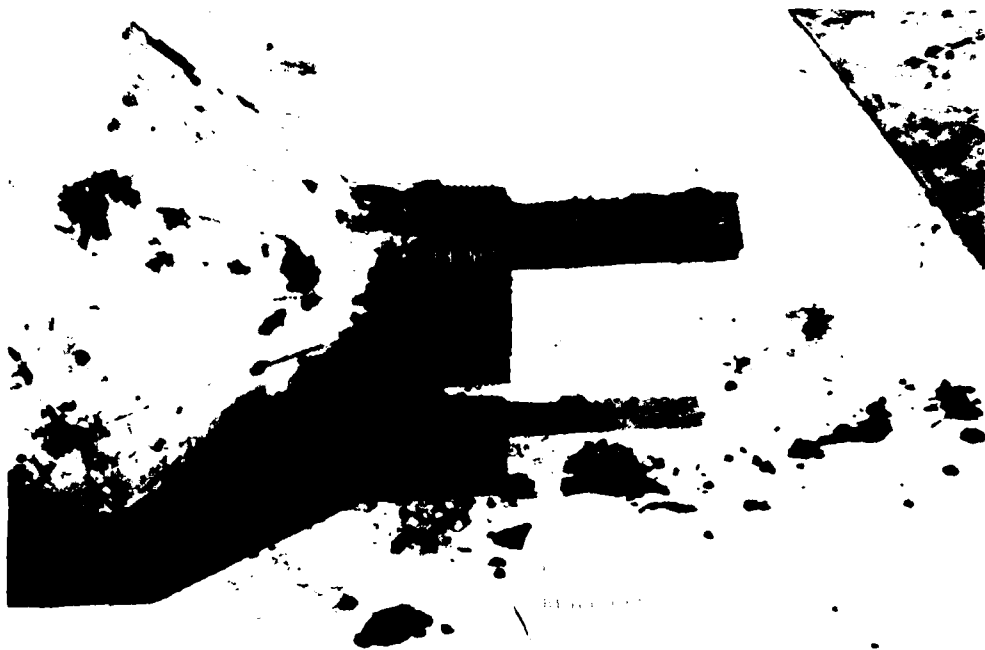
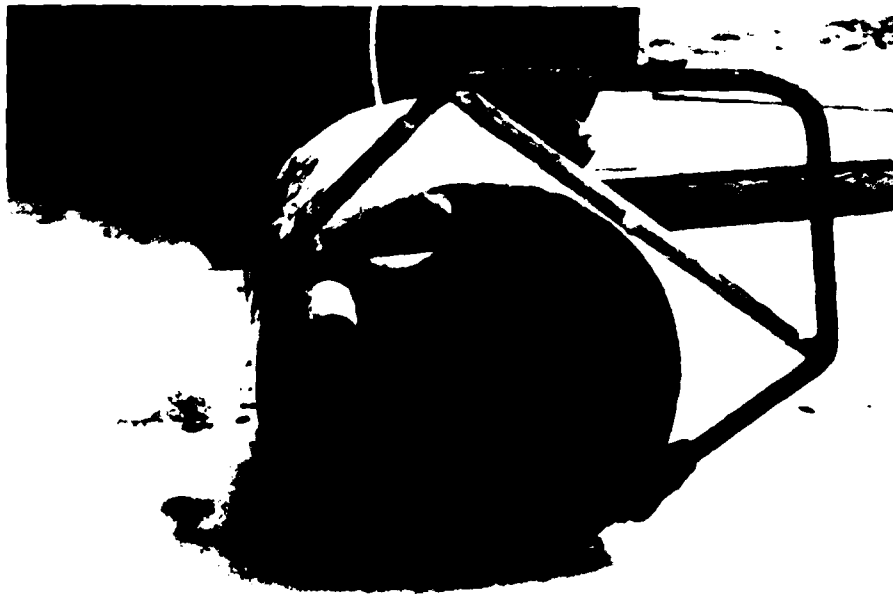
a. Breather tube extends only a short distance below hopper

b. Breather tube extends short distance above top of hopper.

Figure 8. Tremie hopper breather pipe

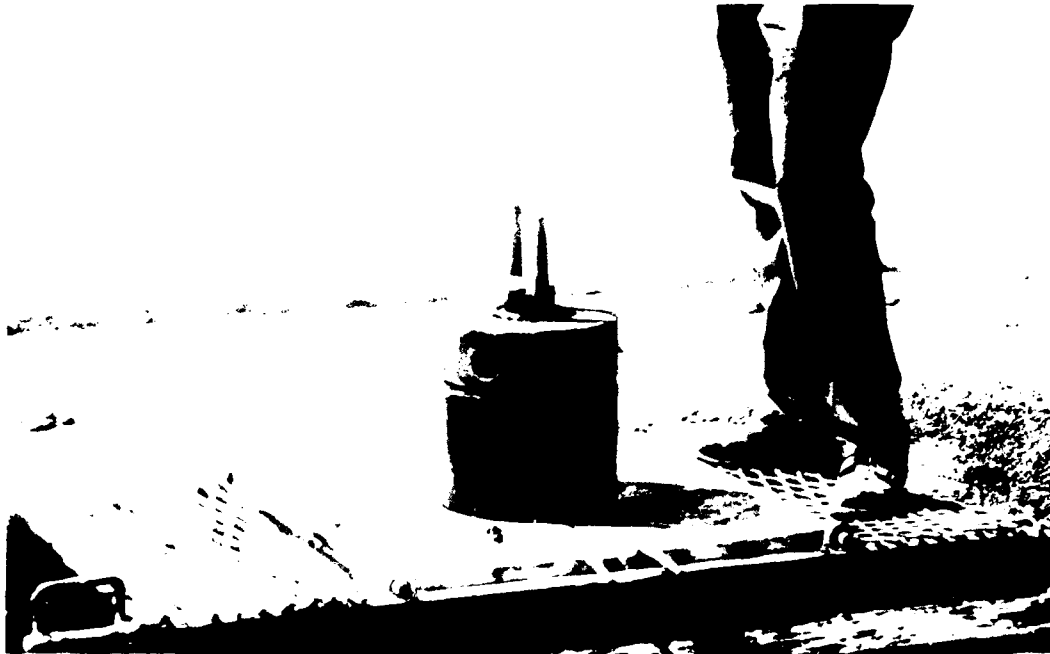
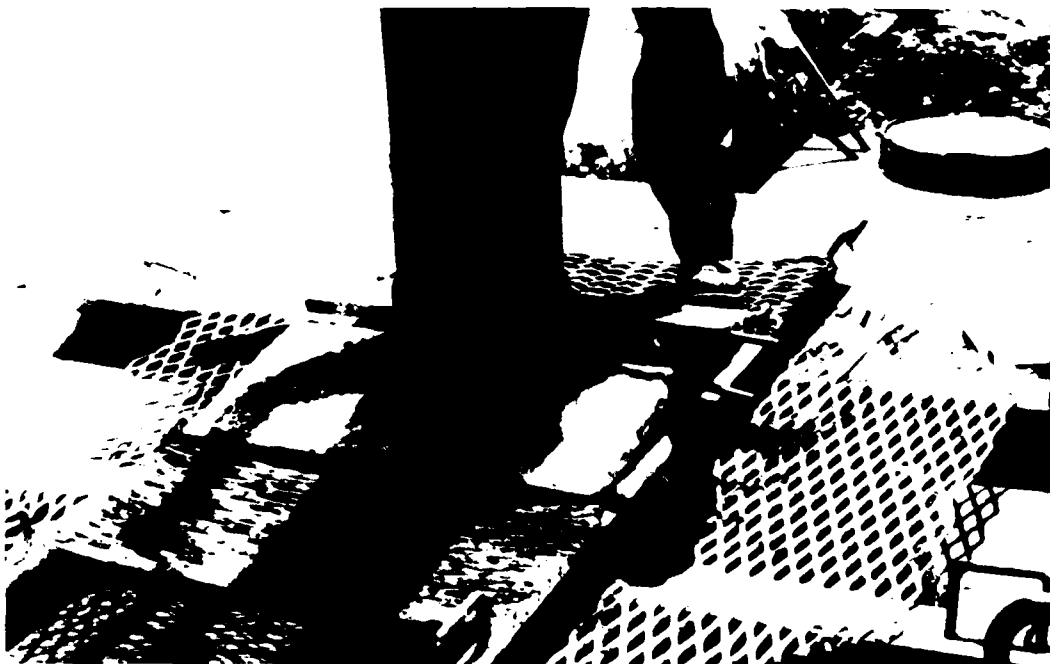
a. Tremie pipe supported by coupling. Loop is used to raise tremie as sections are removed

b. Tremie pipe being raised (note how support plates open to allow passage of couplings)

Figure 9. Tremie support scheme

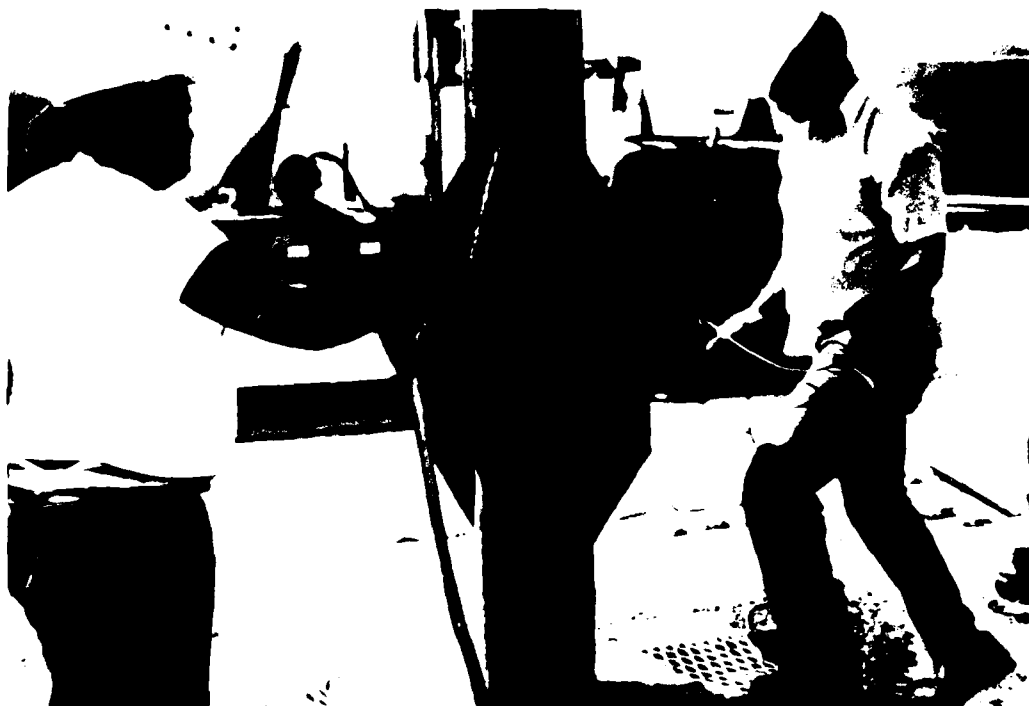
Figure 16. Fins added to tremie pipe  
to ensure proper centering
