DNA 5182F

# THE SIMULATION OF GROUND SHOCK-INDUCED MX TRENCH COLLAPSE

18 October 1980

Final Report for Period 27 March 1978—30 April 1979

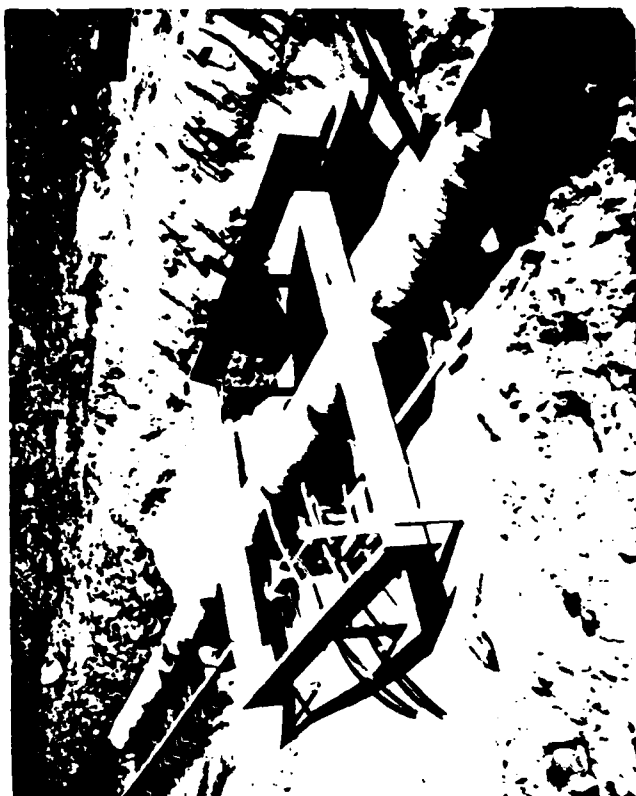
Figure 11. Raining of sand into trench.

(a) Sand fed into hopper.

(b) Area "rained with Overton sand.

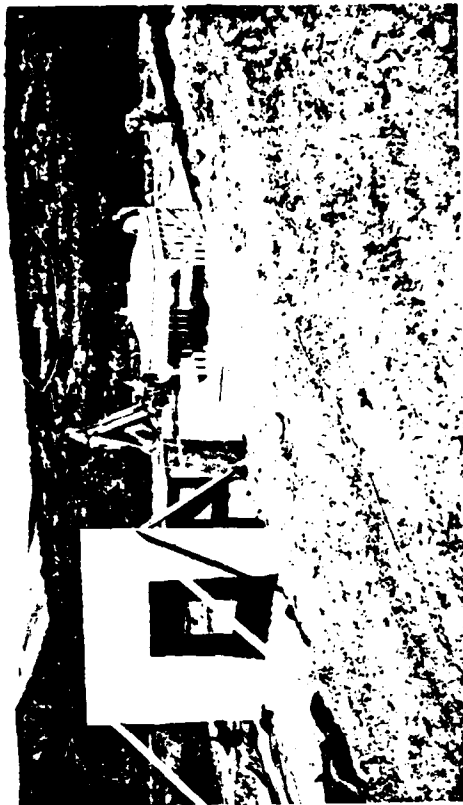
Figure 13. Candle being lowered into test bed.

The main diagnostic to measure the rate and shape of the pipe collapse was high-speed photography, using a framing camera running at about 5  $\mu$ s per frame. The camera looked directly down the axis of the pipe via the turning mirrors mentioned above. The pipe was back-lighted from the opposite end with an explosively driven argon "candle," the length of which (3.05 m) was great enough that the shock wave did not arrive at the end of the candle until after the collapse of the pipe was complete. What was actually photographed was a shadow-graph of the collapsing pipe directly under the HE charge. In this way, both the rate of collapse and the cross-sectional shape of the collapsing pipe were determined. An opal glass window at the end of the argon candle was found to produce much more uniform backlighting than a transparent window. Figure 13(a) shows the candle before being lowered to line up with the pipe and being buried. Figure 13(b) is an overview of the test bed with the candle being buried at the far end. The bunker is off to the left in this view.

(a) Argon candle before being lowered.

(b) Overview of test bed with candle being buried at far end.

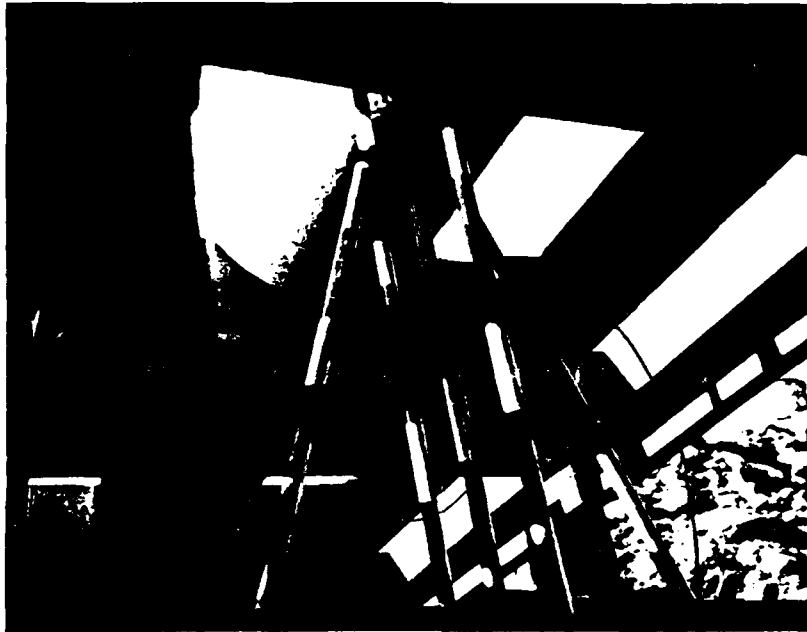
Figure 14. Gauge setup.

14 (a) Below-pipe view of the five bar gauges.

14(b) Schematic cross-section of test bed.

steel flat packs were also distributed in the sand at various distances below the HE charge to measure the ground shock incident on the pipe (see Figure 14).

Two bar gauges were placed at an angle of  $20$  degrees to the vertical under the center of the pipe covered by the HE (see Figure 14). Similarly to the 3 gauges along the vertical, there were four

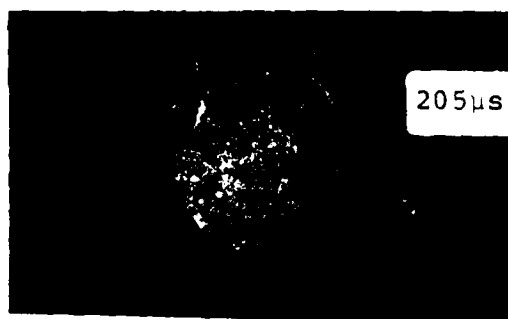
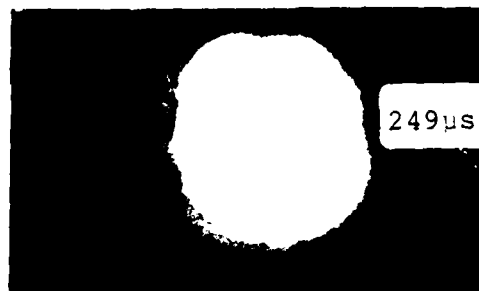
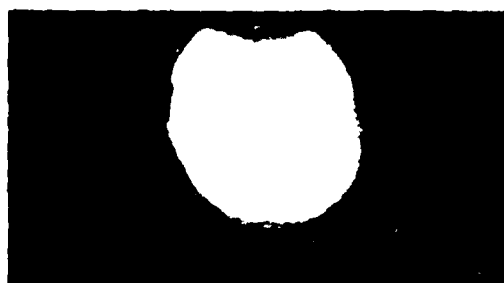
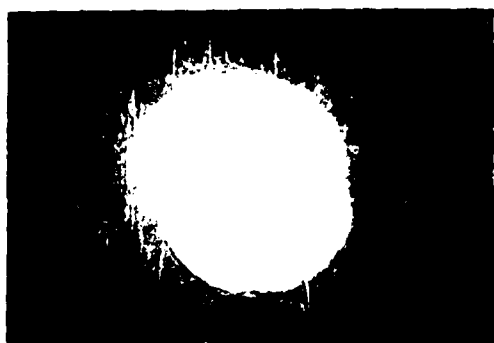
Figure 16. Framing camera photos of pipe blow-in (4.93  $\mu$ s between frames). Frame (1) shows candle turn-on and frame (10) shows first detectable motion.

Based on the pre-shot prediction calculation and limited by the number of frames (80) available on the framing camera, it was determined to run the camera at about 5  $\mu$ s/frame. Since the predicted pipe collapse duration was  $\sim 220$   $\mu$ s, this would give 44 frames to define the behavior of the top surface. The actual speed of the camera was 4.93  $\mu$ s/frame as shot. The camera had to start early enough to record the turn-on of the argon candle which allows absolute timing to be set. All times to be reported will be referenced to time zero being the start of detonation of the line wave generator (console zero). Figures 16, 17 and 18 are the photo record of the collapse (frames 4-9 are deleted since there was no motion during that interval). Frame 1 on Figure 16 is the turn-on of the argon candle (previous frames were all dark) and this was at a time of 205  $\mu$ s as noted. The small indentations at the equator and

poles are due to cable bundles from in-pipe experiments coming out the end of the pipe. There is a slight oblateness to the image which was caused by inexact alignment and imperfect mirrors.

The first detectable movement occurred at frame 10 at a time of 249  $\mu$ s. From subsequent motion it would appear that first motion occurred at 248  $\mu$ s, 24  $\mu$ s following predicted completion of the HE burn at the surface. (This is to be compared with the predicted interval of 24.7  $\mu$ s from the calculation, which used an equation-of-state for a different soil material than that actually employed.) The first wisps of material reach the bottom of the pipe in frame 21 (Figure 18) and completely block out the light by frame 23 at a time of 314  $\mu$ s. This corresponds to a closure velocity of  $\sim 4 \times 10^5$  cm/sec for the material sufficient to block light. The calculated closure (and that observed in the pre-shot test) was  $\sim 1.2 \times 10^5$  cm/sec, over a factor of 3 lower than that observed. Unlike the pre-shot test presented above, there is definite evidence that in this experiment the pipe wall is breaking up under the impulse. Figure 19 is an enlargement of frame 20 showing tendrils of material reaching out. Insufficient light is transmitted to allow a determination to be made of the velocity of the higher density material. This first-impact material is interpreted as being very low density blow-off spalled off the inner surface of the pipe (but adequate to block the light path). The pressure versus time records from the bottom of the pipe (to be presented later) show four (and perhaps 5) distinct impacts (with associated pressures) and this allows us to infer the density of this initial material. The initial pressure pulse is 0.4 kbars which yields a density of  $\sim 0.003$  gm/cm<sup>3</sup> for the first blow-off.
