| REPORT DOCUMENTATION PAGE | | READ INSTRUCTIONS<br>BEFORE COMPLETING FORM | |
|---|---|---|--|
| 1. REPORT NUMBER<br>NRL Memorandum Report 4452 | 2. GOVT ACCESSION NO.<br>AD-A095387 | 3. RECIPIENT'S CATALOG NUMBER | |
| 4. TITLE (and Subtitle)<br>DEFORMATION MICROSTRUCTURE DEVELOPED DURING<br>FATIGUE CRACK PROPAGATION IN TYPE 316 STAINLESS<br>STEEL AT 593 C 593 C. | | 5. TYPE OF REPORT & PERIOD COVERED<br>Interim report on a continuing<br>NRL problem. | |

## DEFORMATION MICROSTRUCTURE DEVELOPED DURING FATIGUE CRACK PROPAGATION IN TYPE 316 STAINLESS STEEL AT 593°C

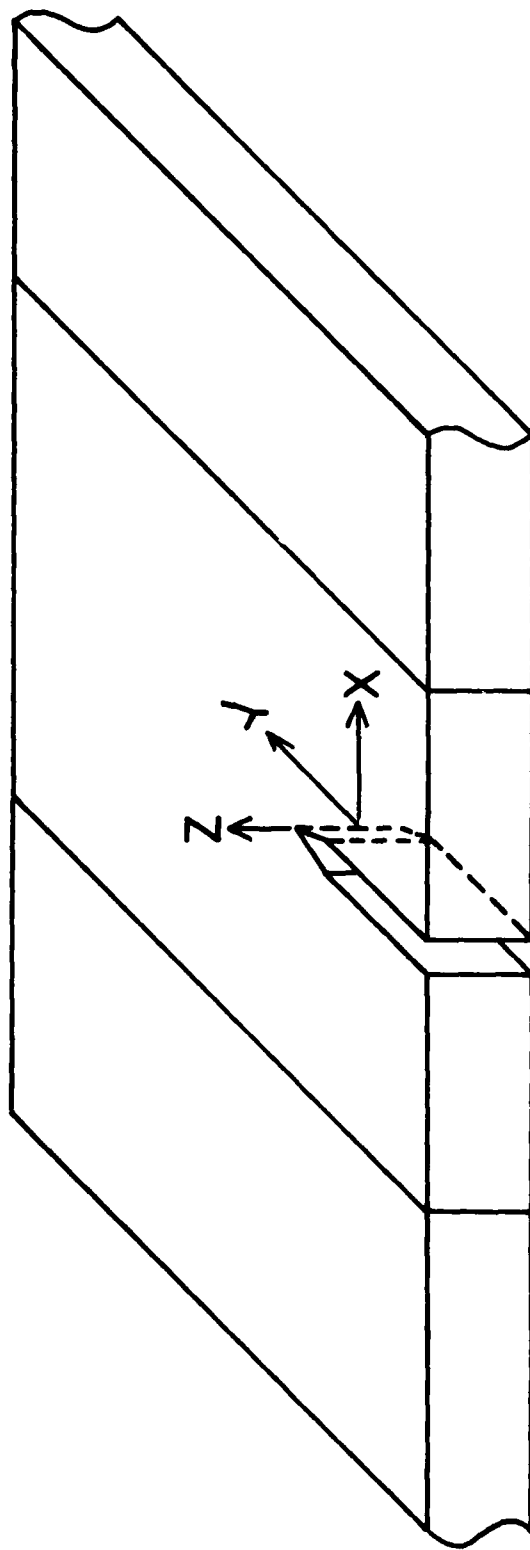
Fig. 1 - Schematic representation of the single-edge-notch cantilever fatigue specimen and the orthogonal coordinate system used to define the location of post-test transmission electron microscopy (TEM) specimens.

Transmission electron microscopy (TEM) foils were prepared from selected fatigue specimens tested at 593°C by removing 3-mm (0.118-in.) diameter cylindrical sections, whose axes were perpendicular to the fracture surface (parallel to X-direction in Fig. 1). The sections were taken at the mid-thickness of the selected specimens. A low speed water-cooled, cut-off-wheel was used to remove 0.25-mm (0.010-in.) thick slices from each cylindrical section beginning at the fracture surface ( $X = 0$ ). The slices were thinned to perforation using a conventional twin-jet electropolishing technique. The resulting thin foils were examined in a JEM-200A transmission electron microscope operated at 200 kV. The analysis of the TEM results was conducted according to previously detailed procedures (12).

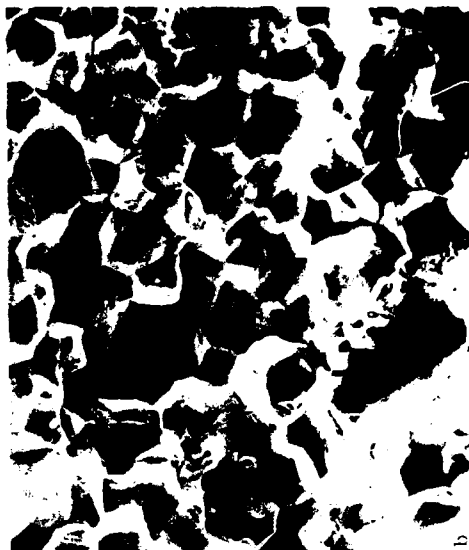
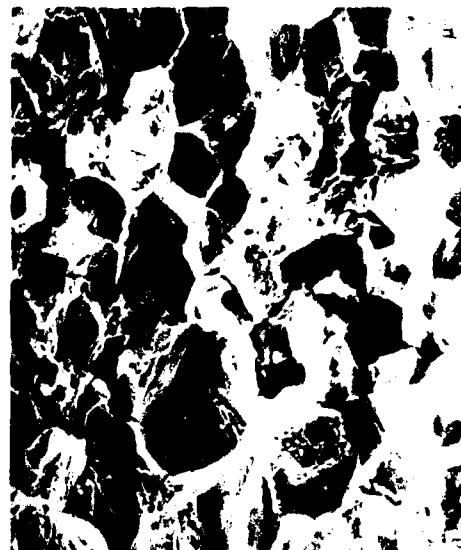
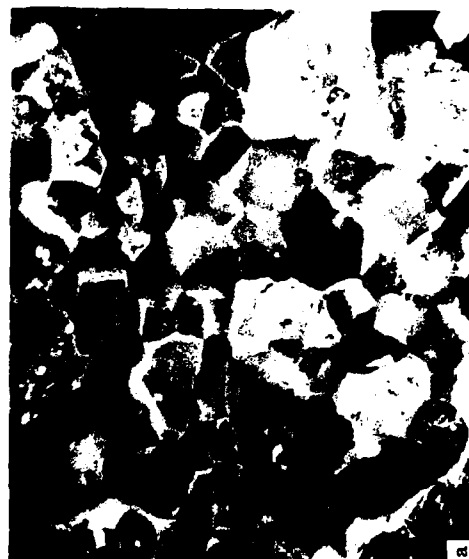
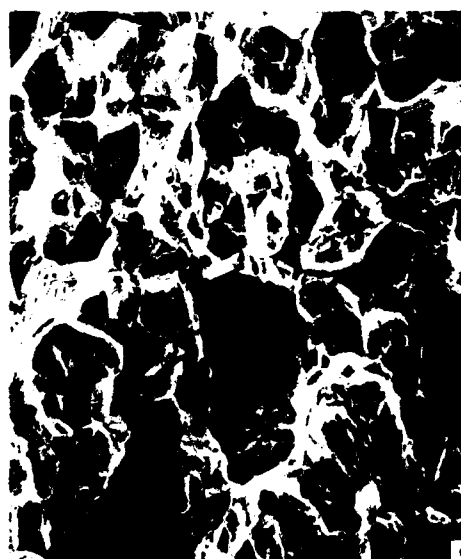
Fig. 3 - Scanning electron micrographs of the crack propagation mode of annealed and 20 percent cold worked, irradiated Type 316 stainless steel tested at 593°C: (a) annealed, zero hold time; (b) annealed, one minute hold time; (c) 20 percent cold worked, zero hold time; (d) 20 percent cold worked, one minute hold time.

The crack propagation mode of the annealed and cold worked, irradiated Type 316 stainless steel tested at 593°C is illustrated in Fig. 3. For the annealed steel, the crack propagation mode was intergranular for both the zero and the one minute hold times, Figs. 3a and 3b. The specimens of the cold worked, irradiated steel indicate a tendency toward a mixed failure mode, Figs. 3c and 3d, and the microscopic features are seen to be distinctly different from those of the annealed specimens. Specifically, these features suggest that processes such as slip band or twin formation have produced localized regions of transgranular crack propagation in addition to those of an intergranular nature.

The SEM and TEM results were performed to show the influence of the irradiation and loading conditions on the crack propagation mode and dislocation substructure of the annealed and cold worked steel at  $593^\circ\text{C}$ . Comparison of Figs. 2 and 3 illustrates that the modes of crack propagation were more intergranular in character for the irradiated specimens, particularly for the zero hold time loading condition. These changes in crack propagation mode were reflected by the higher crack propagation rates previously observed for these irradiated specimens (11). Inspection of Table 1 also indicates that the substructure results are consistent with the fractographic evidence. In particular, the substructure results show that the matrix dislocation density of the irradiated specimens was decreased relative to the equivalent unirradiated specimens. Since it is well known that the square root of the matrix dislocation density is directly proportional to the matrix stress level (12), the dislocation density results demonstrate that the reduced level of matrix deformation in the irradiated specimens was directly associated with the increased tendency toward an intergranular crack propagation mode.
