# DEFENSE CONFERENCE ON

## NONDESTRUCTIVE TESTING (284)

27-29 NOVEMBER 1979.

NAVAL AIR REWORK FACILITY  
NAVAL AIR STATION  
PENSACOLA, FLORIDA 32508

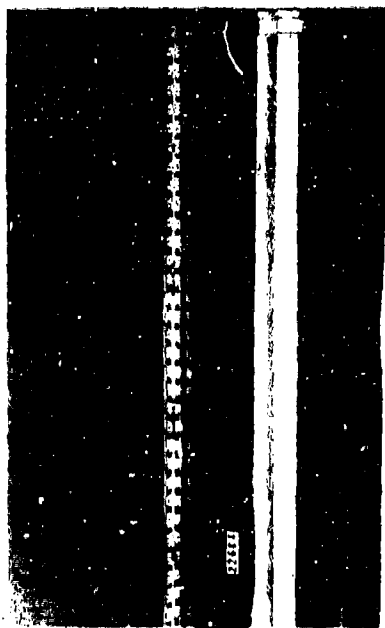
Figure 1. Barrel with Slot

A specific example is the 155 mm M185 cannon barrel. This barrel contains a 66 inch long, 1 inch wide, and 0.4 inch deep key way on the outside surface in the high pressure, high stress region. Figures 1 and 2 show this slot.

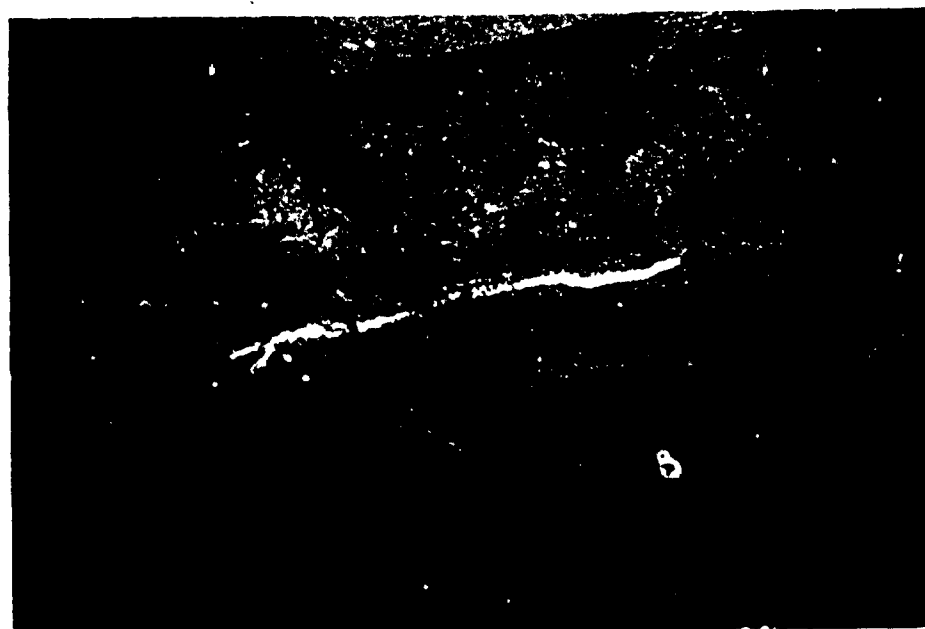
FIGURE 11. PUTTY TAPE RECORD OF AN UNDERWATER  
MAGNETIC PARTICLE INSPECTION

NCSC has supported two underwater magnetic particle inspections, both of which were also discussed in "Stereophotography, Practice" earlier in this paper. In both cases, the ac yoke and fluorescent particles were used, bringing the particles topside on putty tape. Figure 11 shows one strip of putty (from the destroyer) illuminated

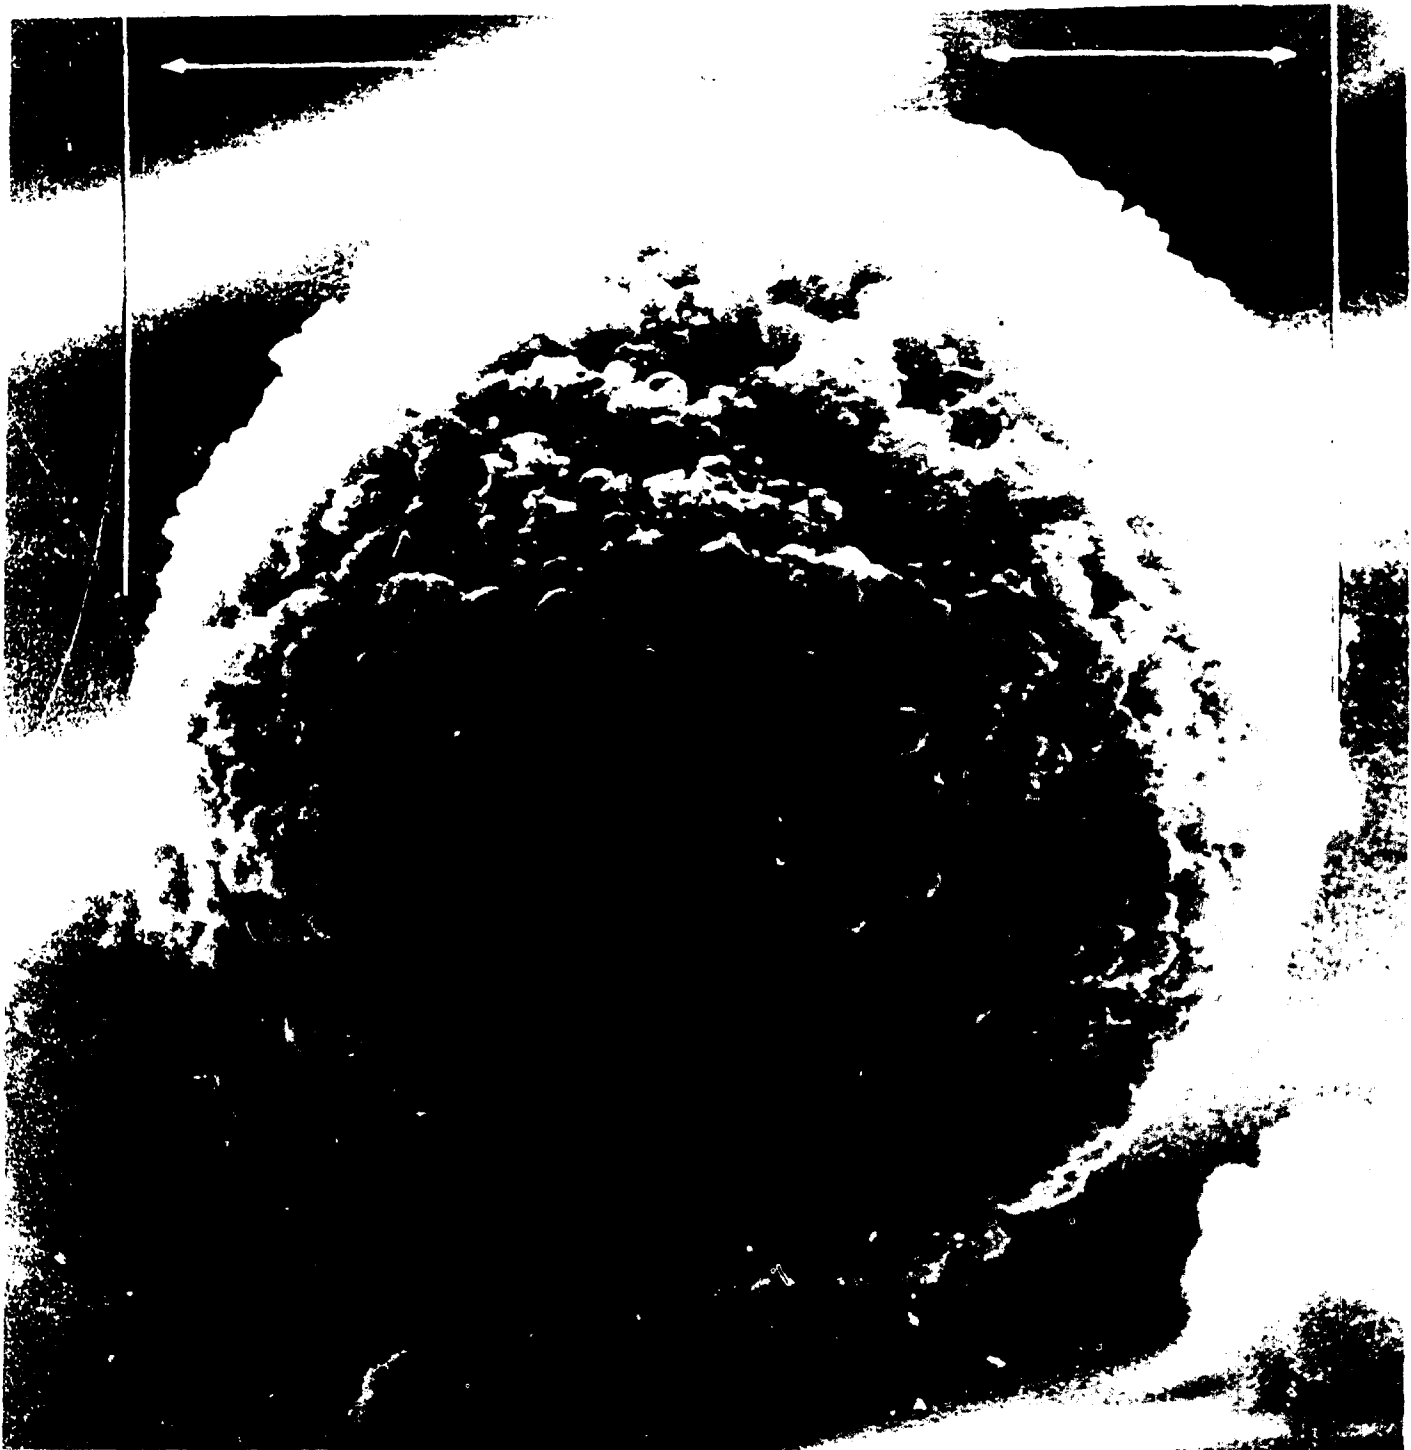
Figure 1. Scanning Electron Microscope Photograph (Courtesy Hughes Aircraft Co) of a microcapsule agglomerate at 4200X. Note individual capsules separate easily on impact at surface to be inspected.

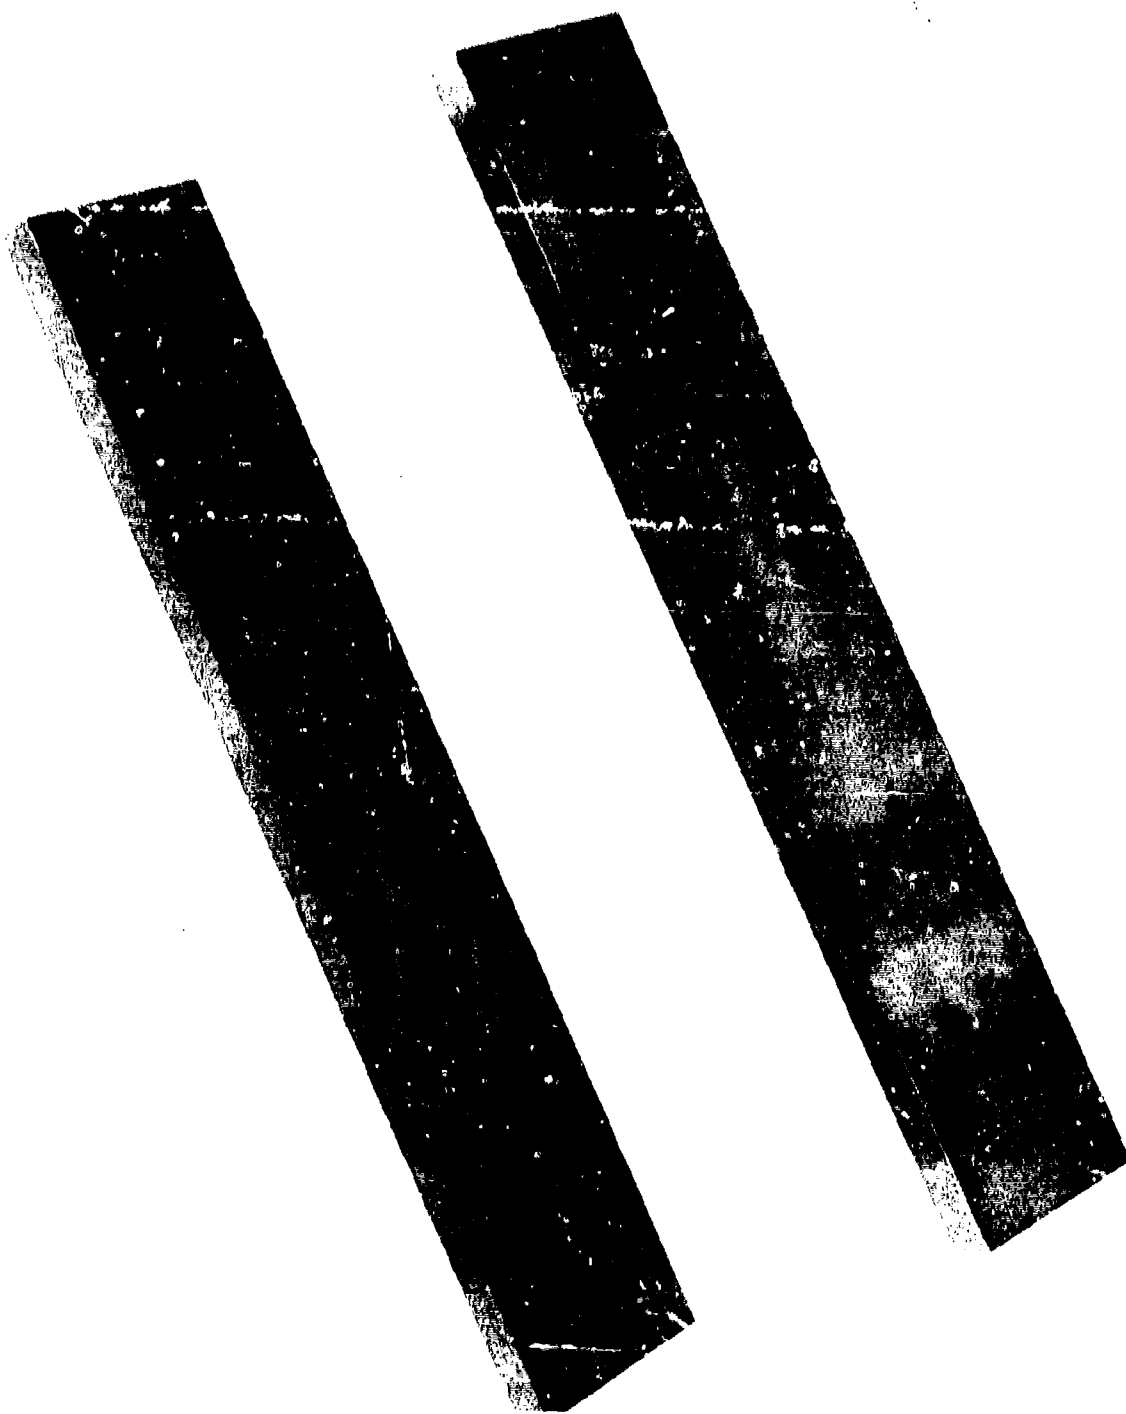
Figure 5. Fatigue Crack Standards for Group VIA and B Penetrants
