**MATERIALS FOR HIGH-TEMPERATURE HYDROGEN  
FLUORINE ENVIRONMENTS**

(Final Report, AFWL Project Order 78-002  
June 1976 - December 1978)

C. E. Holcombe, Jr.  
L. Kovach

March 1981

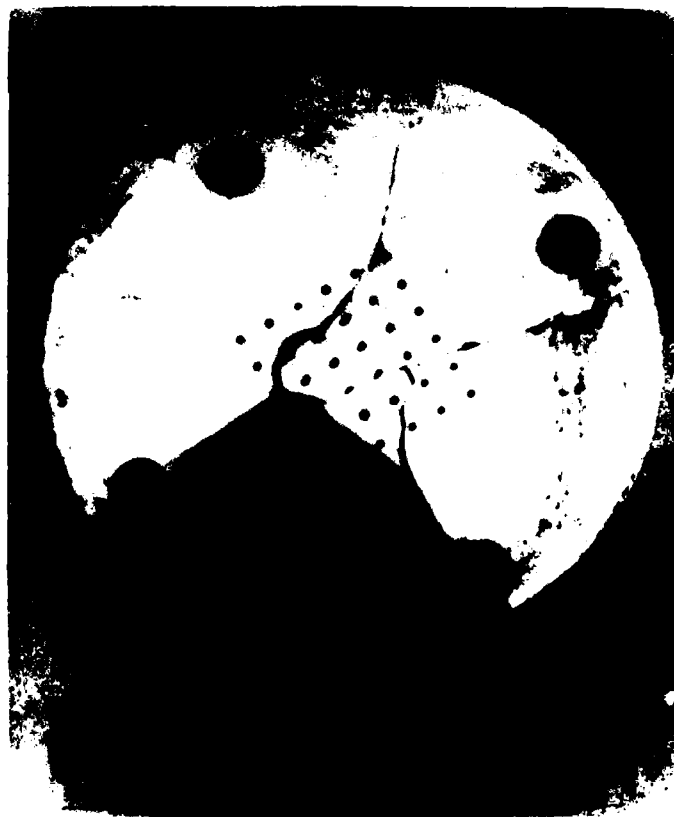
181383  
Figure 19. ALUMINA TEST PLATE FACE EXPOSED TO HYDROGEN FLUORIDE FLAME.

Figure 19 shows the exposed side of the plate, which evidently experienced some corrosion.

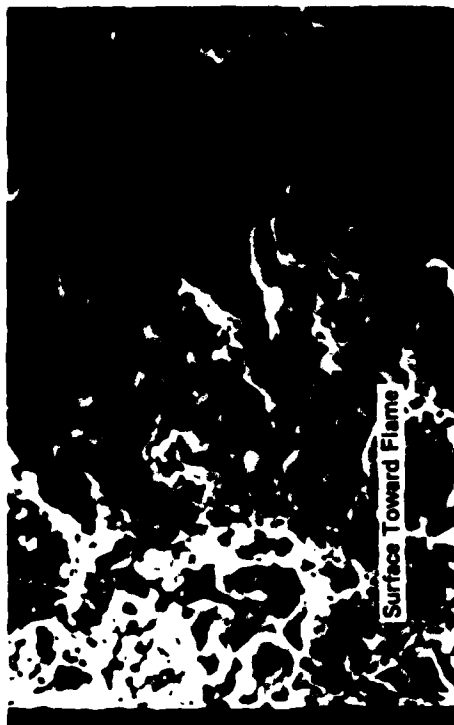
Figure 32. SCANNING-ELECTRON-MICROSCOPE PHOTOGRAPH OF LANTHANUM FLUORIDE COATING ON LANTHANUM HEXABORIDE. (Edge view of top coating on cylinder.)

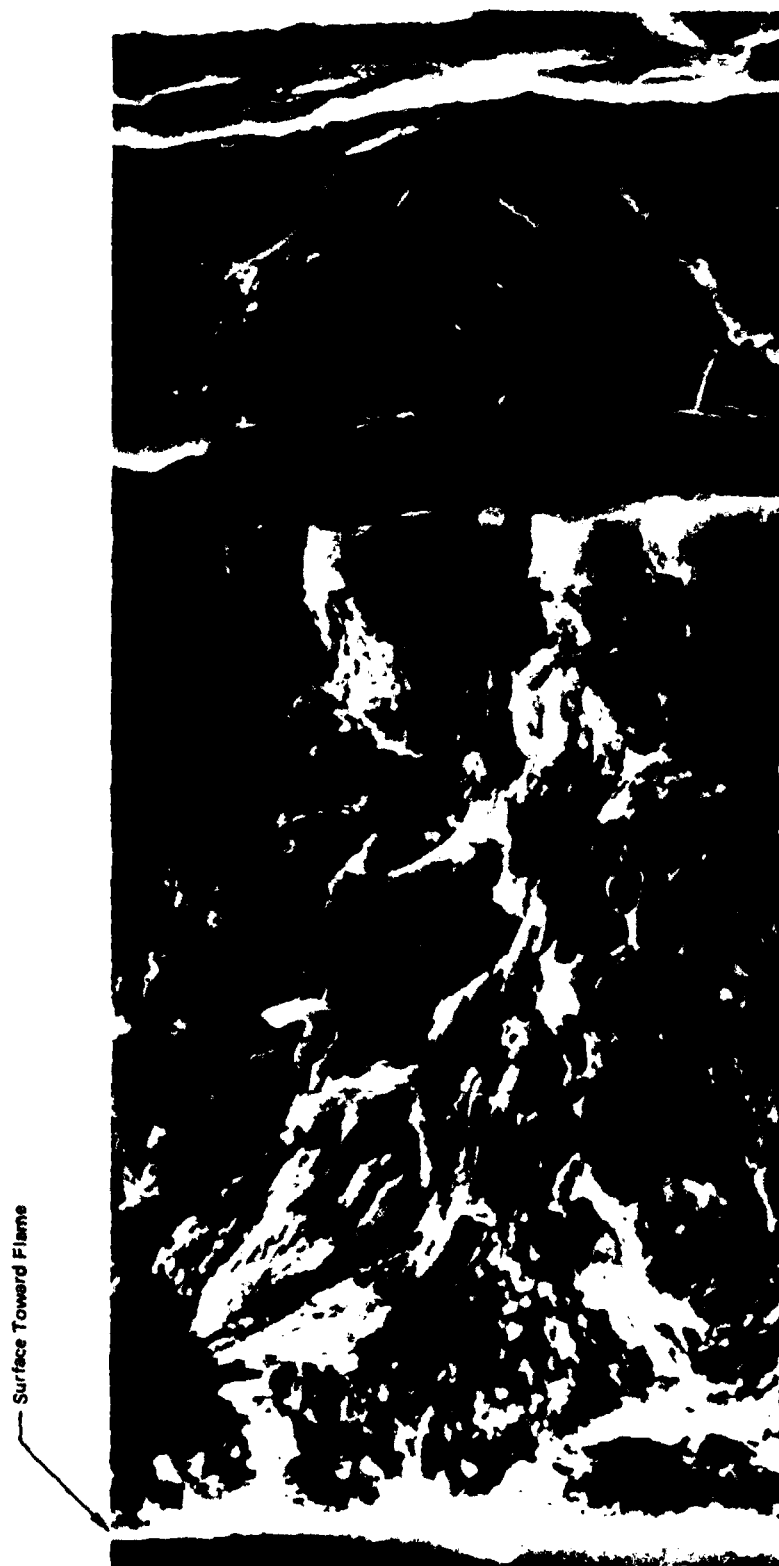
185302  
Figure 57. SCANNING ELECTRON MICROSCOPE PHOTOGRAPH OF LANTHANUM FLUORIDE COATING ON LANTHANUM HEXABORIDE AFTER  $3 \times 10^4$  H<sub>2</sub> EXPOSURE. (Edge view of top coating on cylinder; 3000X.)
