Technical Report 659

# FEASIBILITY TESTS OF THE REMOTE MEDICAL DIAGNOSIS SYSTEM

January 1981

Naval Medical Research and Development Command

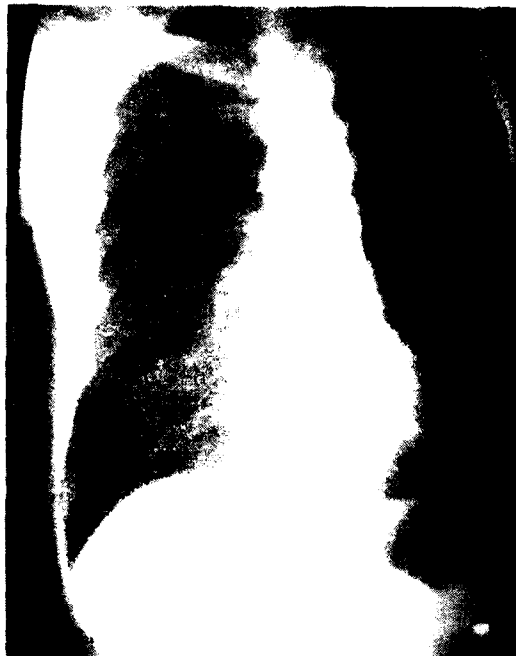
B1. Transmitted image, from JUNEAU to NOSC, uhf. live, 15 May 1975.

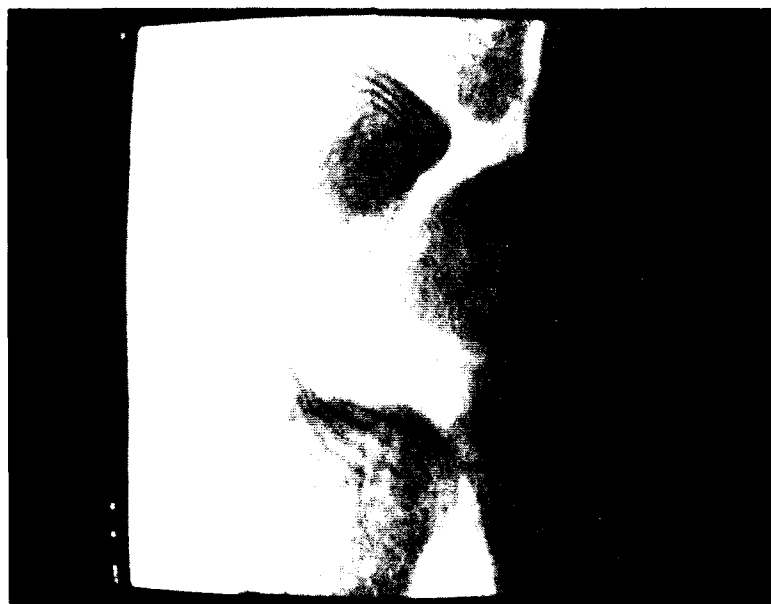
B13. Received image, from NOSC to NRMC, hf, 11 February 1975.

Figure B12 shows the received image of an X-ray sent via land line from NOSC to NRMC San Diego, 11 February 1975. Figure B13 records the received image of the same X-ray, this time transmitted via hf link. The wavy lines in this figure illustrate the effects of noise interference in the hf spectrum.
