ROYAL AIRCRAFT ESTABLISHMENT

Technical Report 80043

⑥ MEASUREMENTS OF THE DYNAMIC PERFORMANCE OF THE MAIN DRIVE FAN OF THE RAE 5 METRE PRESSURISED LOW SPEED WIND TUNNEL.

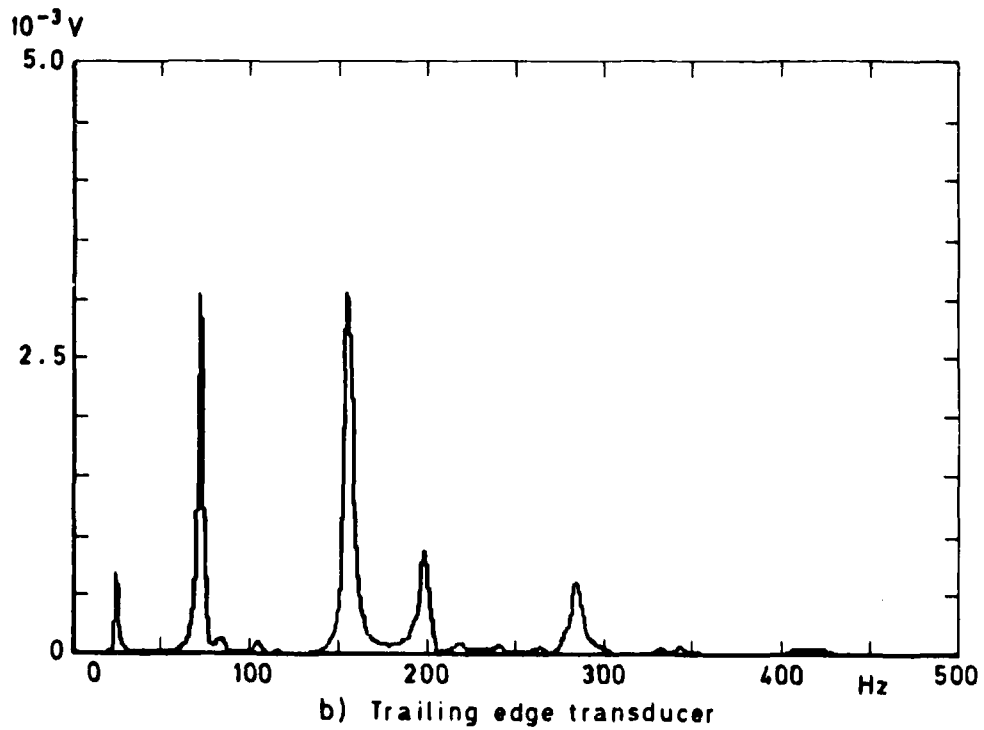
a) Leading edge transducer

b) Trailing edge transducer

Fig 5a&b Response of blade to leading edge hit

Figs 4 and 5 show typical spectra from one particular blade. In Fig 4 the blade was hit at the trailing edge and the response of the two accelerometers is shown; Fig 5 shows the response to a leading edge strike. All of the modes seen in the static testing, with individual blades mounted on a heavy bedplate, can be seen in the accelerometer results for each blade when assembled into the complete fan. The 100 Hz bending mode is not pronounced and the 250 and 330 Hz modes are only seen on some of the traces. In comparison with Fig 3, differences may be due to mounting the blades onto the steel hub and the behaviour of the complete assembly. The modes at 75 Hz and at 330 Hz now show complicated double peaks on some traces and this could be another effect due to the complete structure rather than an isolated blade.

From these results, one of the chosen modes (first order torsion at 75 Hz) is seen to give relatively poor results. Examination of Figs 4 and 5 confirms a complicated response in that particular mode and further tests did show two closely spaced vibration modes; typically at 69 and 75 Hz. In the long term, it may therefore be better to base the analysis on just the 23 and 150 Hz modes. On one occasion the tip of Blade 14 was damaged when a plywood panel lifted and was blown round the circuit. The blade was removed for repair and replaced by Blade 10, which explains the one occurrence in Fig 7 for Blade 10.

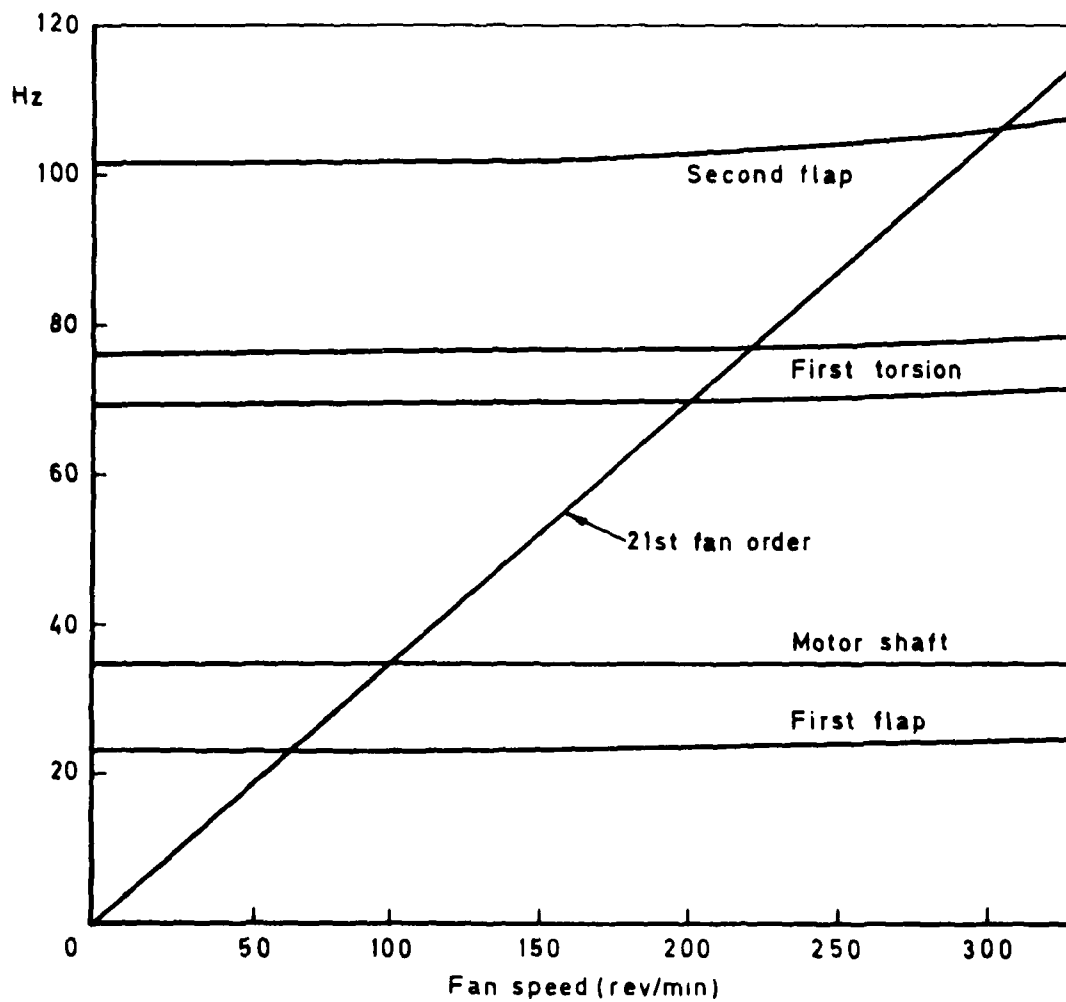
Fig 14 Interference diagram

Fig 14 shows the interference diagram in which the blade frequencies, for the basic modes, are shown cross-plotted against rotation speed - there being a centrifugal effect which increases the mode frequency with increased rotational speed. The likely sources of fan-ordered excitations are shown on the diagram. Twenty-first order excitation results from each blade passing through the wakes of 21 pre-rotation vanes and is the most likely source of aerodynamic excitation. The predicted resonant conditions are fan rotation speeds of about 65, 200, 220 and 300 rev/min (depending on blade temperatures and the exact centrifugal effects). Also shown is a motor frequency at 34.8 Hz. This is a shaft vibration where the dc motor oscillates on its shaft, which connects to the ac motor shaft. However, a Holset coupling effectively isolates the fan shaft from the motors, except at about 7 Hz, and so the aerodynamic excitation which would coincide at about 100 rev/min should not lead to any motor instabilities, which could be felt at the blades. Excitations of 10 fan orders and 210 fan orders might also be felt by the shaft, but again should be isolated from the blades.

Many of the resonant or driven conditions seen in Figs 15 and 16 are also seen in the interference diagram of Fig 14. In particular, the intersection of the twenty-first fan order with the first three basic modes, at approximately 65, 200, 220 and 300 rev/min, corresponds with peaks in the dynamic performance. All of these fan speeds are conditions where dynamic activity is increased; the region around 215 rev/min is an area of confusion, with several closely-spaced excitations shown especially by the torsion-sensitive gauge. In general the peaks seen in the dynamic performance can be explained by pre-rotation vanes providing a driving input at the appropriate frequency to excite the basic fan modes

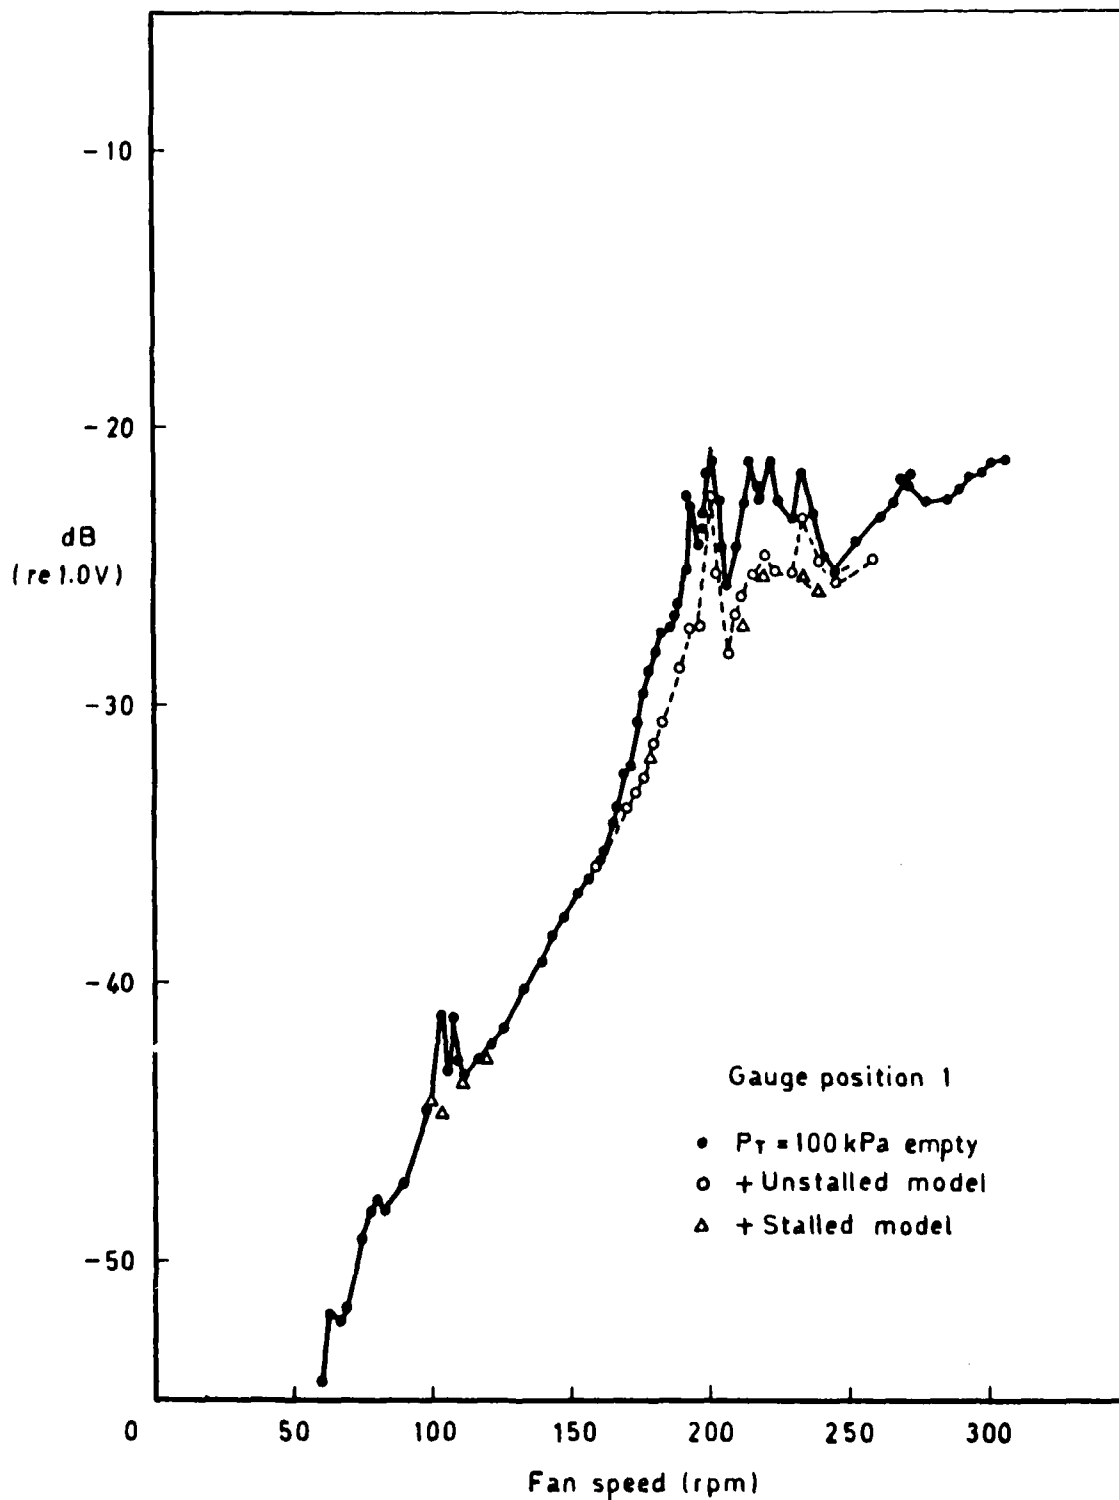
Fig 20 Effect of a model. Gauge 1

Figs 20 and 21 show the effects due to the presence of a model in the test section, again for the two different gauge positions. All previous results were for an empty tunnel. For position 1 (torsion and flapping), the only effects of a model, both stalled and unstalled, were in the fan speed range between 175 and 225 rev/min. This has been seen to be a complicated region in terms of fan dynamic response and so the presence of a model is beneficial, but there is very little difference between a stalled and unstalled model. For the 'flapping' gauge, position 3 Fig 21, the unstalled model causes a decrease of activity between about 175 and 200 rev/min but increases the resonance at 215 rev/min, believed to be associated with first mode torsion. However, the stalled model damps the response above 200 rev/min as well as between 175 and 200 rev/min. In all cases the wake of the model, in this case a 1/13 scale A300B, appears to break up a regular flow at fan speeds around 200 rev/min and does not introduce any other excitations in doing so.
