ROCK ISLAND ARSENAL IL ENGINEERING DIRECTORATE  
COATING OF STEEL PISTONS WITH BEARING MATERIALS. PHASE 1.(U)  
OCT 80 M SOLANKI

**COATING OF WEAPON COMPONENTS WITH  
BEARING MATERIAL (Phase 1)**

**TECHNICAL REPORT**

**ROCK ISLAND ARSENAL  
ROCK ISLAND, ILLINOIS 61299**

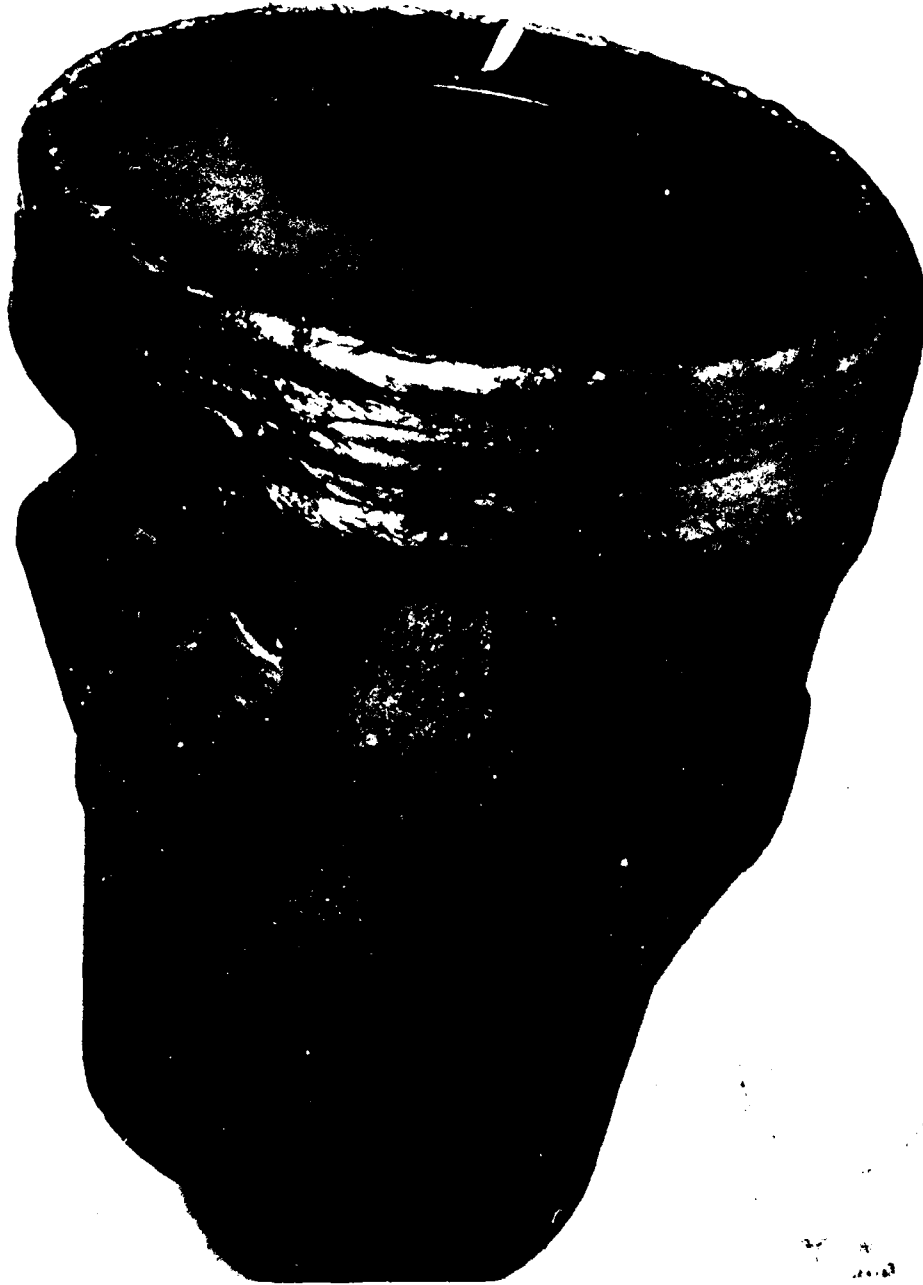
FIGURE 10. M174 PISTON COATED WITH Al-BRONZE (UNFINISHED).

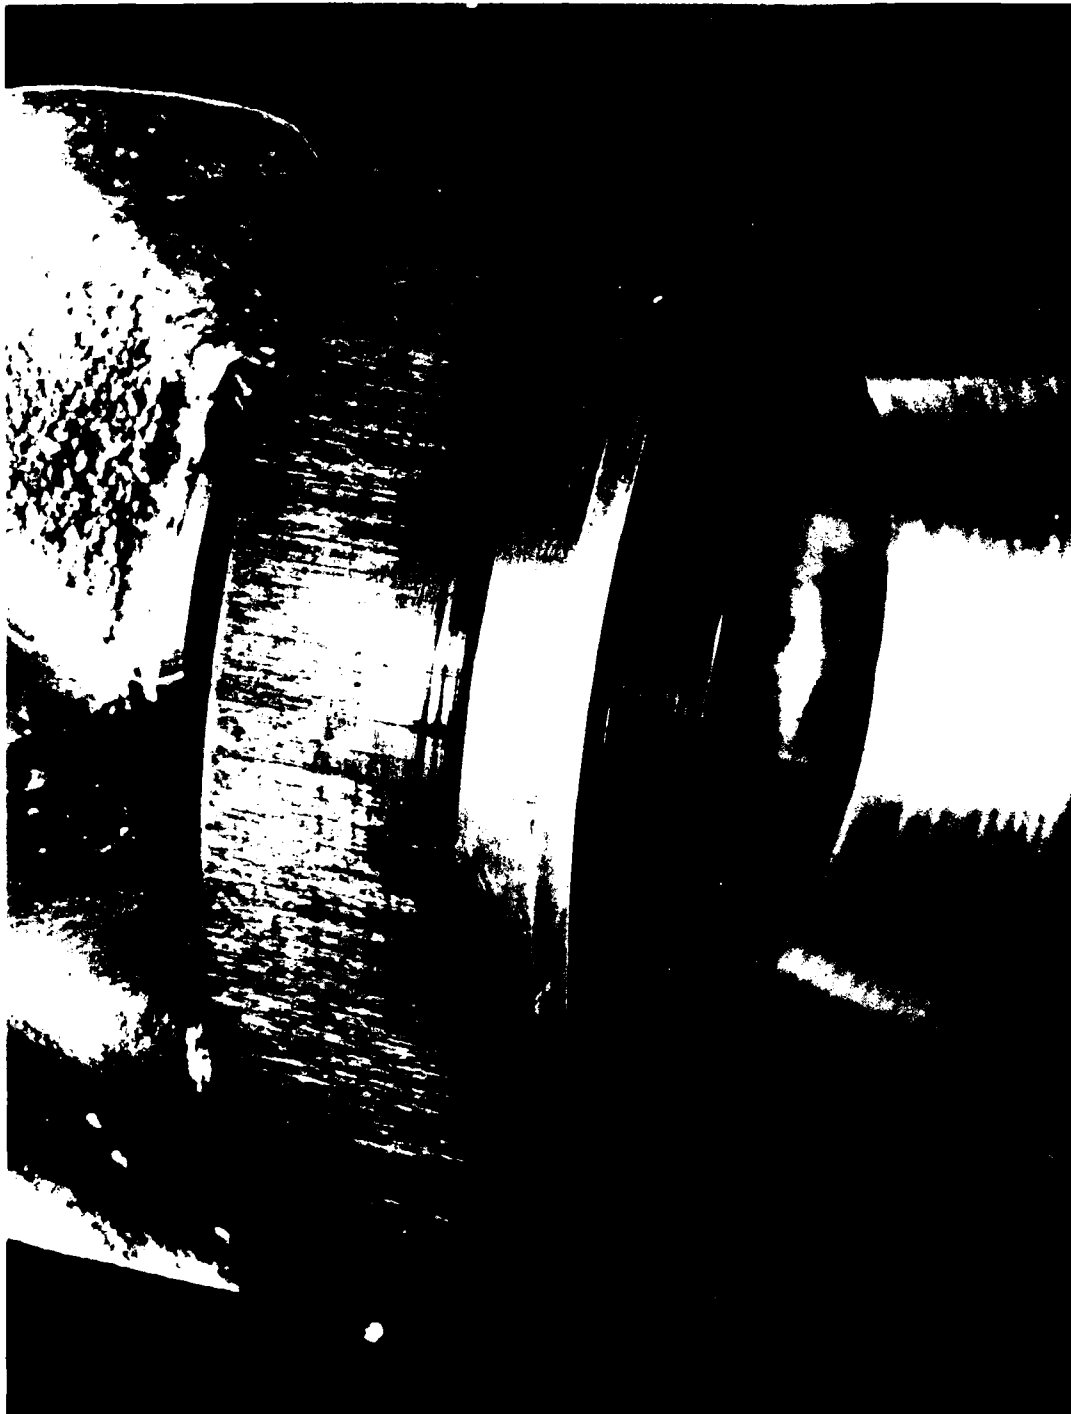
FIGURE 12. LIGHT SCORING ON OUTER BEARING SURFACE OF M174 PISTON  
AFTER TEST FIRING.

After simulation testing, the piston was then sent to Yuma Proving Ground, AZ for live-firing test where a total of 518 rounds were fired. At the conclusion of the test the recoil mechanism was disassembled and the piston was visually examined. It was observed that no adverse degradation of the piston had occurred. Only a few additional scratches were evident and none of these scratches were of any appreciable depth. The piston is considered in excellent condition for additional testing.

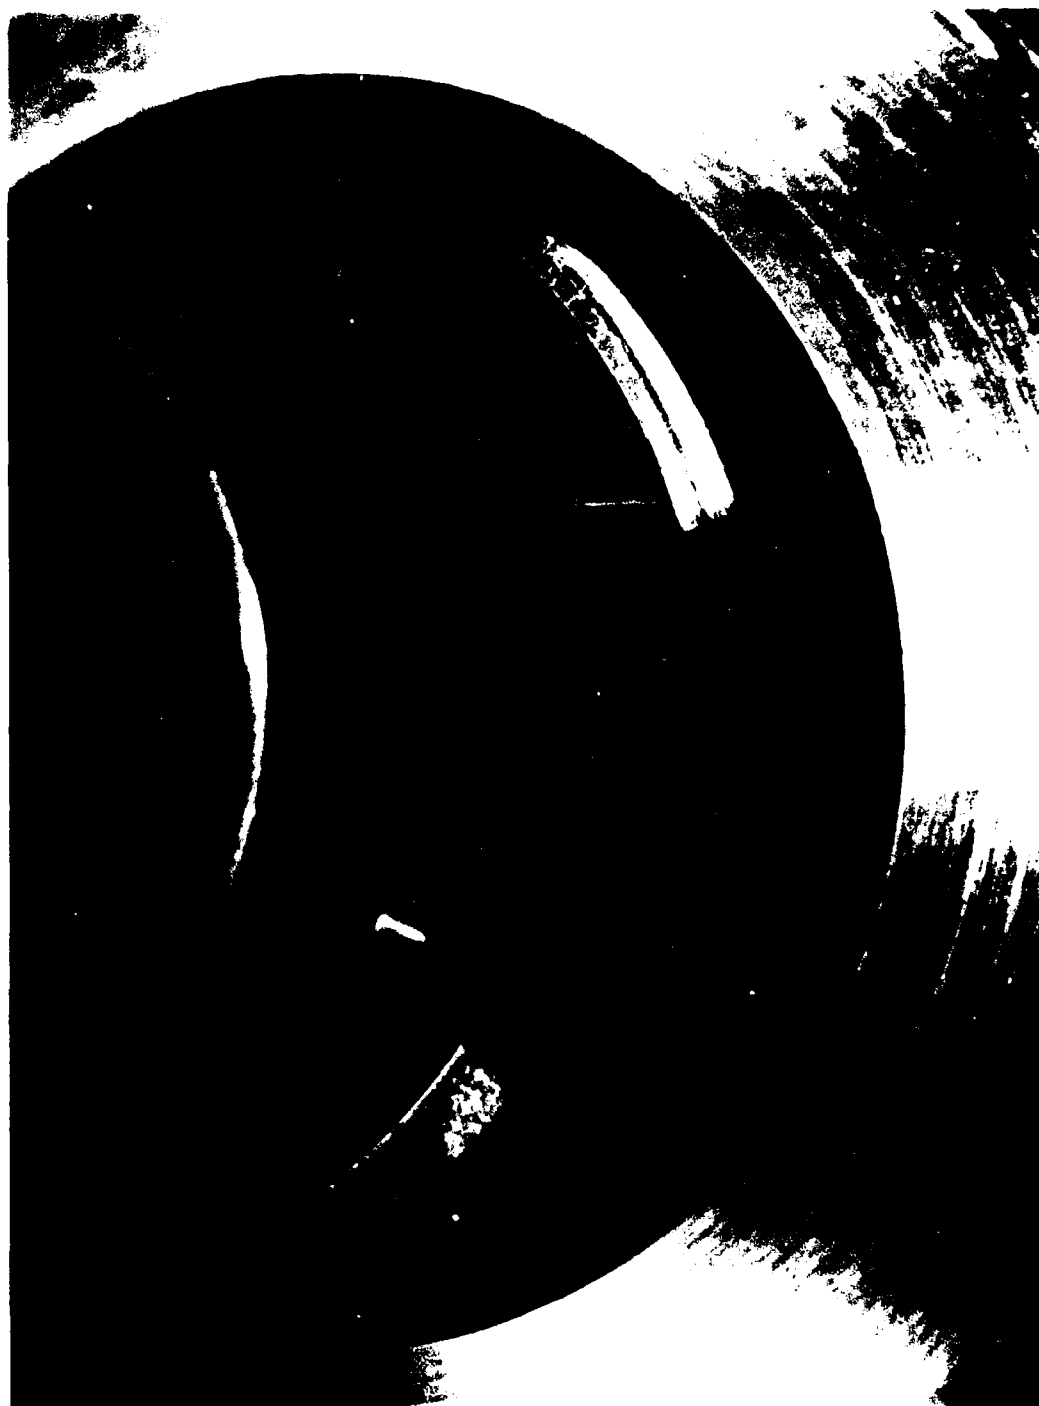
FIGURE 13. LIGHT SCORING ON INNER BEARING SURFACE OF M174 PISTON  
AFTER TEST FIRING.
