METHODOLOGY INVESTIGATION,

FINAL REPORT

CHAMBER VERSUS ENVIRONMENTAL DETERIORATION TESTS

UNITED STATES ARMY TROPIC TEST CENTER

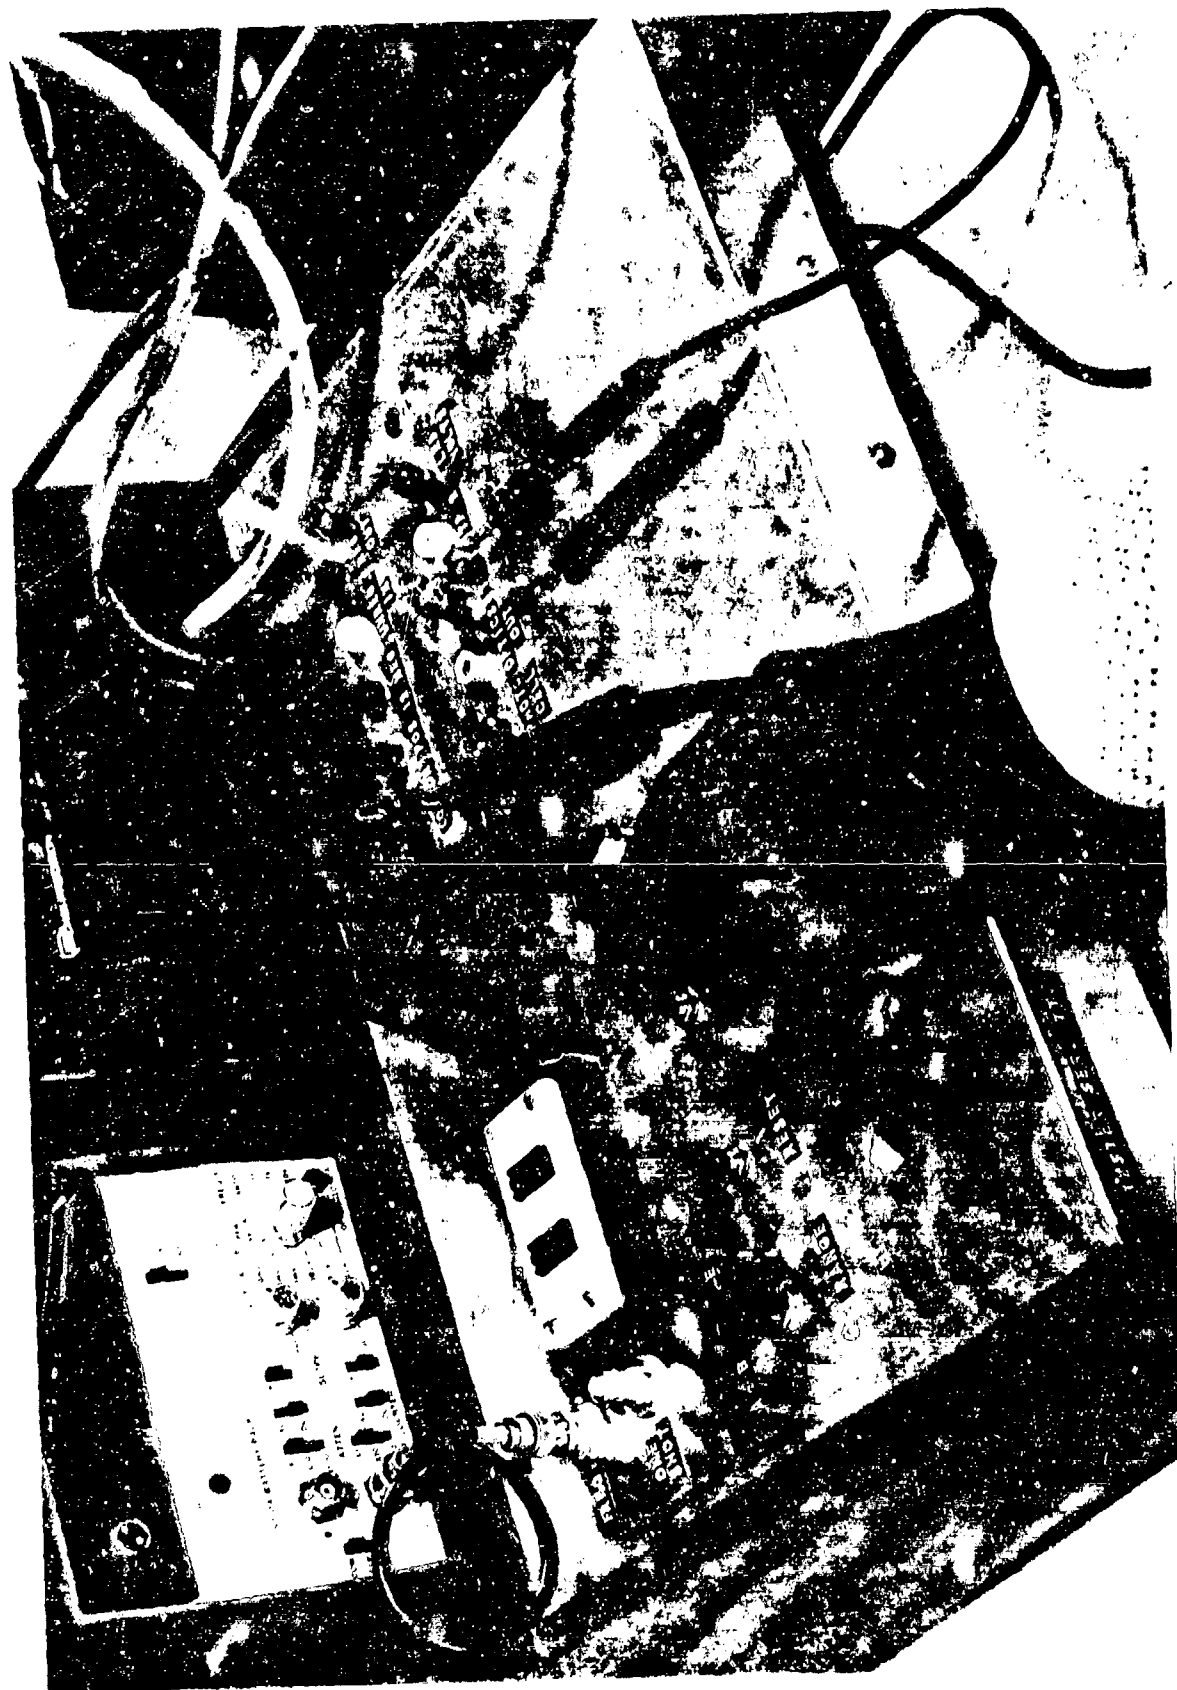
Figure 15. Optical/Digital Electronic System Tester.
