FLOOD PLAIN INFORMATION  
GRAND RIVER  
TRUMBULL COUNTY  
OHIO

CORPS OF ENGINEERS, U.S. ARMY

BUFFALO DISTRICT  
JULY 1975

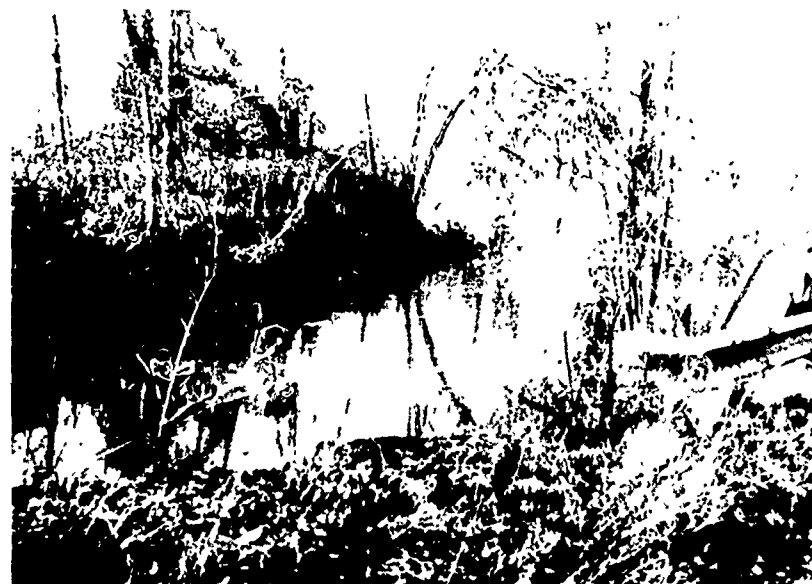
Figure 2—View of channel and banks looking upstream from Hoffman Norton Road, at river mile 85.51.

**Channel Conditions and Development** - The channel, banks, and immediate overbanks of the Grand River are similar throughout most of the study reach. The channel itself resembles a snake writhing back and forth across the flood plain as shown on Plate 2. River banks and immediate overbank areas are heavily wooded with only a few clearings near road crossings. Typical conditions along the banks are shown on Figures 1 and 2. The flood plain areas farther away from the river are more varied in that they are either wooded or used for agricultural purposes. Figures 3 and 4 show the distinction between the wooded areas and farmlands.

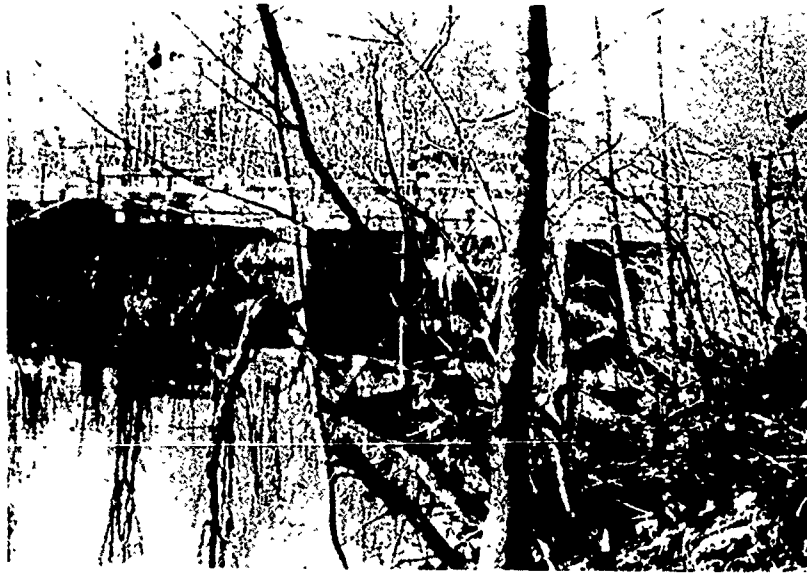
**Figure 5**—View of upstream face of State Route 87 bridge, looking downstream, at river mile 80.03

There are ten bridges which cross the Grand River within the study limits. Figures 5 through 8 show some of the bridges and their waterway openings. Table 2 compares elevations of the bridges with the Intermediate Regional and Standard Project Flood elevations. If, during either the IRF or SPF, bridge openings become clogged with brush and fallen trees, then such obstructions would cause higher flood elevations upstream than normally would have occurred.

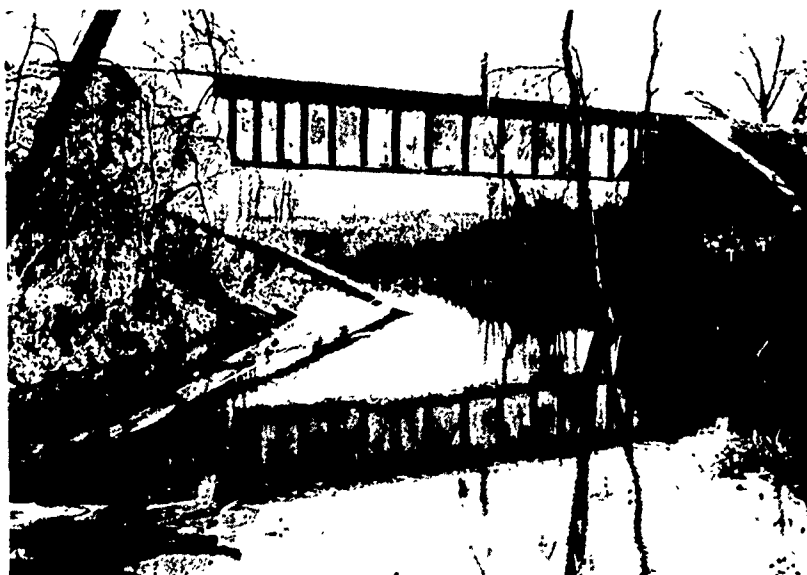
**Figure 8—View of downstream face of Baltimore & Ohio Railroad bridge, looking upstream, at river mile 90.98.**

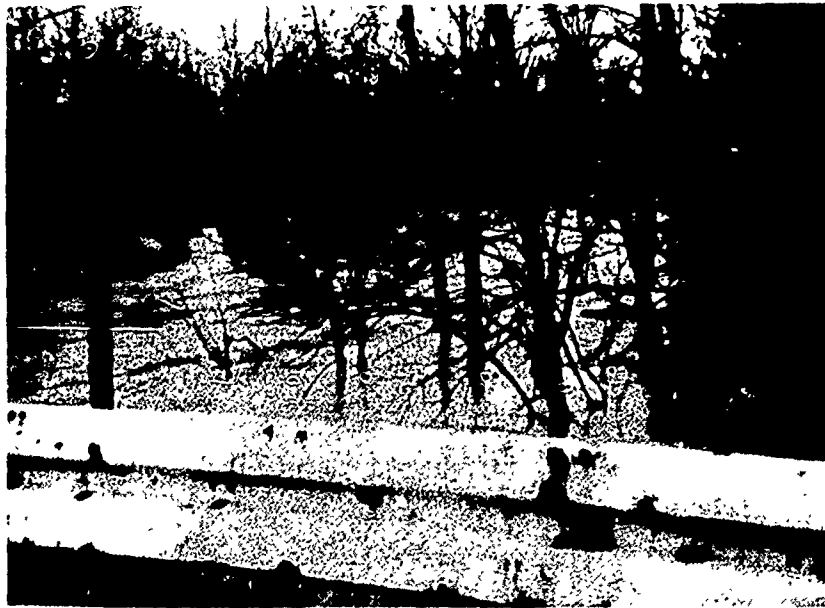
**Figure 9**—View of Grand River looking upstream from State Route 87 bridge during March, 1970 flood, at river mile 80.03.

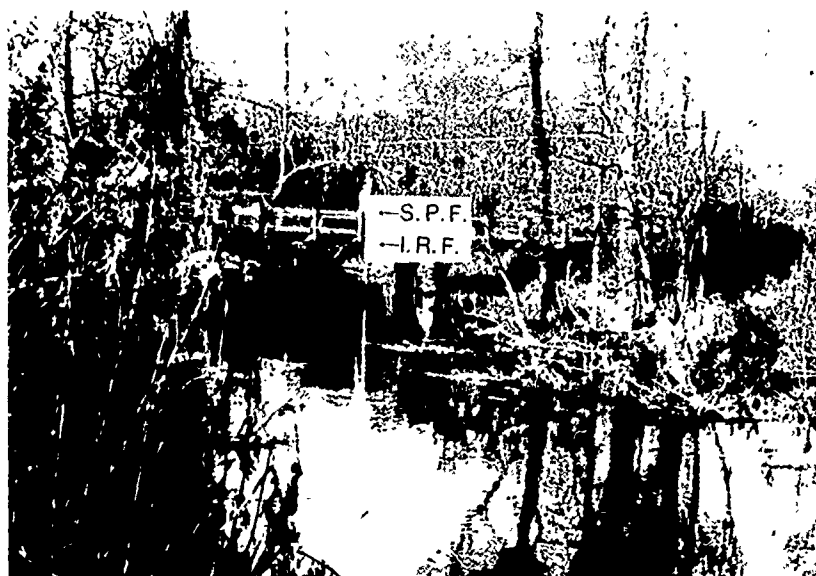
**Figure 12**—Heights of the Standard Project and Intermediate Regional Floods are shown by the arrows on the County Line Donley Road bridge at river mile 77.04

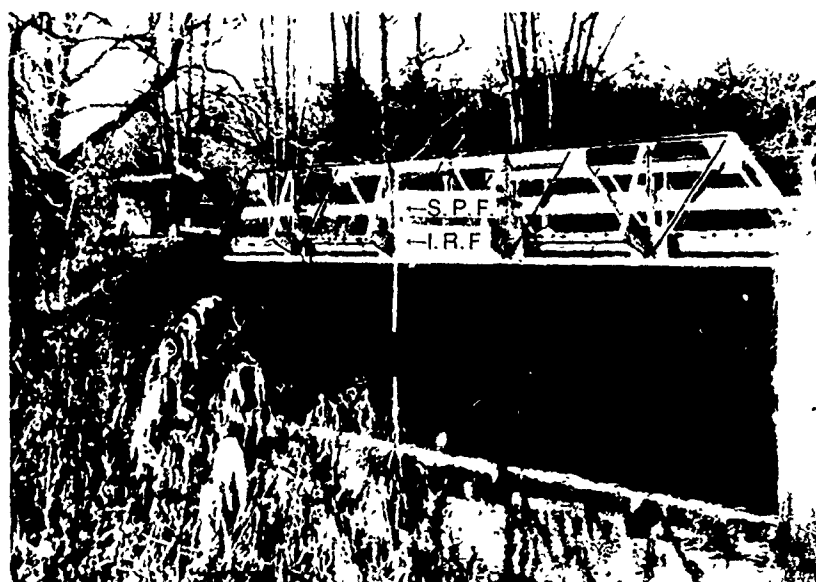
**Figure 13**—Heights of the Standard Project and Intermediate Regional Floods are shown by the arrows on the Hyde Oakfield Road bridge at river mile 85.31.

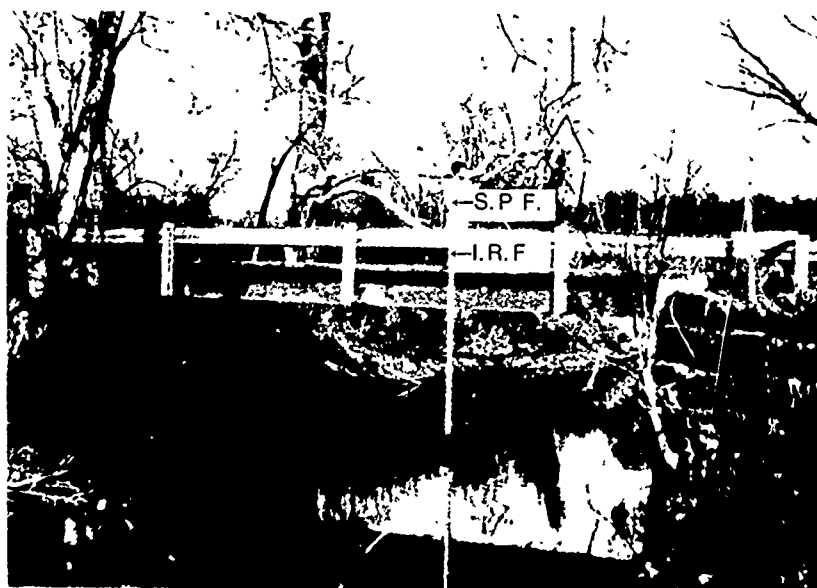
**Figure 15**—Heights of the Standard Project and Intermediate Regional Floods are shown by the arrows on the Wood Curtis Road bridge at river mile 90.56.
