**LEVEL**  
**FLOOD PLAIN INFORMATION** **(12)**  
**OTTAWA RIVER-TENMILE CREEK**  
**SYLVANIA AND VICINITY**  
**LUCAS COUNTY, OHIO**

PREPARED FOR  
OHIO DEPARTMENT OF NATURAL RESOURCES  
DIVISION OF PLANNING, FLOOD PLAIN MANAGEMENT SECTION  
AND  
TOLEDO METROPOLITAN AREA COUNCIL OF GOVERNMENTS  
TOLEDO-LUCAS COUNTY PLAN COMMISSIONS  
MAUMEE WATERSHED CONSERVANCY DISTRICT  
SYLVANIA MUNICIPAL PLANNING COMMISSION

BY  
CORPS OF ENGINEERS U. S. ARMY  
DETROIT DISTRICT

JUNE 1975

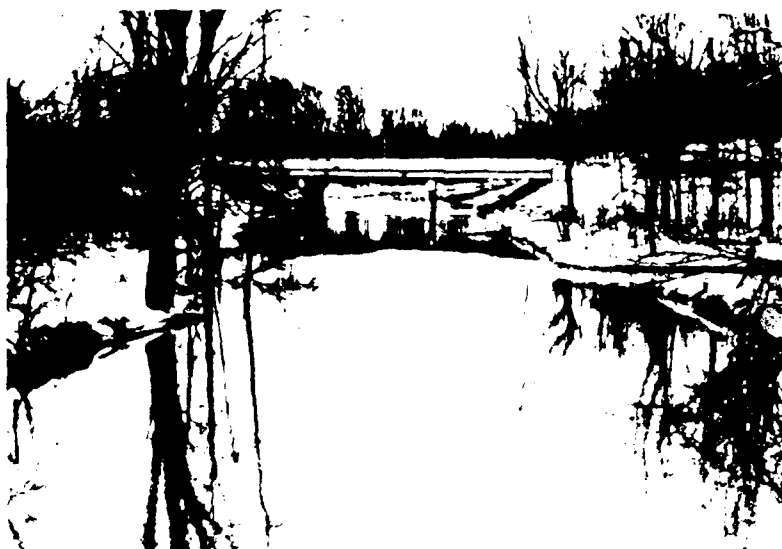
Upstream face of the I-475 Bridge at river mile 16.81 near Sylvania, Ohio

**Obstructions to flood flows** - Natural obstructions to flood flows include trees, brush, and other vegetation growing along the stream banks in the flood plain. Man-made encroachments and constrictions such as dams, bridges, floodwalls, levees, and highway and railroad embankments can also create more extensive flooding than would otherwise occur. Six of the 27 bridges that cross the flood plains of Ottawa River and Tenmile Creek within the study limits are shown on Figures 1 and 2. Currently, local authorities have plans to replace Harroun Road bridge at river mile 19.68 and Brint Road bridge at river mile 23.03 along their present alignment. The profiles and flooded area maps and bridge data are based on the existing structures and do not reflect the proposed improvements.

The location of each of these 27 bridges is shown on the profiles at the end of the report. The sharp drop or "stair step" effect is the result of encroachment by the bridges and their roadway embankments across the flood plain. The magnitude of this drop is an indication of the ability or inability of the structure to pass the flood discharges under consideration. The absence of these structures would have resulted in a relatively smooth sloping line for each flood.

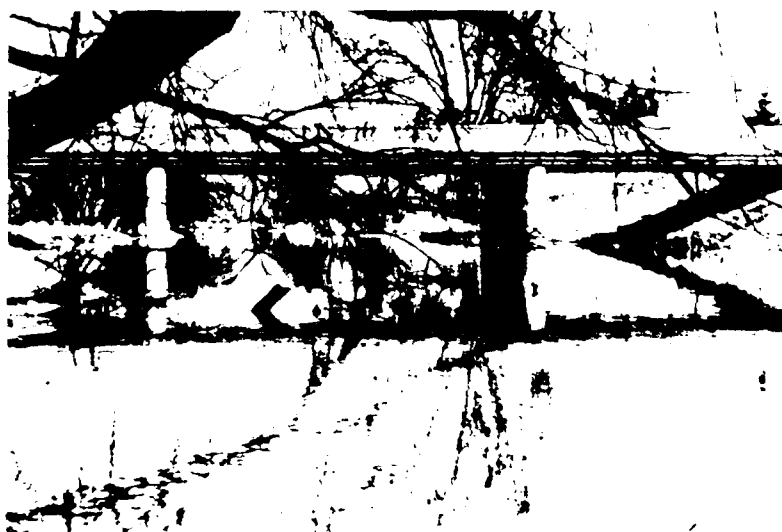
Downstream face of the Sturbridge Road Bridge at river mile 17.65 near Sylvania, Ohio

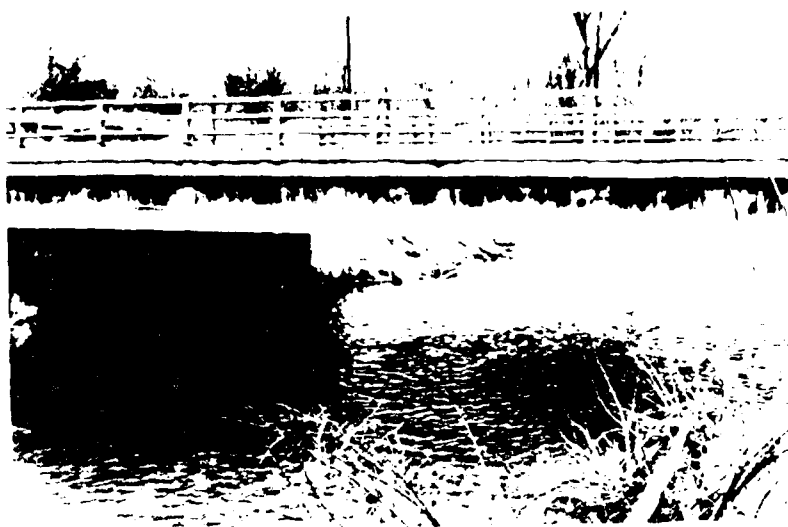
Downstream face of the South Main Street Bridge at river mile 20.15 in Sylvania, Ohio

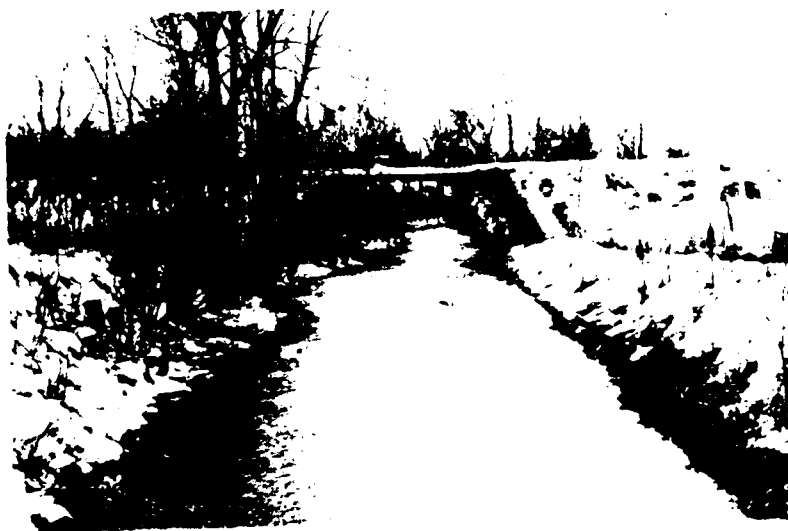
Downstream face of the Penn Central Railroad Bridge at River mile 20.24 in Sylvania, Ohio

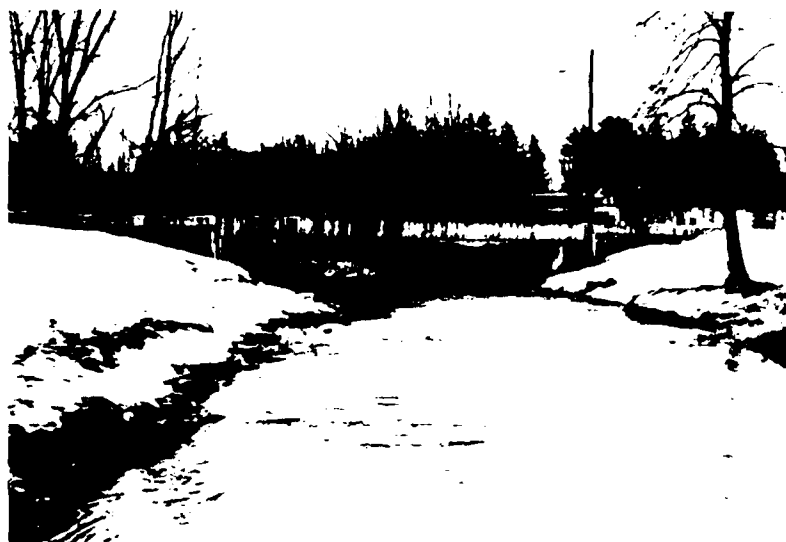
Upstream face of the Silica Drive Bridge at river mile 20.43 in Sylvania, Ohio

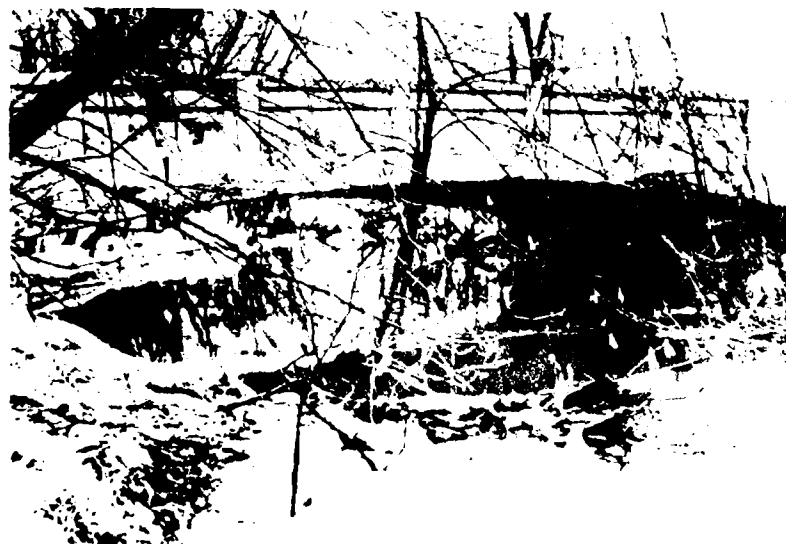
Downstream face of the Kilburn Road Bridge at river mile 29.20 near Sylvania, Ohio

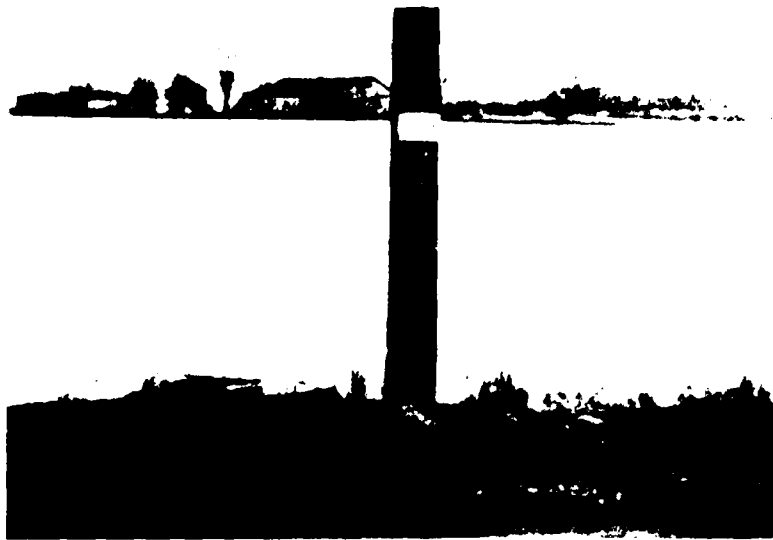
Flooded farmland at the corner of Sylvania Avenue and Mitchaw Road looking north from Sylvania Avenue

Although floods of varying magnitude have occurred on the Ottawa River and Tenmile Creek, they have caused little damage. This can be attributed to the little development in the flood plains. In July, 1958, a summer storm caused flooding of agricultural lands in the study area. Pictures of this flood are shown on Figure 3 and on the cover sheet.

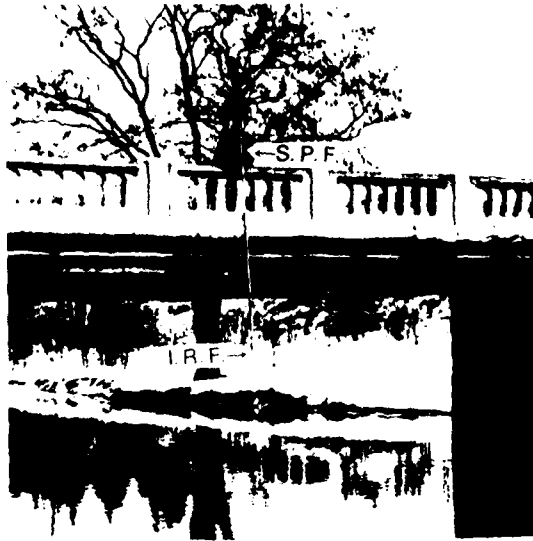
Sturbridge Road Bridge at river mile 17.65.

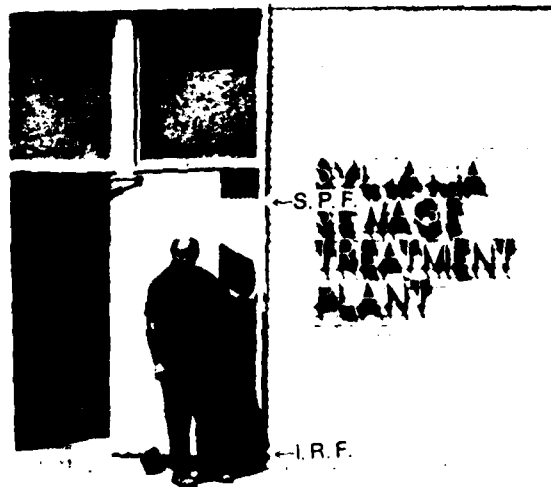
Sylvania Sewage Treatment Plant at river mile 19.86.

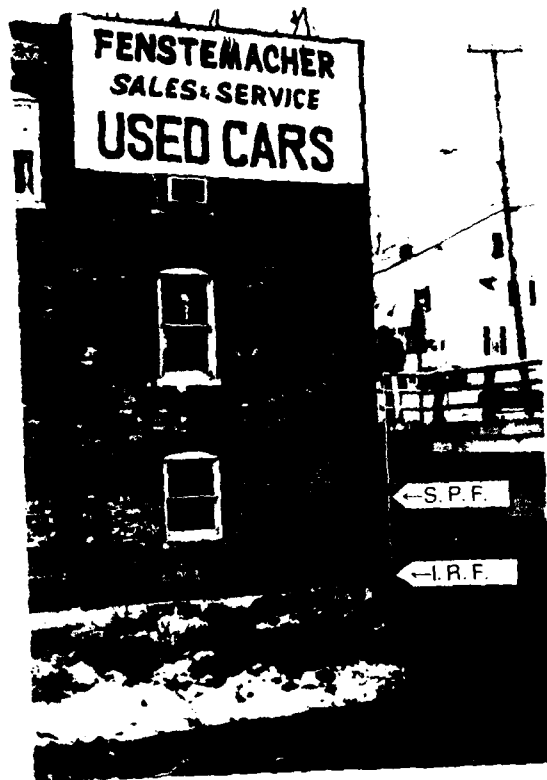
Commercial building on Main Street  
at river mile 20.15.

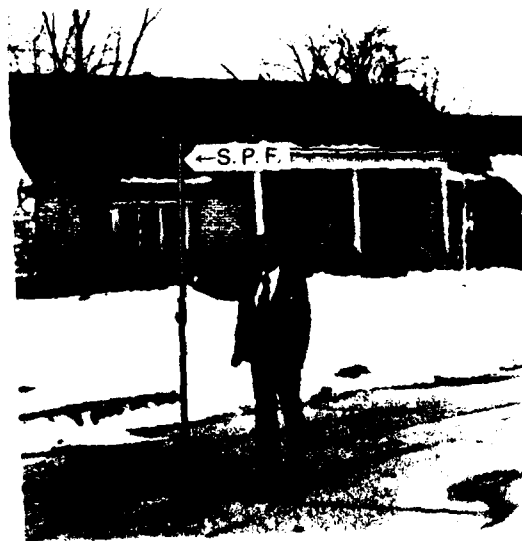
Residential development along  
Apple Creek Road at river mile  
20.74. This area would not be  
inundated by the IRF.

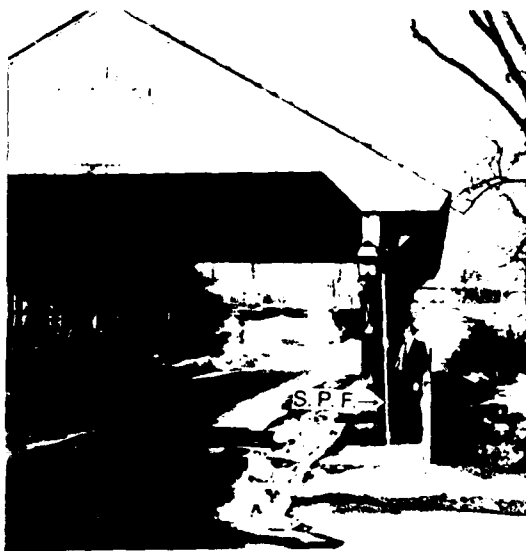
Olde Post Road Bridge at river mile 21.02.

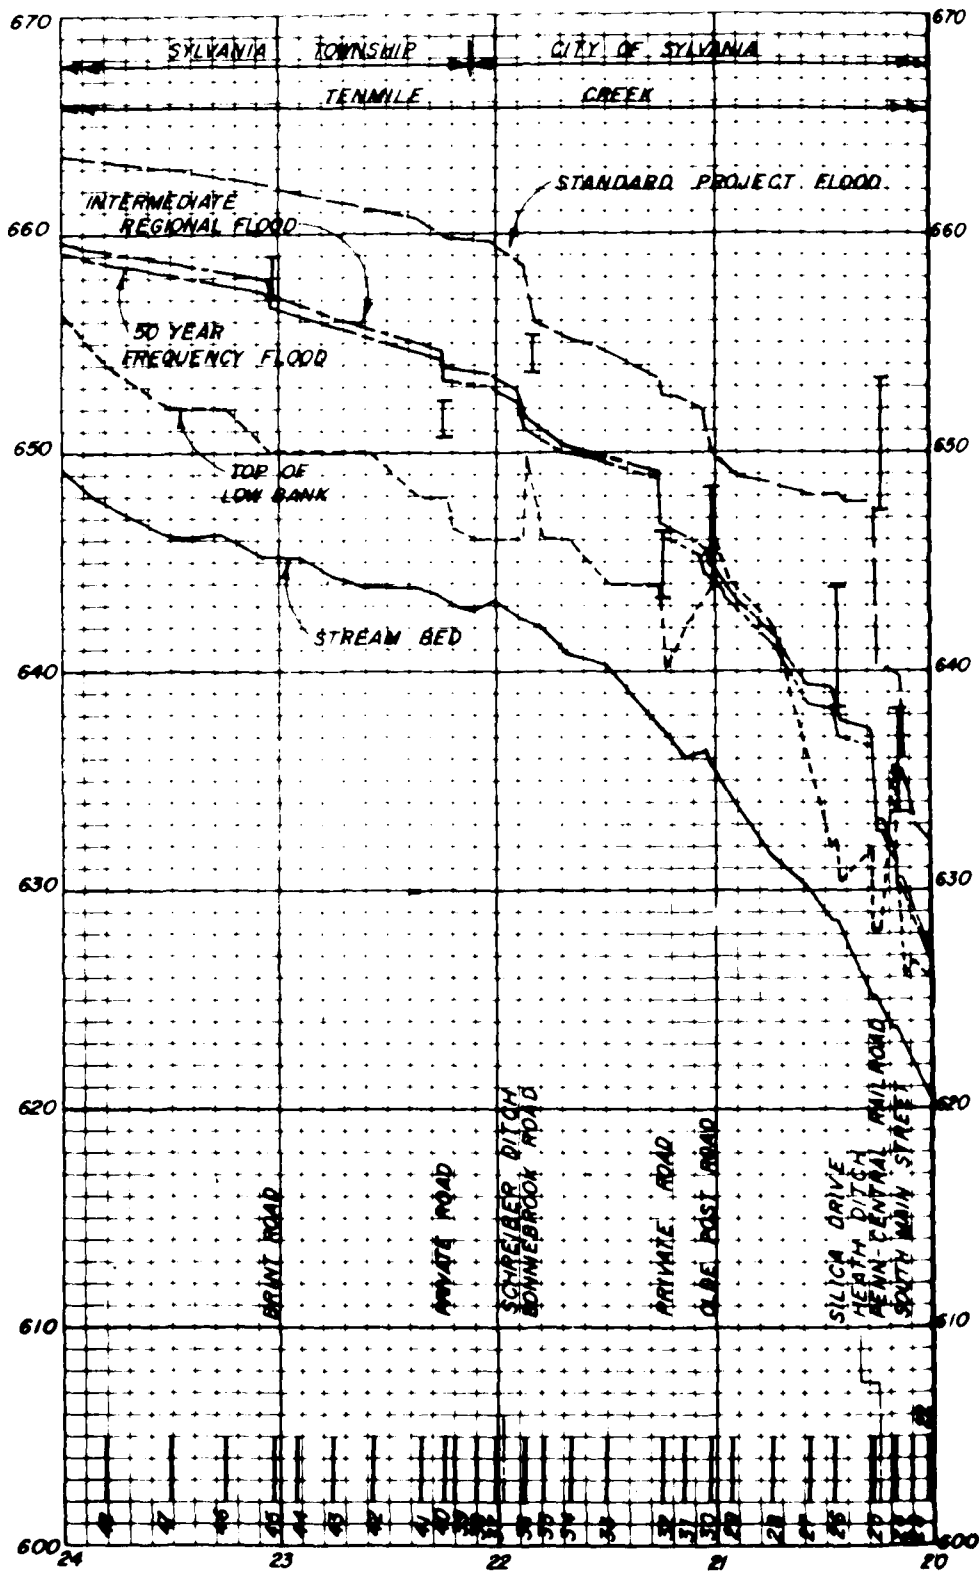
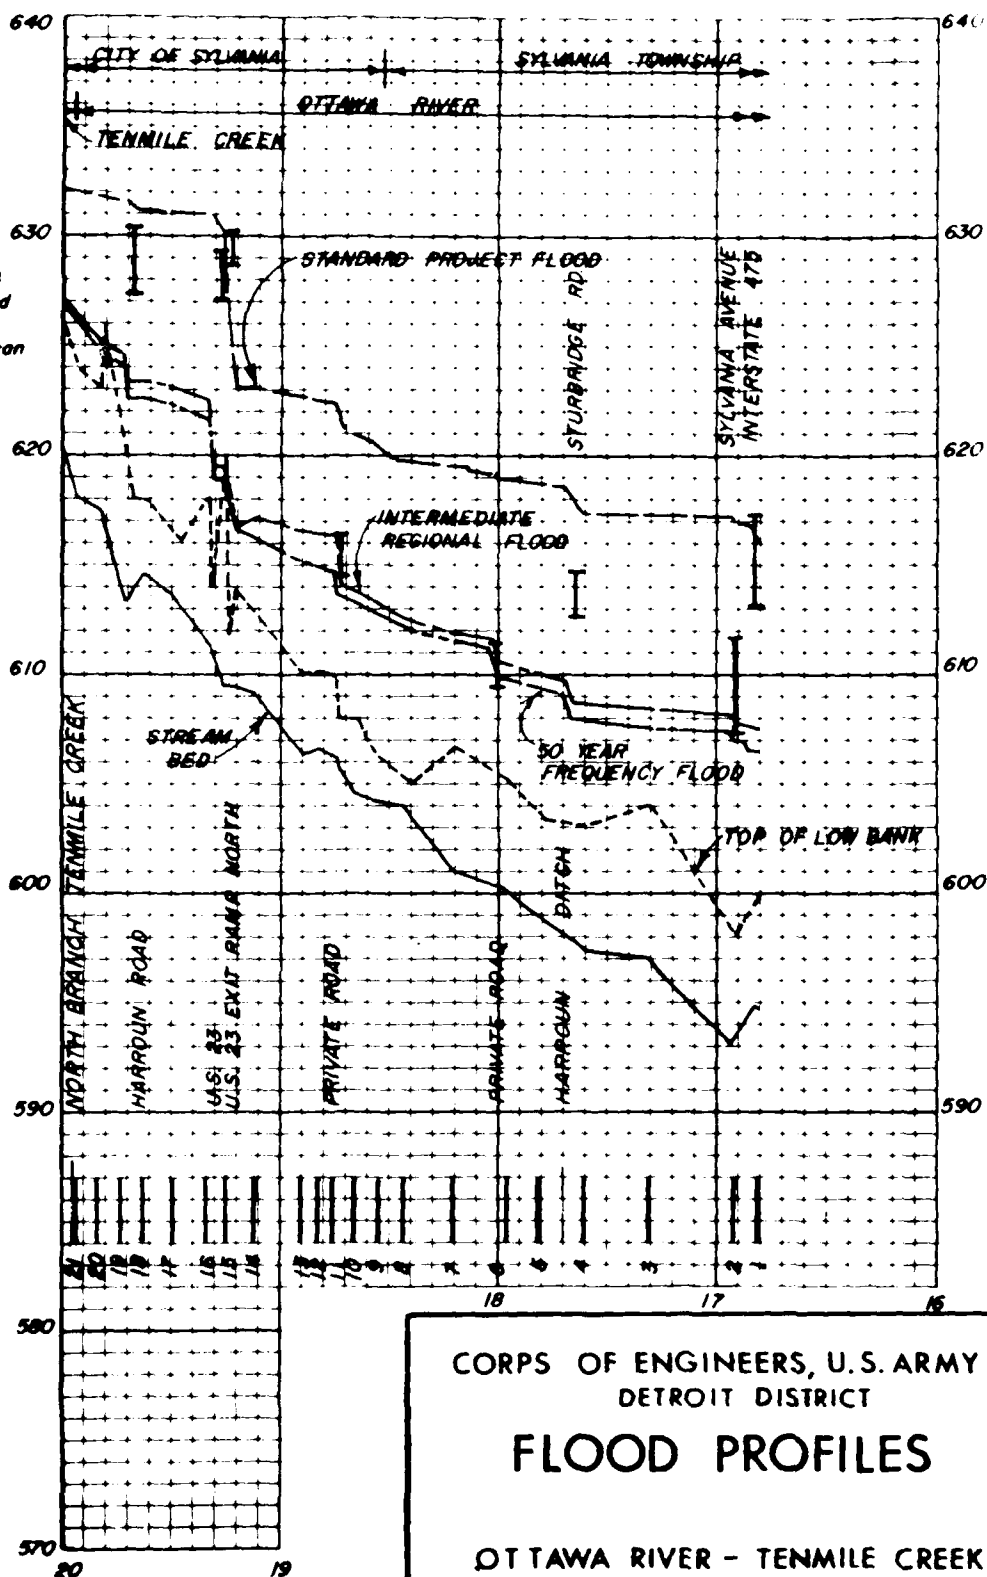
## FLOOD PROFILES

- 1 Profiles represent 1974 state of urbanization and channel conditions
- 2 Floodway encroachment can raise profiles

- NOTES
1. Profiles represent 1974 state of urbanization and channel conditions
  2. Floodway encroachment can raise profiles.

The elevations on the profiles have been translated into flooded areas on Plates 3 through 8. Upstream of each bridge, the outline of the flooded area fans out as a result of the restriction to flow. The degree to which this fanning out takes place depends a great deal upon both the topography and the magnitude of the drop shown on the profiles at each bridge.

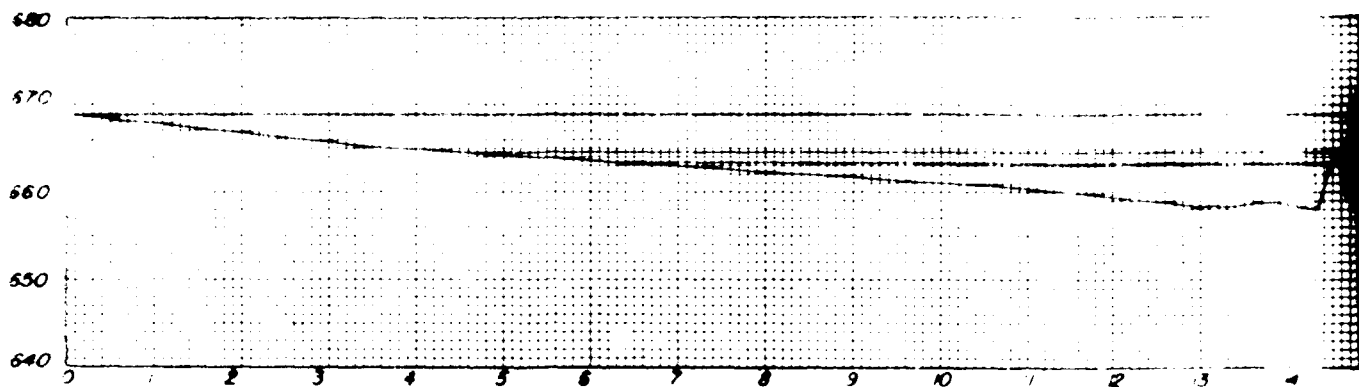
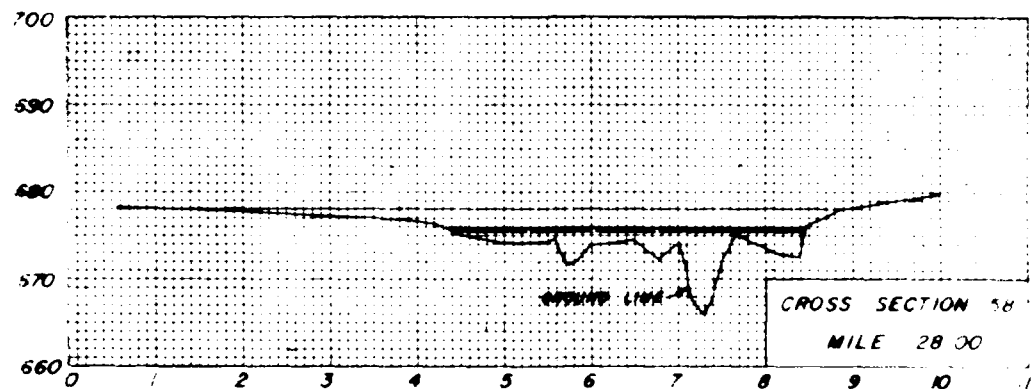
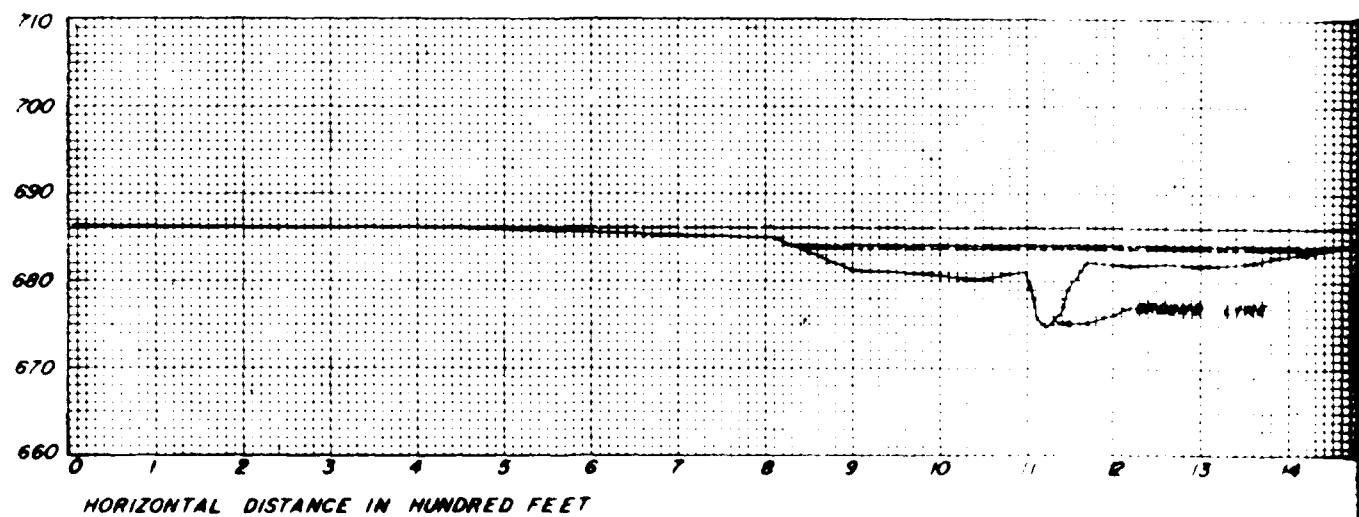
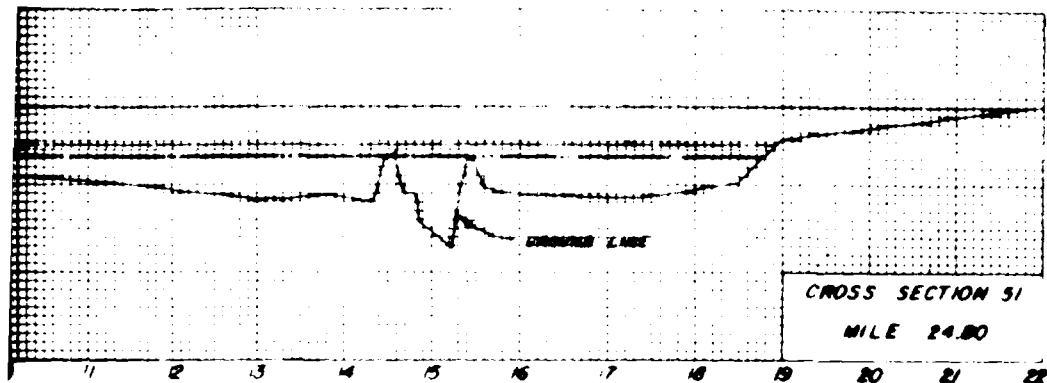
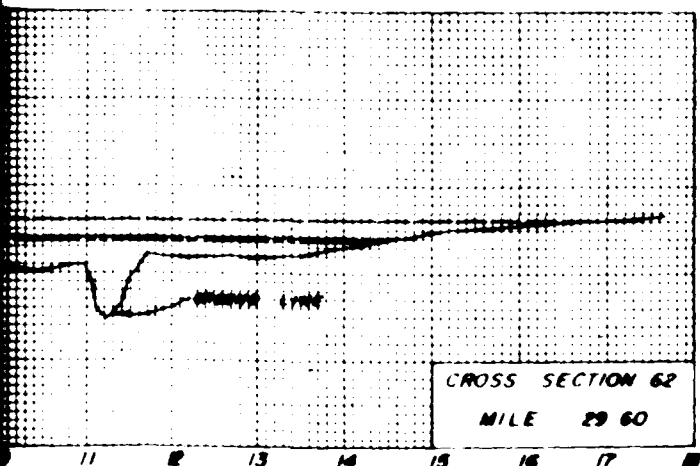
## CROSS SECTIONS

Sections are based on actual field surveys and U.S. Geological Survey Maps

There is a dramatic change in the topography from the lower to the upper limit of the study area. At the lower limit and throughout the City of Sylvania, Ottawa River flows in a well defined valley while the upstream portion of Tennile Creek flows through flat lands which are typical of the lake plains of the central lowlands physiographic province. This difference is illustrated by the cross sections at the end of the report.
