# FLOOD PLAIN INFORMATION, EAST BRANCH, PERKIOMEN CREEK AND INDIAN CREEK, BUCKS AND MONTGOMERY COUNTIES, PENNSYLVANIA.

THIS REPORT WAS PREPARED FOR BUCKS COUNTY AND MONTGOMERY COUNTY PLANNING COMMISSIONS BY U.S. ARMY CORPS OF ENGINEERS, PHILADELPHIA DISTRICT

REPT. NO: DAEN/NAP-82040/FPI32-74/10  
OCTOBER 1974

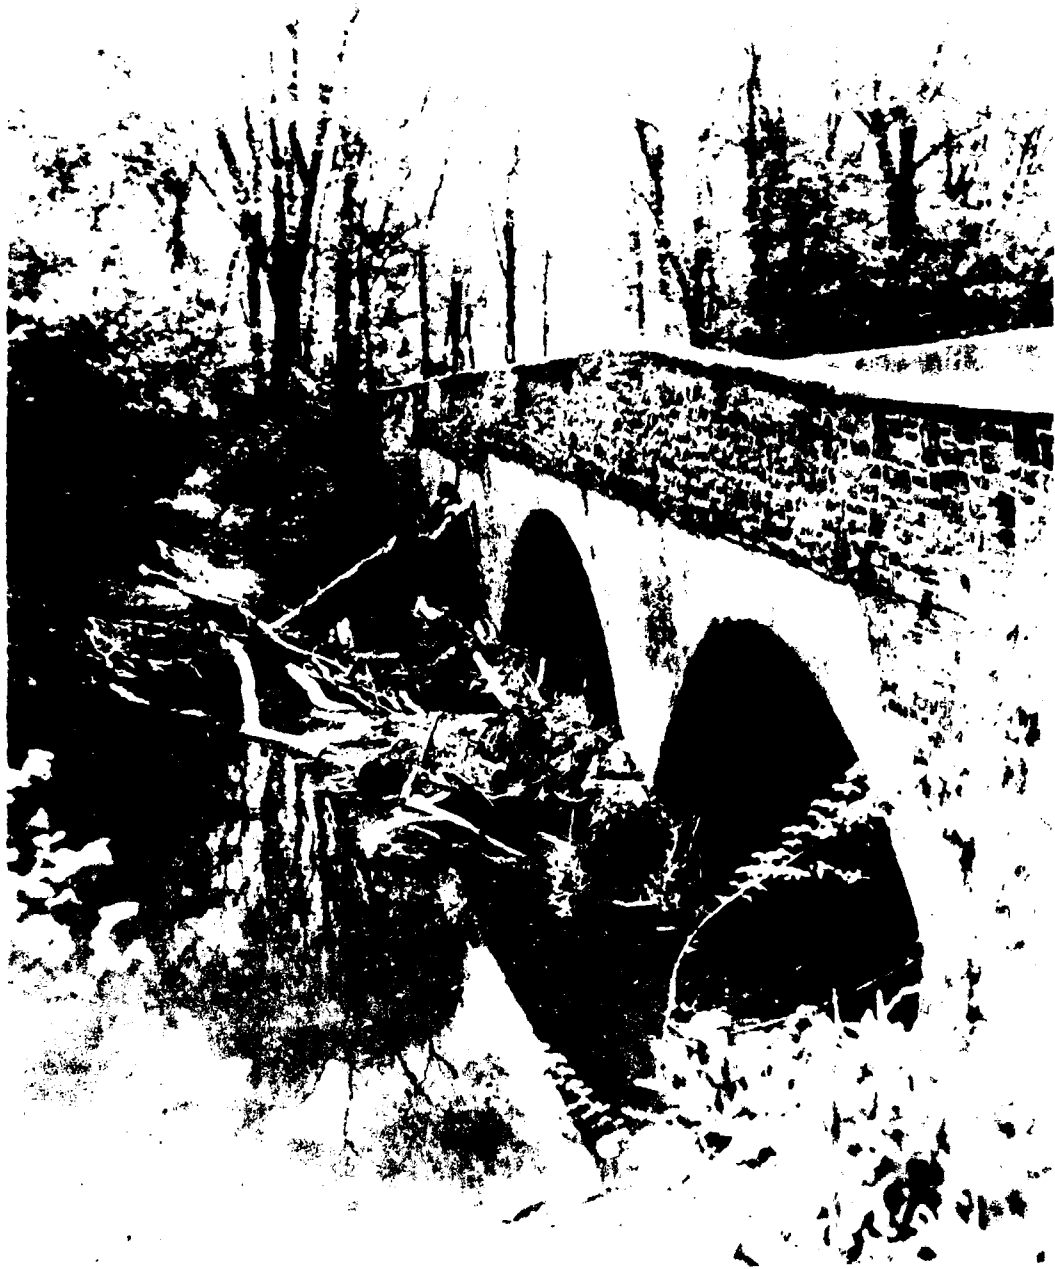
**FIGURE 1** - Debris deposited at the Camp Road Bridge would be obstructive to floodflows.

In general, obstructions restrict floodflows and result in overbank flows and unpredictable areas of flooding; destruction of or damage to bridges and culverts; and, an increased velocity of flow immediately downstream. It is impossible to predict the degree or location of the accumulation of debris; therefore, for the purposes of this report, it was necessary to assume that there would be no accumulation of debris to clog any of the bridge or culvert openings in the development of the flood profiles. A representative obstruction to floodflows is shown in Figure 1.

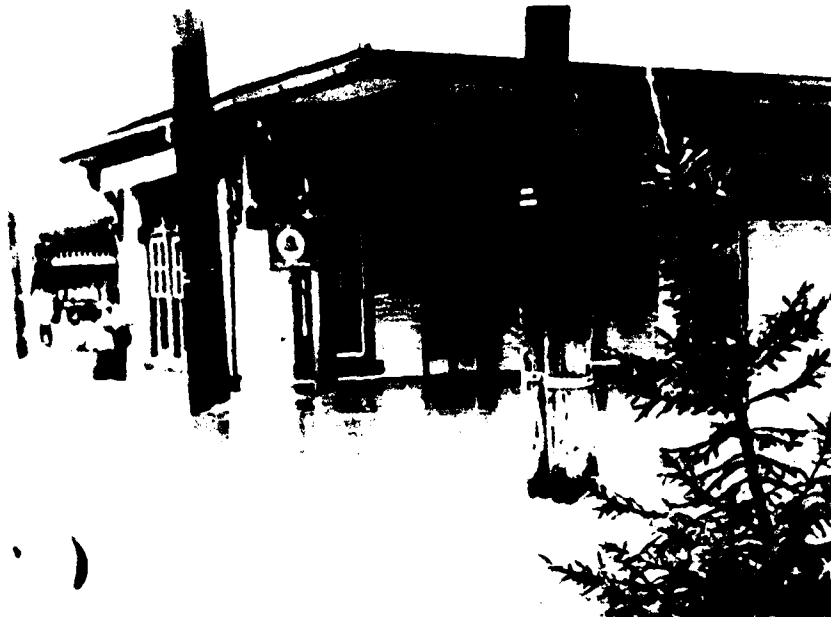
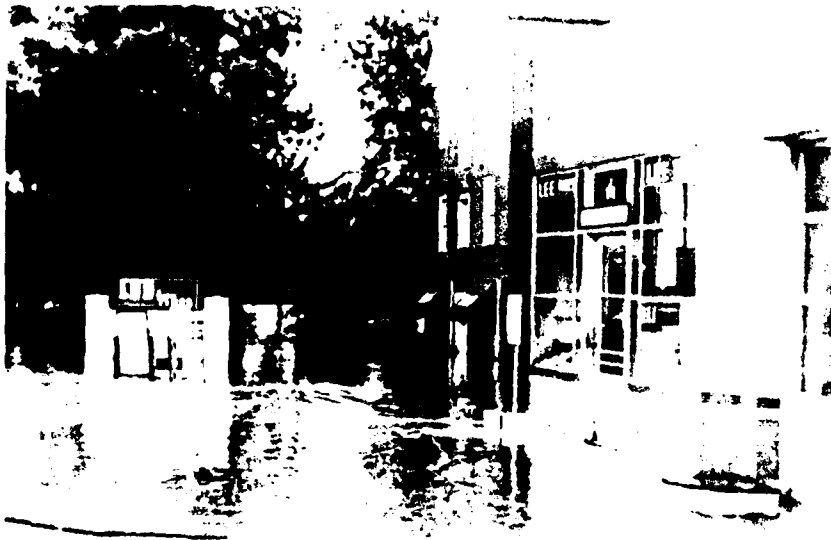
FIGURES 2 and 3 - Sellersville area during the August 9, 1942, flood.

August 9, 1942 - Heavy rainfall which began late on August 8th and continued into August 9th caused serious flooding on the East Branch Perkiomen Creek. Damage resulting from this flood was extensive throughout the study area, with the Borough of Sellersville being hardest hit. Figures 2 and 3 show photographs of the August 1942 flood in the Sellersville area.

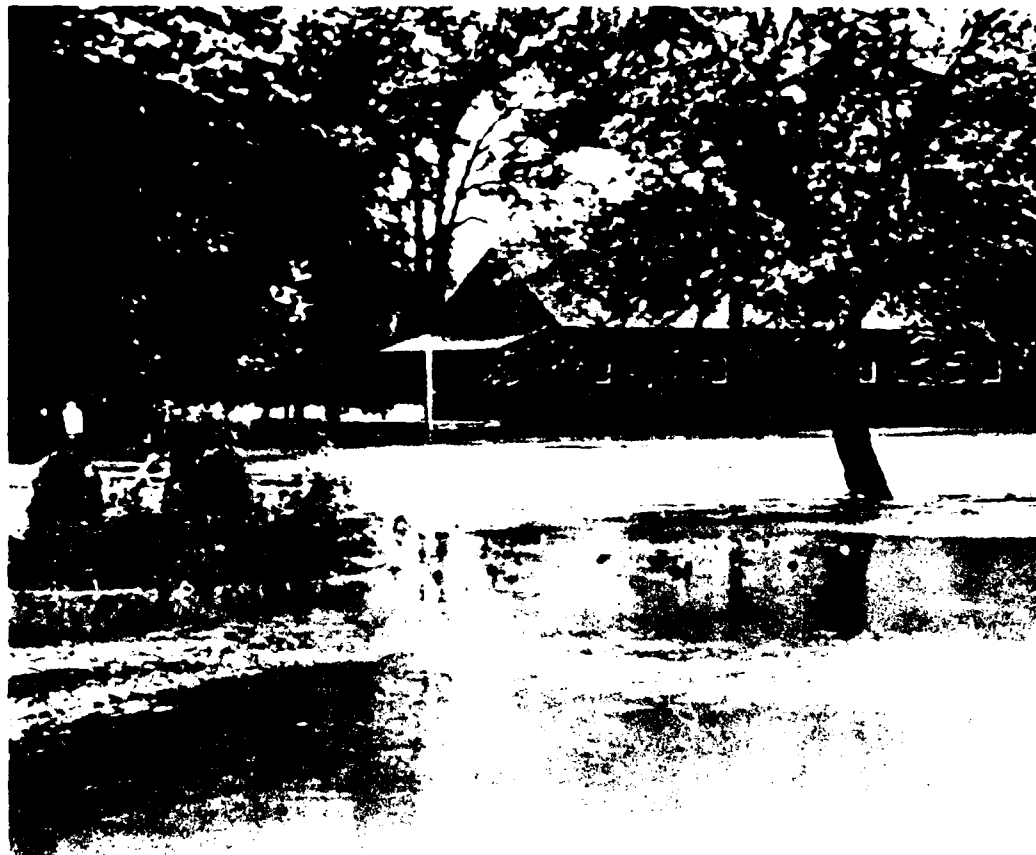
**FIGURE 4** - Lenape Park in Sellersville during the June 22, 1972, flood.

June 22, 1972 - Heavy rains associated with Tropical Storm Agnes caused the East Branch Perkiomen Creek to overflow its banks on this date. A Boy Scout Cabin in Lenape Park, Sellersville, was surrounded by water and is shown in Figure 4. U.S. Route 309 was covered with water but was not closed.

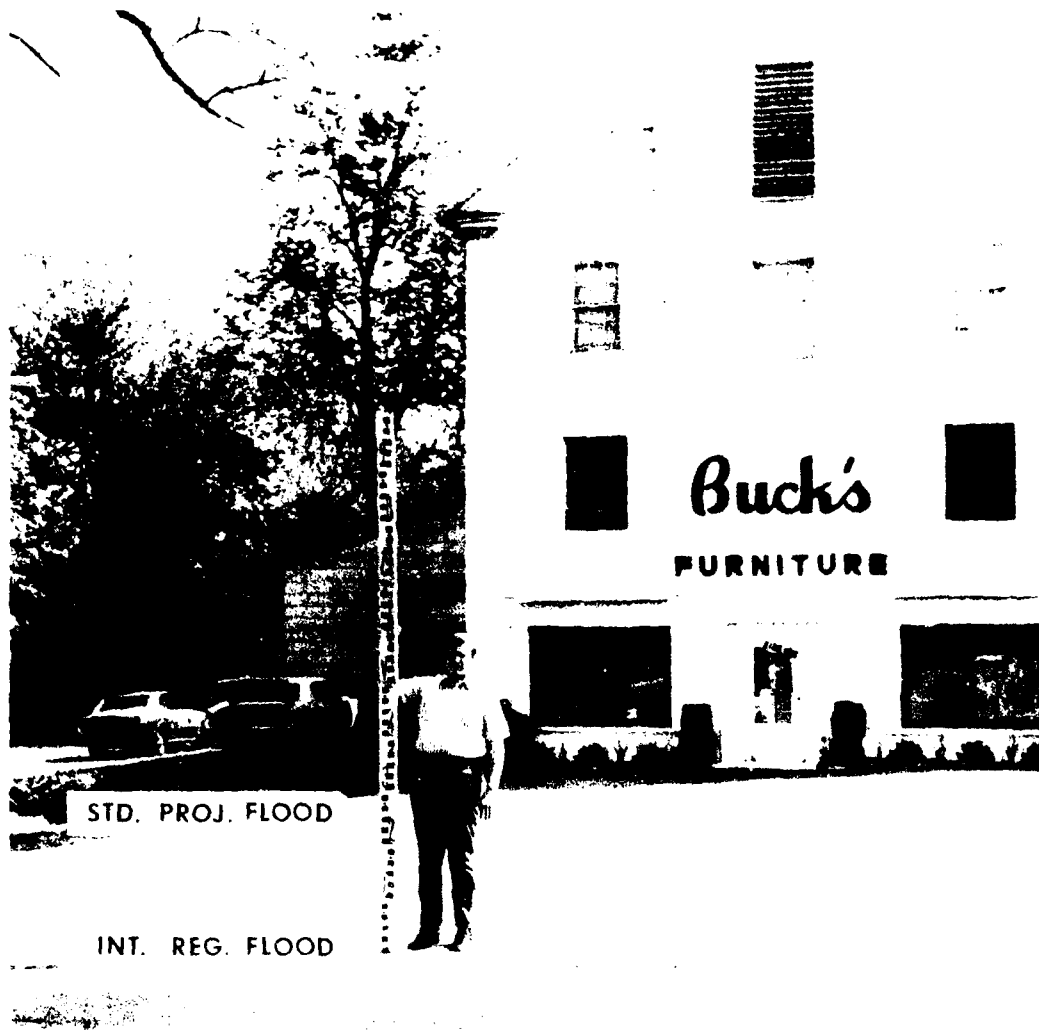
FIGURE 5 - Possible future flood heights at Buck's Furniture Store in Sellersville.

Photographs, future flood heights - The levels that the Intermediate Regional and Standard Project Floods might reach at various locations in the East Branch Perkiomen Valley are indicated on the following photographs.

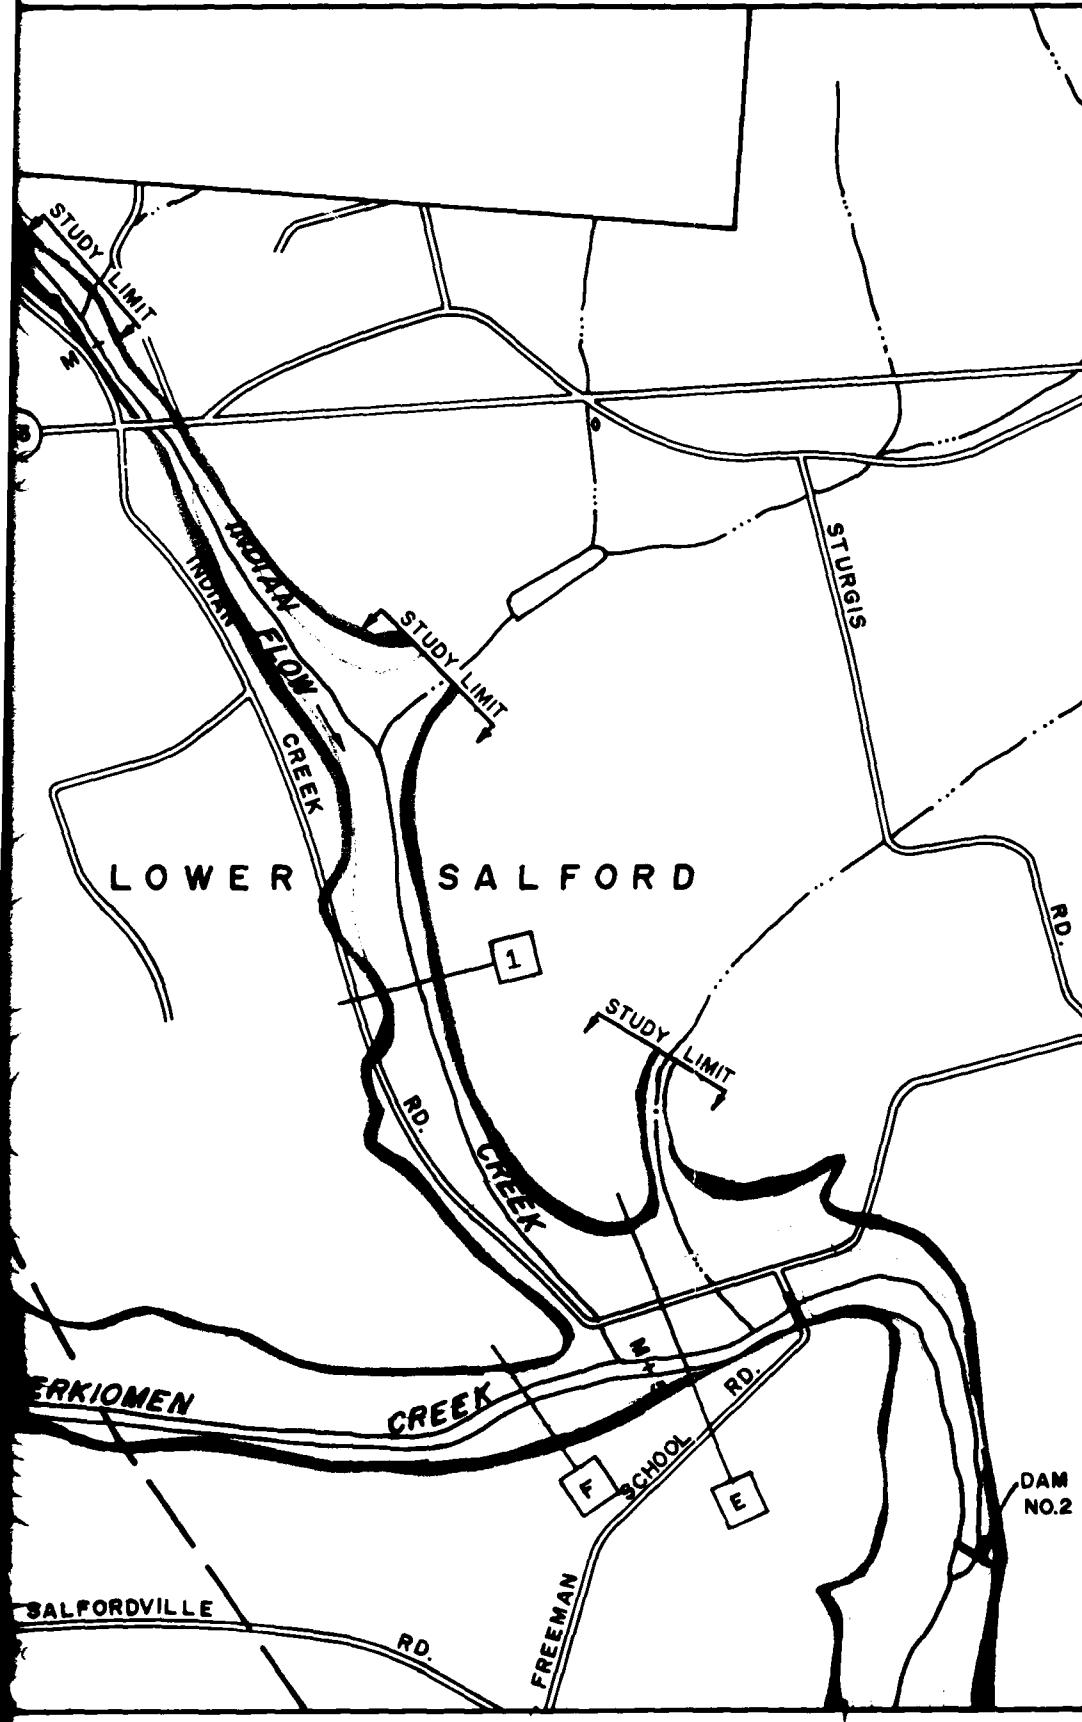
**OVERFLOW LIMITS**

**Flooded areas and flood damages** - The areas along the East Branch Perkiomen Creek and Indian Creek that would be flooded by the Standard Project Flood are shown on Plate 2, which is also an index map to Plates 3 through 12. Areas that would be flooded by the Intermediate Regional and Standard Project Floods are shown in detail on Plates 3 through 12. The actual limits of these overflow areas may vary somewhat from those shown on the maps because the scale of the maps and contour intervals do not permit precise plotting of the flooded area boundaries. As may be seen from these plates, floodflows from the East Branch Perkiomen Creek and Indian Creek inundate a large portion of the East Branch Perkiomen Valley. The highest stages of flooding throughout the study area occur when the floodwaters from the East Branch Perkiomen Creek meet with the high stages of Perkiomen Creek.

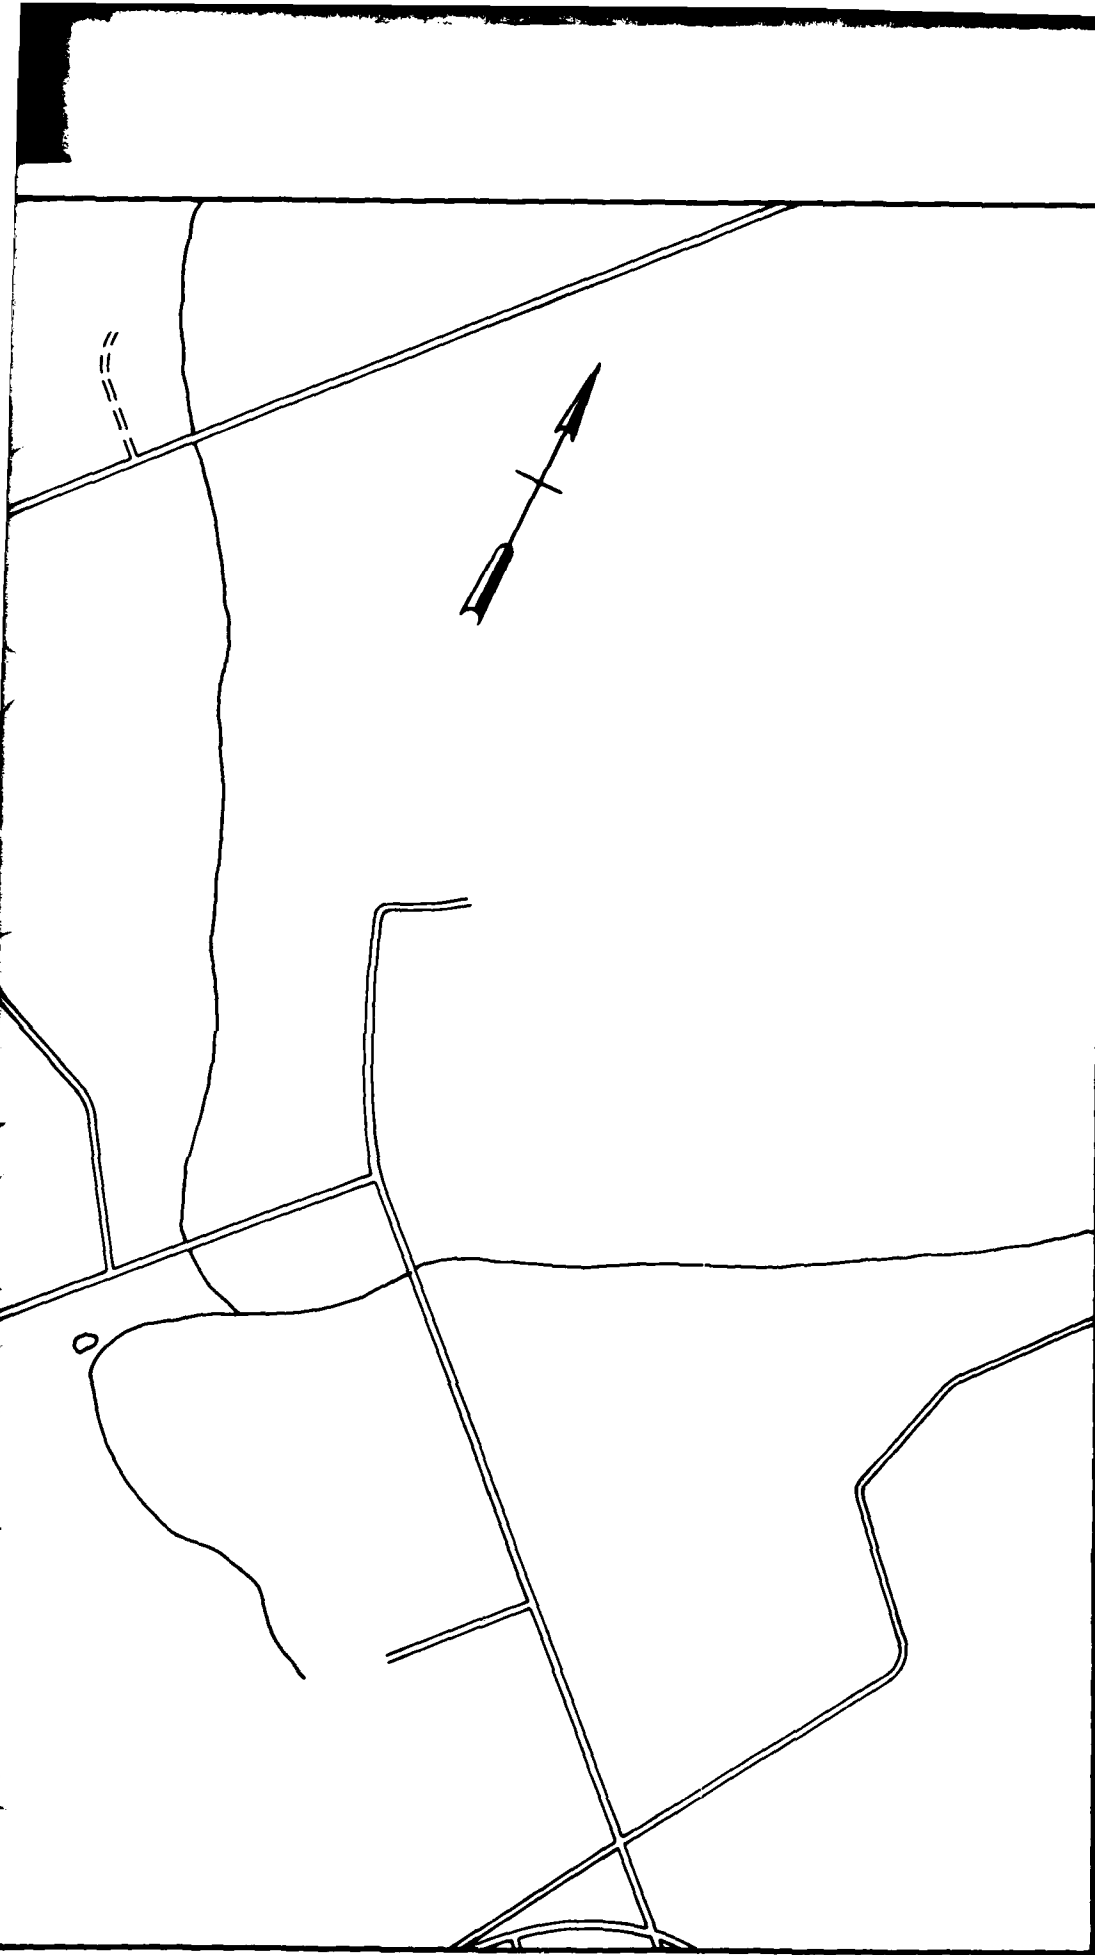
DEPARTMENT OF THE ARMY  
PHILADELPHIA DISTRICT, CORPS OF ENGINEERS  
PHILADELPHIA, PENNSYLVANIA  
**FLOOD PLAIN INFORMATION**  
**EAST BRANCH PERKIOMEN CREEK**  
**BUCKS & MONTGOMERY COUNTIES, PA.**  
**FLOODED AREAS**

**OVERFLOW LIMITS**

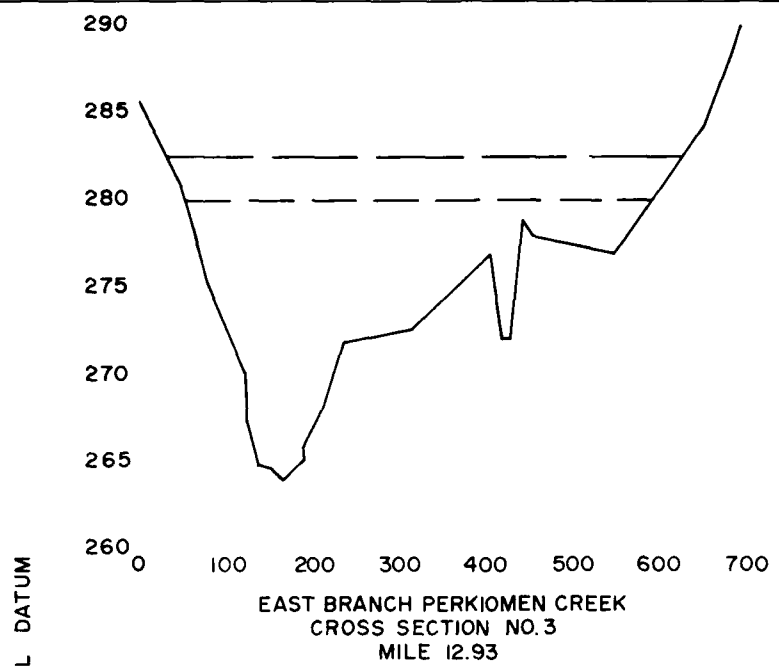
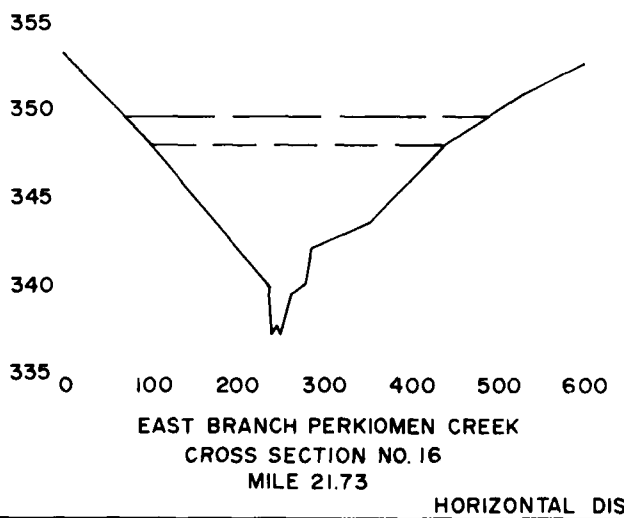
DEPARTMENT OF THE ARMY  
 PHILADELPHIA DISTRICT, CORPS OF ENGINEERS  
 PHILADELPHIA, PENNSYLVANIA  
 FLOOD PLAIN INFORMATION  
 EAST BRANCH PERKIOMEN CREEK  
 BUCKS AND MONTGOMERY COUNTIES, PA.  
 SELECTED CROSS SECTIONS  
 EAST BRANCH PERKIOMEN CREEK

The areas that would be flooded by the Intermediate Regional and Standard Project Floods include farmland and scattered commercial and residential properties, along with the associated streets, roads, and private and public utilities in the study area. Considerable damage to these facilities would occur during an Intermediate Regional Flood. However, due to the wider extent, greater depths of flooding, higher velocity flow and longer duration of flooding during a Standard Project Flood, damage would be even more severe than during an Intermediate Regional Flood. Plates 13 through 18 show water surface profiles for the Intermediate Regional and Standard Project Floods. Depth of flow in the channel can be estimated from these illustrations. Typical cross sections of the flood plain at selected locations, together with the water surface elevation and lateral extent of the Intermediate Regional and Standard Project Floods are shown on Plates 19 and 20.
