FLOOD PLAIN INFORMATION

WHITE CLAY CREEK

NEW CASTLE COUNTY, DELAWARE

PREPARED FOR THE NEW CASTLE COUNTY DEPARTMENT OF PLANNING BY THE DEPT. OF THE ARMY, PHILADELPHIA DISTRICT, CORPS OF ENGINEERS, PHILADELPHIA, PA.

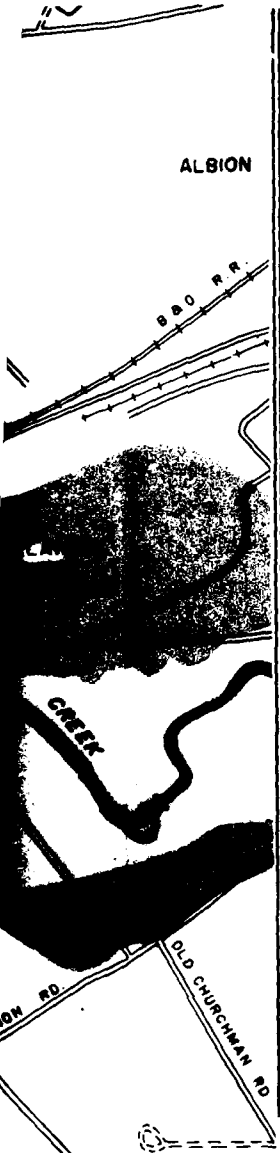
STANDARD PROJECT
FLOOD (SPF)

PROFILES in the
Flood Plain Information Report
show elevations of
these floods
for the entire study area

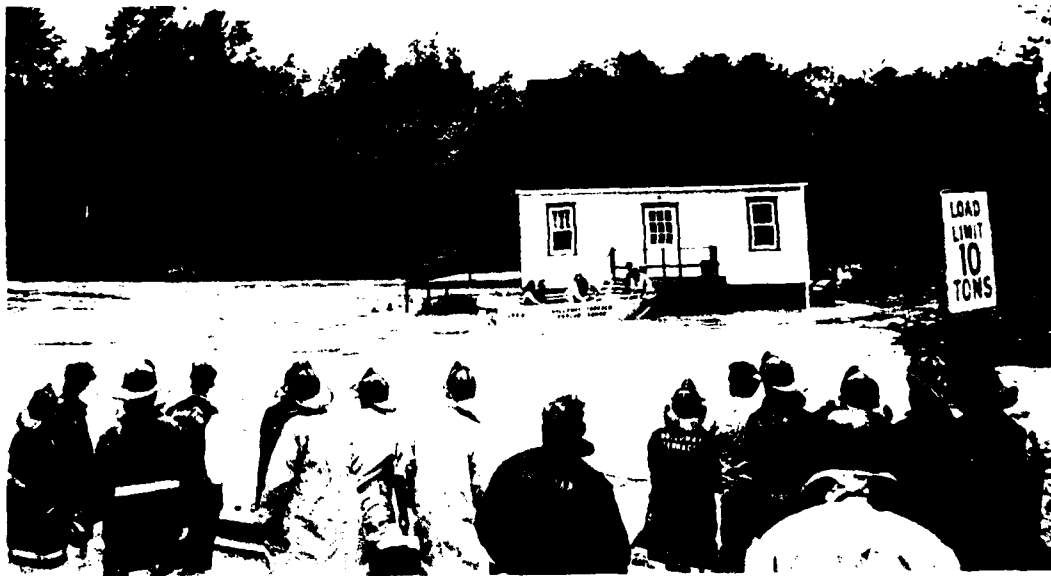
FIGURE 4 - A house on Red Mill Road is completely isolated by the floodwaters of White Clay Creek. Two young men are being rescued by members of local fire companies. (*WEEKLY POST* Staff Photograph by Eric Crossan.)

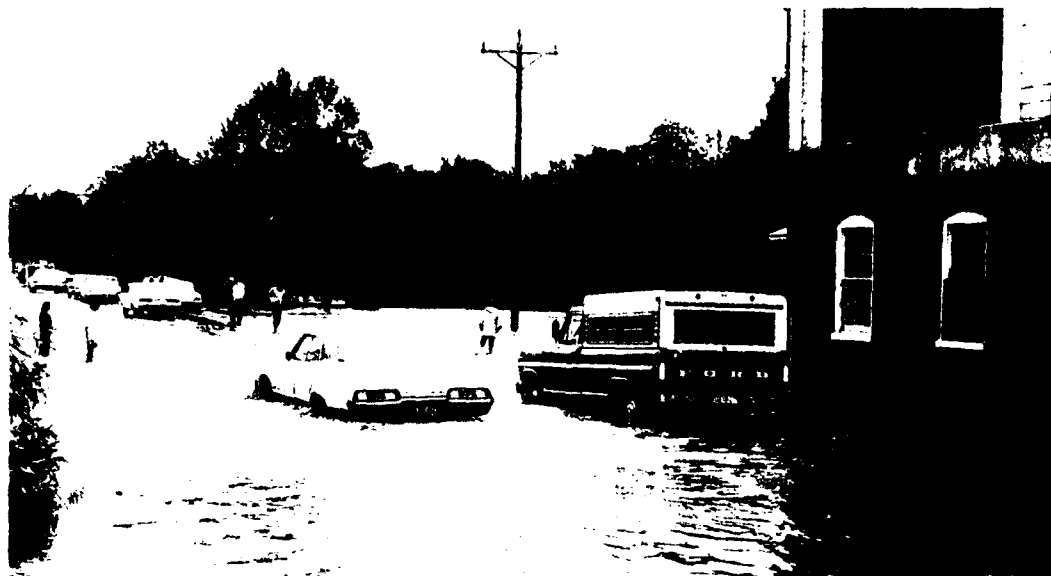
FIGURE 5 - Vehicles attempt to pass through the floodwaters of White Clay Creek that cover Chapel Street near the Curtis Paper Company. (Photograph by Everett.)

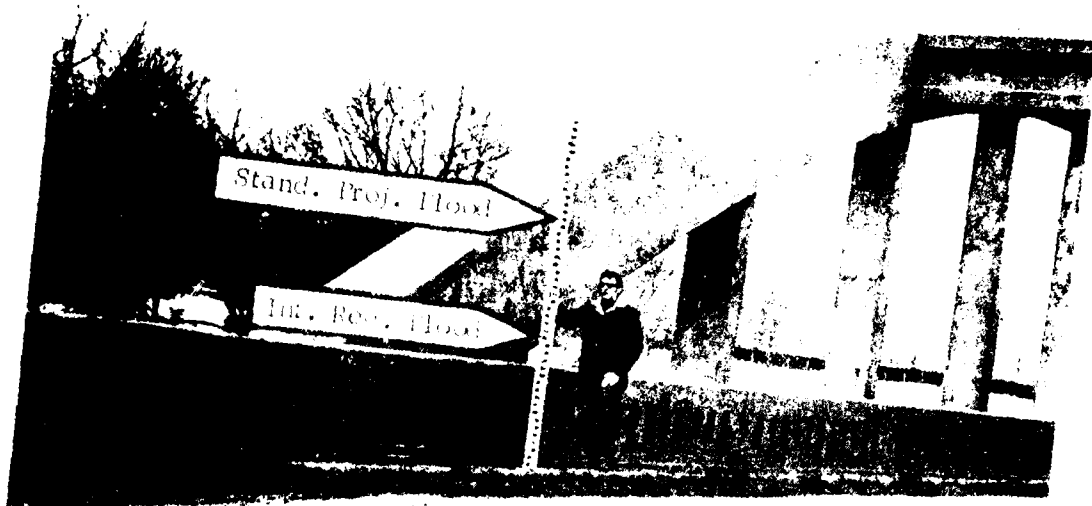
FIGURE 6 - Future flood heights on Del. Rt. 7 near the entrance to Delaware Park Race Track.

Photographs, future flood heights - The levels that the Intermediate Regional and Standard Project Floods are expected to reach at various locations along White Clay Creek are indicated on the following photographs.

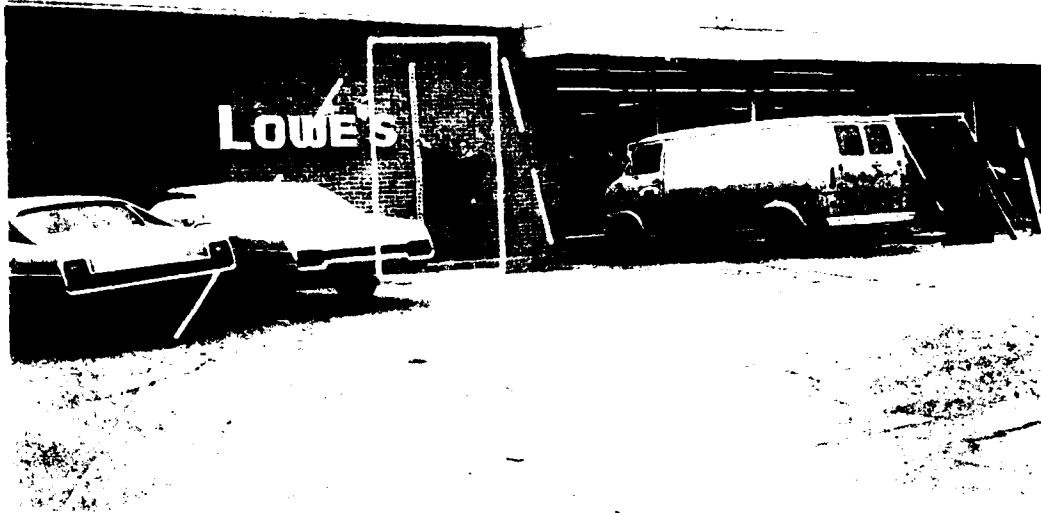
FIGURE 8 - Future flood heights at Lowe's of Wilmington located on Wilmington-Christina Pike (Del. Rt. 7)

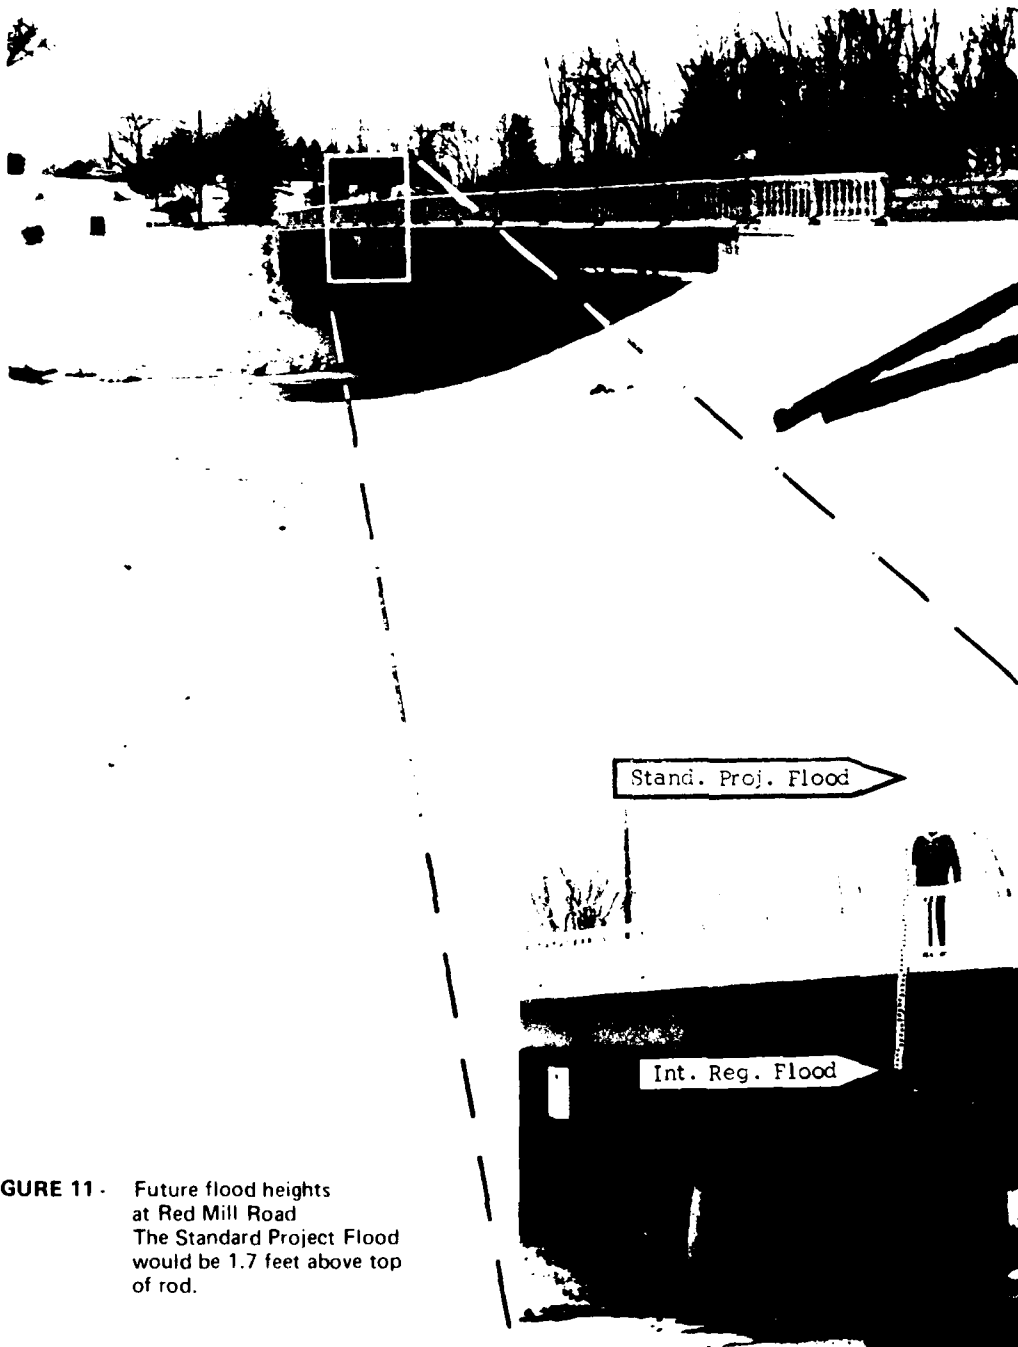
FIGURE 11 - Future flood heights at Red Mill Road
The Standard Project Flood would be 1.7 feet above top of rod.

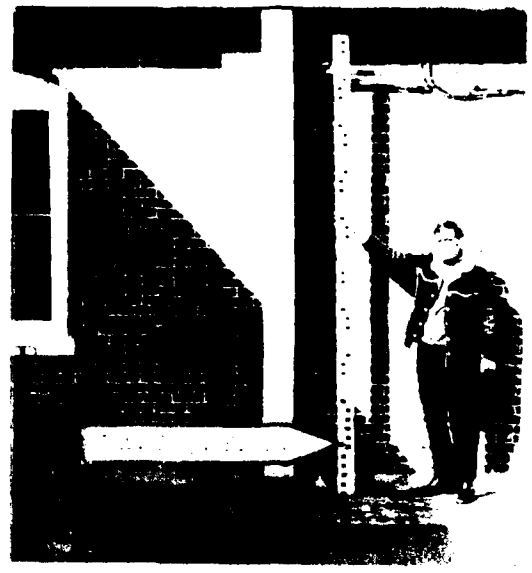
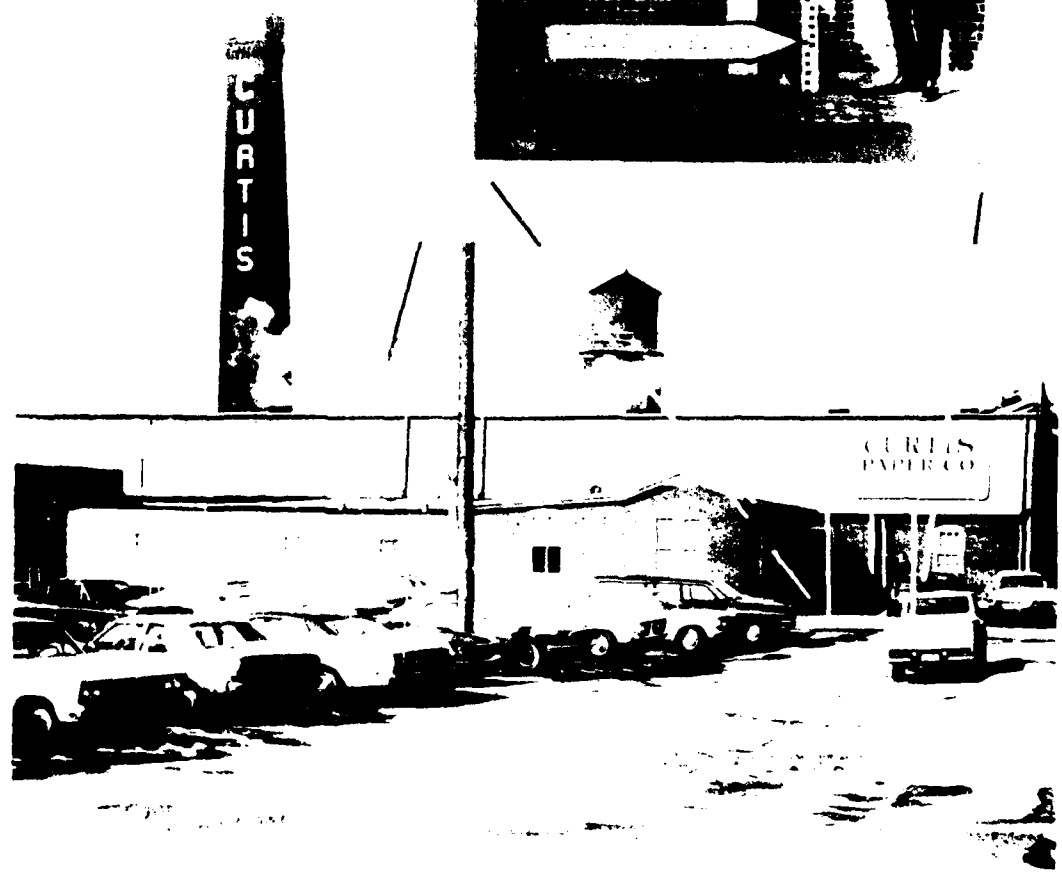
FIGURE 12 - Future flood heights at the Curtis Paper Co. on Chapel St. (Del. Rt. 72). The Standard Project Flood would be 3.3 feet above top of rod.
