**CUYAHOGA RIVER, OHIO  
RESTORATION STUDY**

**THIRD INTERIM PRELIMINARY  
FEASIBILITY REPORT  
ON EROSION AND SEDIMENTATION**

**VOLUME I - MAIN REPORT**

**U.S. ARMY CORPS OF ENGINEERS, BUFFALO DISTRICT  
1776 NIAGARA STREET  
BUFFALO, NEW YORK 14207**

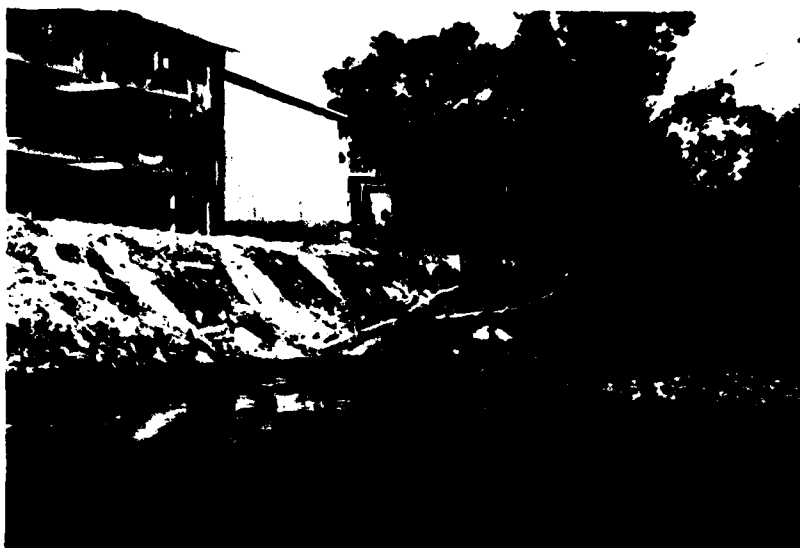
Photo 1 - Encroachment from apartment development  
(Cuyahoga River 1978.)

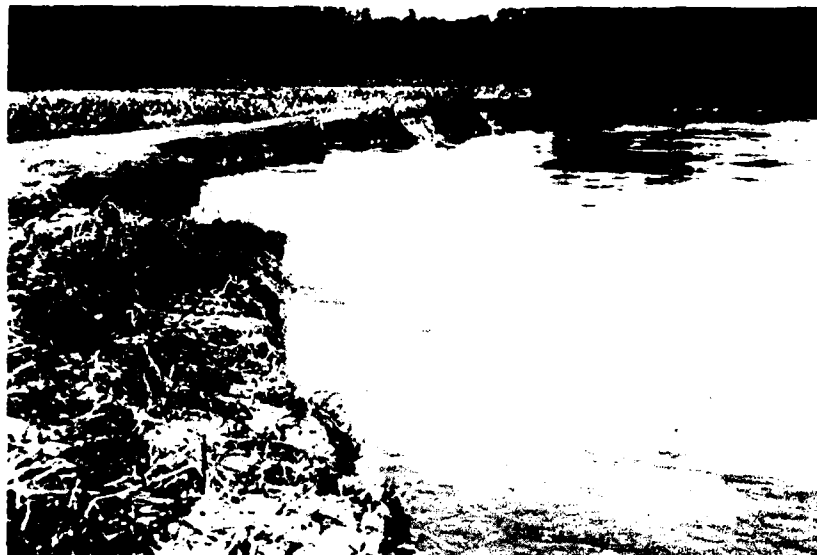
Photo 3 - Bank erosion next to a cropfield (Cuyahoga River 1978.)

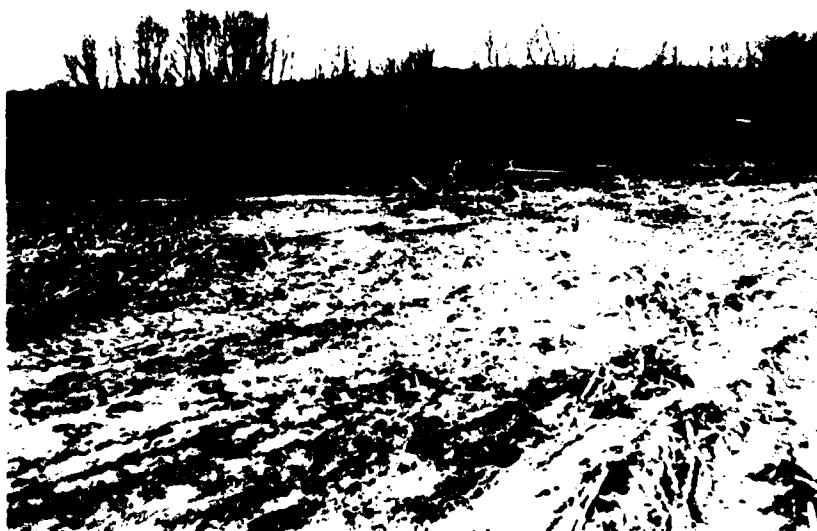
Photo 4 - Erosion of the land surface in a cropfield after harvesting (Cuyahoga River 1978.)

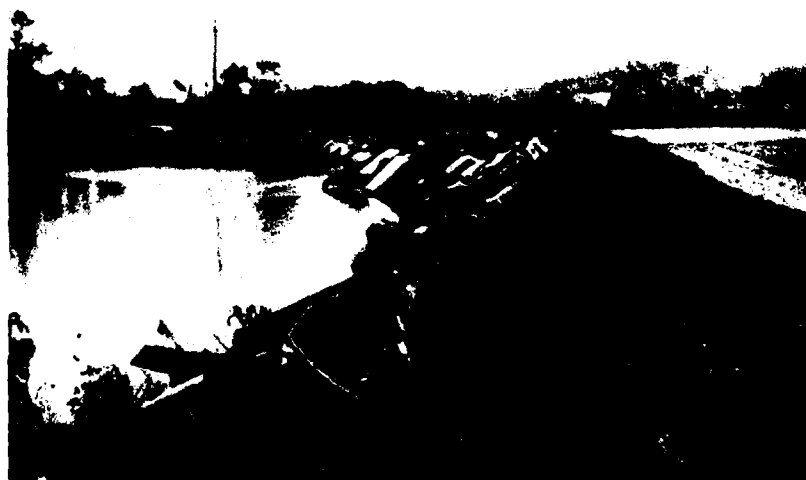
Photo 6 - Bank erosion with autos providing erosion  
control (Cuyahoga River 1971.)

In general terms, the Cuyahoga River between Independence (river mile 13.8) and Old Portage (river mile 40.25) can be classified as a meandering stream with many unstable reaches. Present conditions are probably not greatly different than those of hundreds of years ago, since the name of the river may have been derived from Indian words for "crooked." In addition, names of tributaries such as Mud Brook, Yellow Creek, and Sand Run indicate an early history of natural influences on water quality. The main differences at present appear to be largely due to increased erosion due to man-made disturbances such as highway and building construction activities, surface mining operations, cropping and timbering practices which remove the protective vegetation covering, etc. Photographs 1 through 5 illustrate examples of these problems. Photograph 6 shows bank erosion near Jaite and an attempt at controlling that erosion.
