| 4. Title and Subtitle<br>EMERGENCY CABIN LIGHTING INSTALLATIONS: AN ANALYSIS OF CEILING- VS. LOWER CABIN-MOUNTED LIGHTING DURING EVACUATION TRIALS | | 5. Report Date<br>Feb <del>1980</del> 1981 | 6. Performing Organization Code |
| 7. Author(s)<br>Burton P. Chesterfield, Paul G. Rasmussen, and Robert D. Dillon | | 8. Performing Organization Report No.<br>125 | |

EMERGENCY CABIN LIGHTING INSTALLATIONS: AN  
ANALYSIS OF CEILING- VS. LOWER CABIN-MOUNTED  
LIGHTING DURING EVACUATION TRIALS

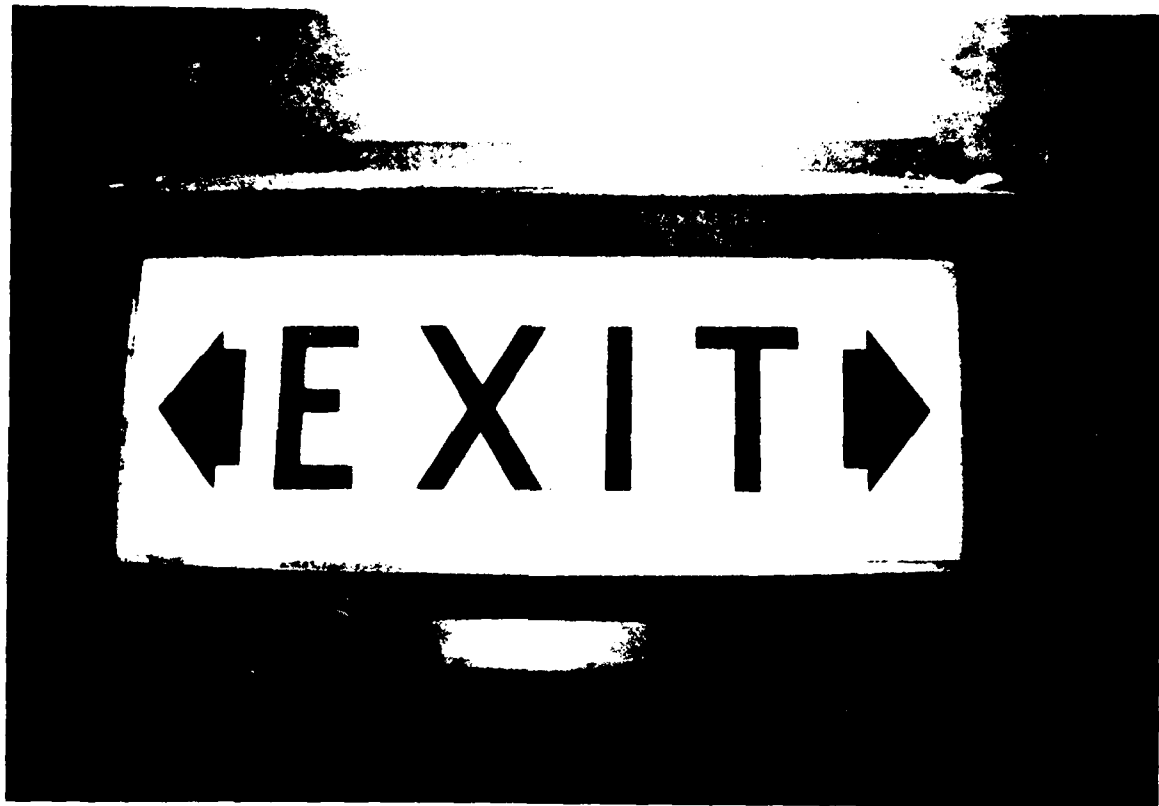
Figure 5. Cross-aisle exit locator sign mounted above the intersection of main and cross aisle at ceiling height.

The lighting system used for comparison was composed of ceiling-mounted fixtures with incandescent bulbs providing general aisle illumination of 1.2 lux (0.11 foot candle) at seat armrest height without smoke in the cabin. This value is more than twice the minimum value required by FAR 25.812(c)(9). A single incandescent cross-aisle exit locator sign and two exit identification signs were also used as part of the conventionally mounted emergency lighting system. The cross-aisle sign (Figure 5) was a Luminator (TM)\* unit located 245cm (96.5 in) above the floor and provided 0.32 lux (0.03 foot candle) on the cross aisle which is also above the minimum specified by FAR 25.812(d). One of the two exit identifier signs was a cabin sidewall-mounted Luminator (TM)\*\* unit located 137cm (54 in) above the floor. The other exit identifier was a Grimes\*\*\* unit mounted 198cm (78 in) above floor level and above the Type A exit (Figure 6).
