NAVY EXPERIMENTAL DIVING UNIT

REPORT NO. 12-80

MK-12 SURFACE SUPPORTED DIVING SYSTEM
COMPONENT CORROSION PROTECTION EVALUATION

December 1980

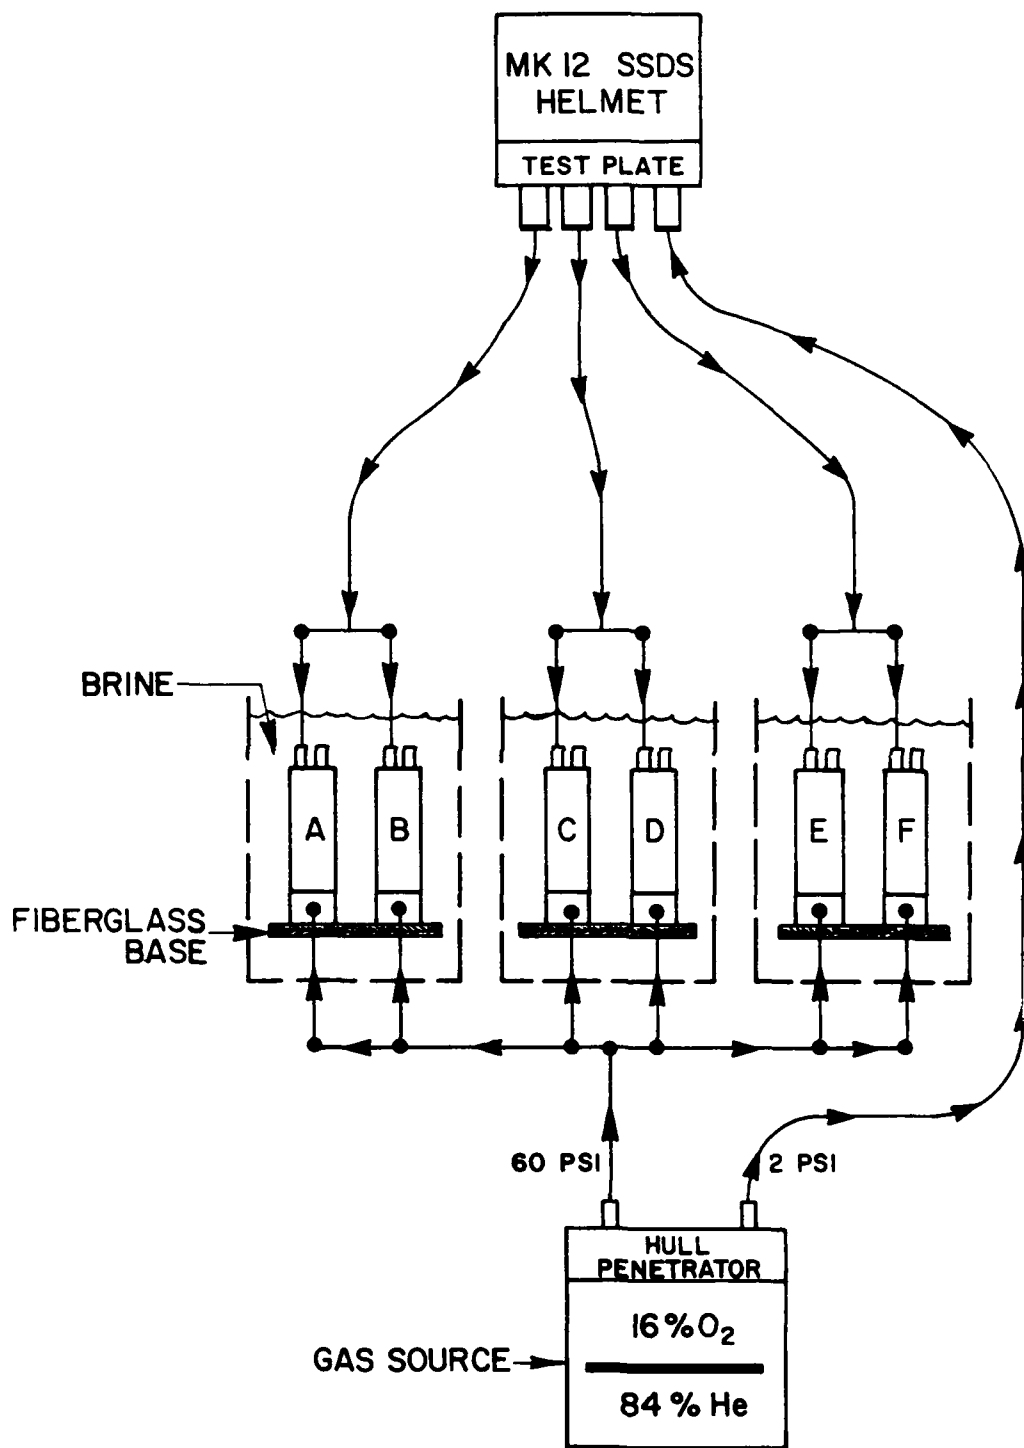
Figure 2. Test Setup

The test plan is provided in Appendix A. The test set up is shown in Figure 2.
