ESL-TR-81-22

**TEST & EVALUATION OF COMMERCIALY  
AVAILABLE HALON 1211 HAND-PORTABLE  
FIRE EXTINGUISHERS FOR USE IN  
HABITABLE & CARGO COMPARTMENTS  
OF USAF AIRCRAFT**

**MAY 1981**

**FINAL REPORT**

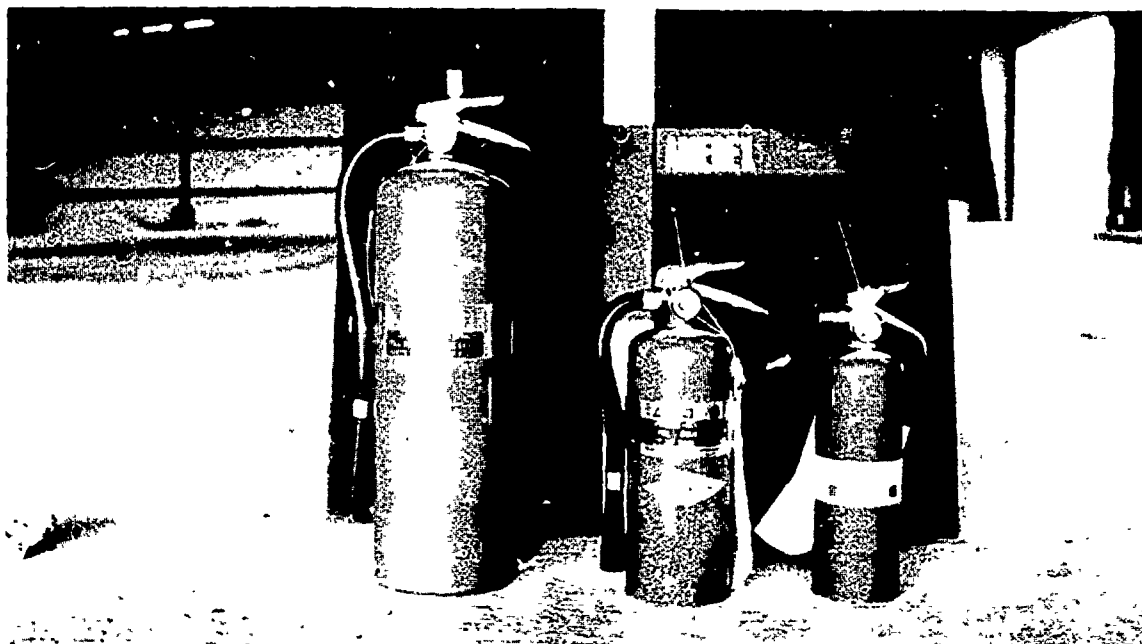
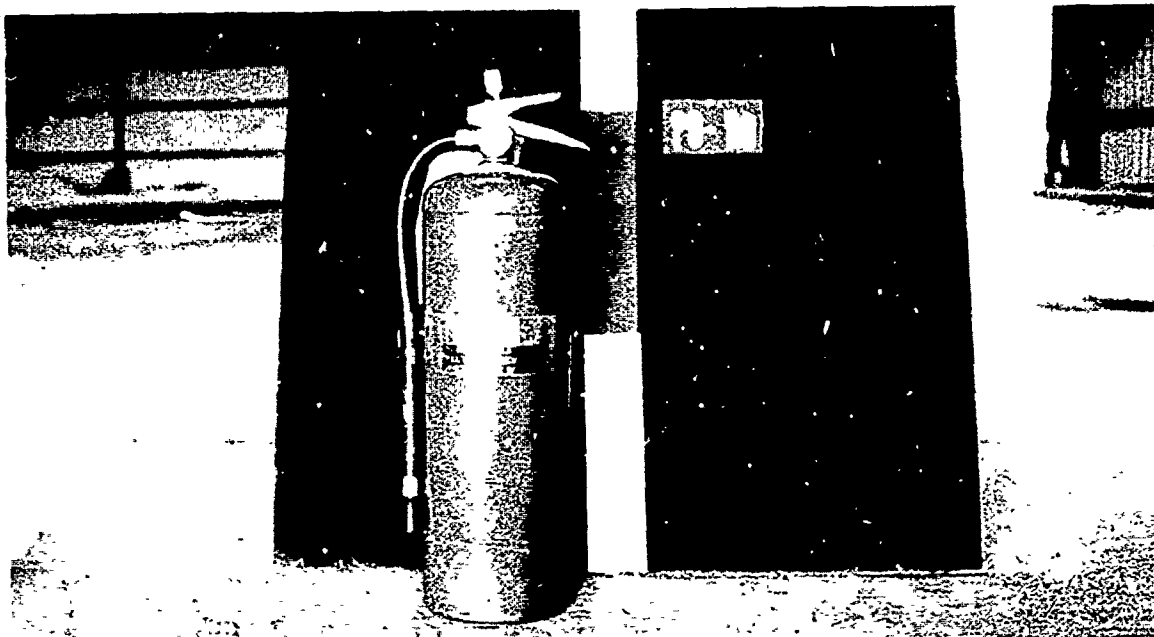
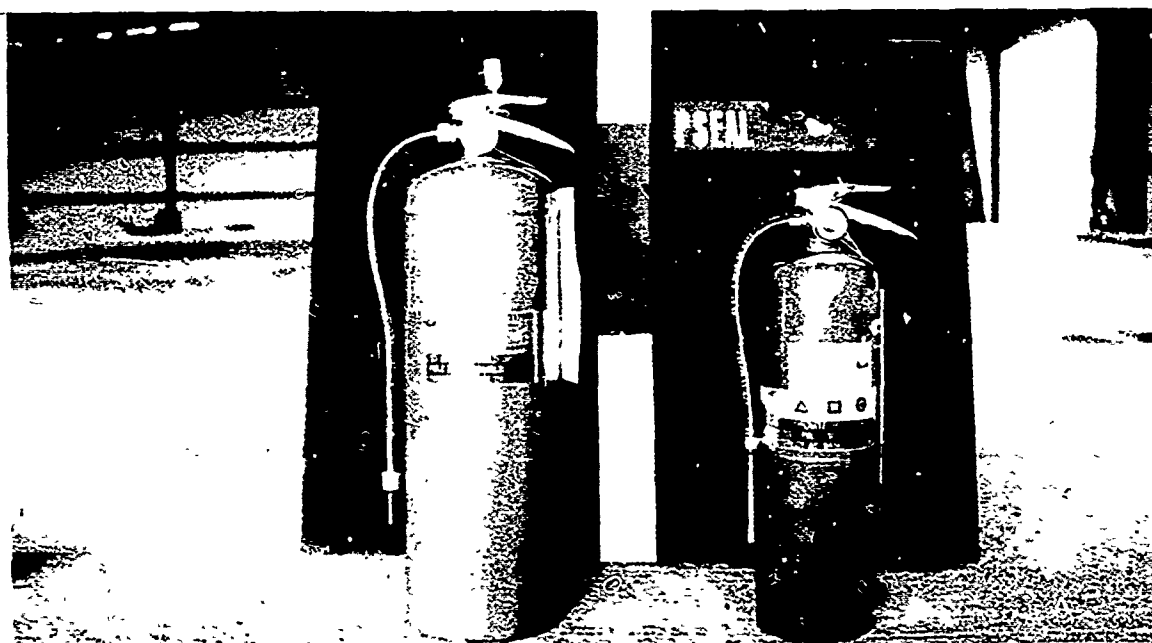
b. Figures 4 through 9 depict the range of test samples of each manufacturer which underwent the test and evaluation program.

Figure 4. Amerex Test Items

Figure 5. Ansul Test Items

Figure 6. Graviner Test Items

Figure 7. Pemall Test Items

Figure 8. Potter-Roemer Test Item

Figure 9. Protectoseal Test Items

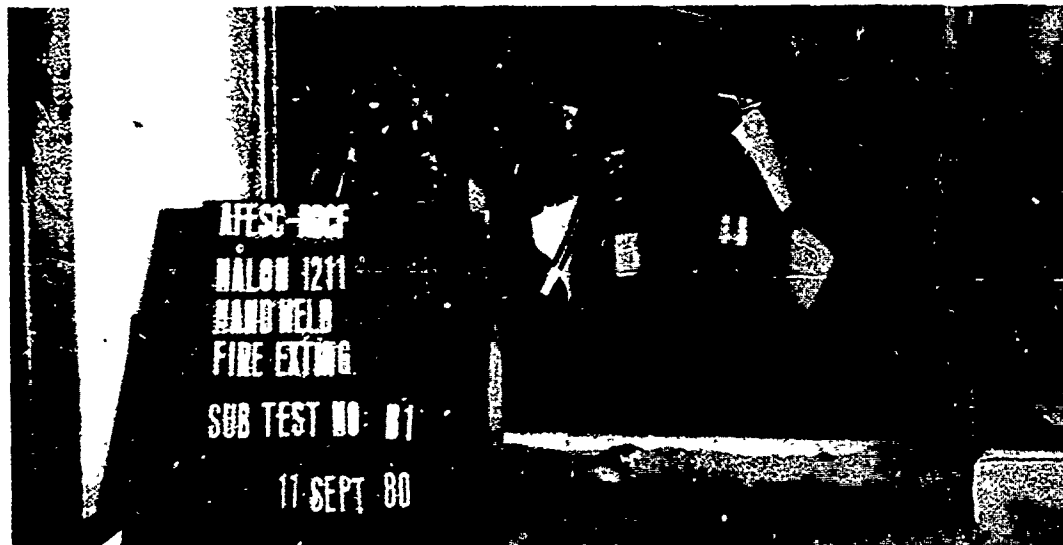
Before testing, all test items were operationally tested, recharged to manufacturer's specifications, and checked for leakage around O-rings and valve seals. Extinguishers were then placed inside a Branson Engineering Co. Model 4510-1N high temperature chamber (Figure 20) and placed under high temperature stress. The following temperature sequence was employed in testing.

Figure 20. Branson Engineering Co. Model 4510-1N High Temperature Chamber Containing Test Items

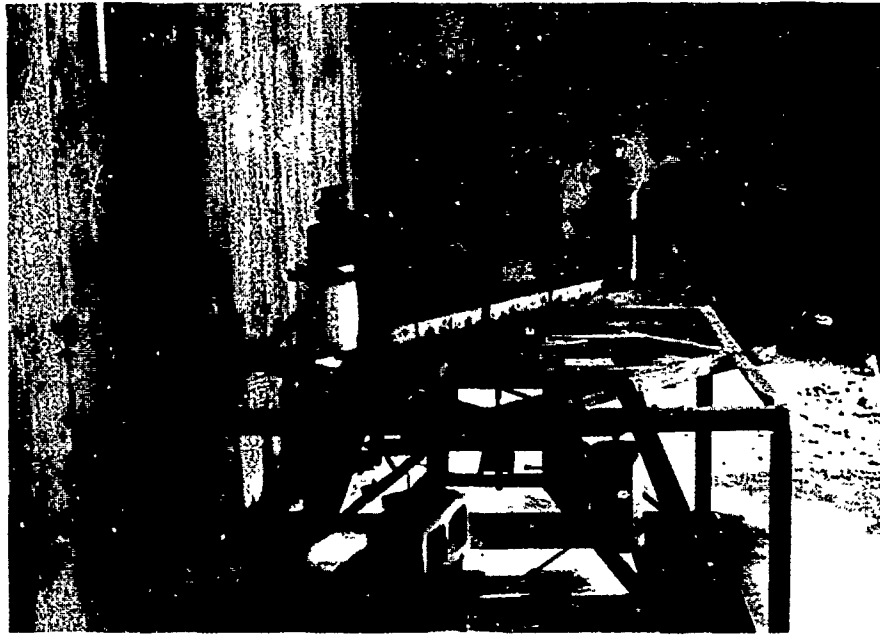
Figure 27. Outward Lateral Acceleration Test

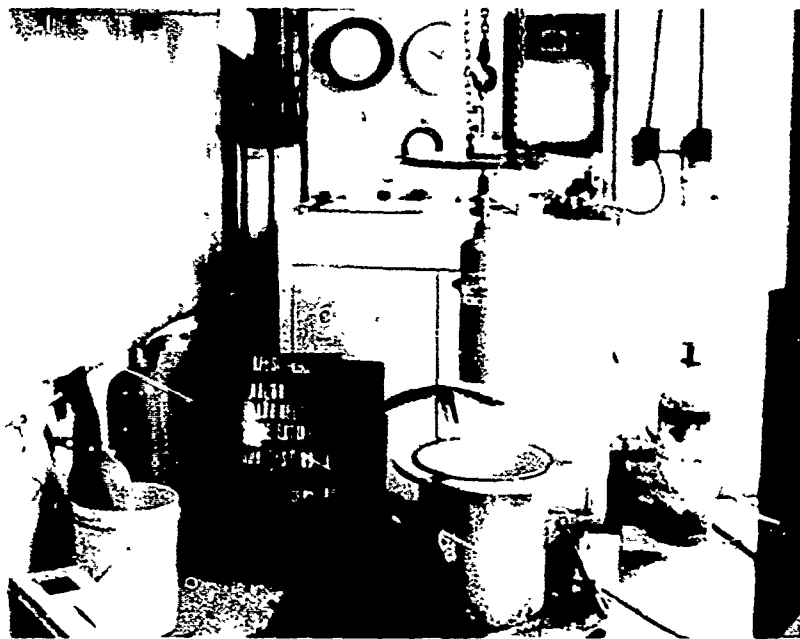
Each extinguisher was hydrostatically tested using equipment manufactured by Hydrotest Products, Inc., Model HTP-1-14-R-#1338 (Figure 30). This equipment was Bureau of Explosives certified under Number BA 2779/272-16/Testing. Test cylinders were x-rayed after hydrostatic test to detect structural deformation resulting from over-pressurization.

Figure 30. Test Setup - Hydrostatic Testing

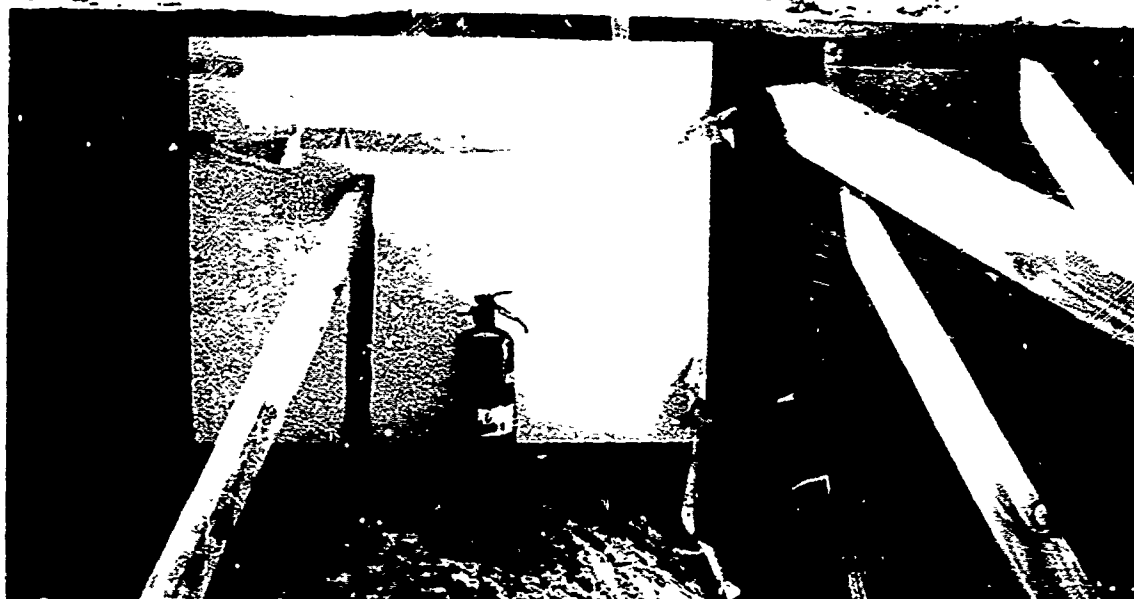
Extinguisher was filled and pressurized to manufacturer's specifications, then placed against a sandfilled backstop inside a concrete reinforced bunker (Figure 34). A ground-mounted caliber .50 machine gun was positioned outside the bunker with the barrel projecting through an aperture in the steel door (Figure 35).

Figure 34. Extinguisher Inside a Concrete Reinforced Bunker

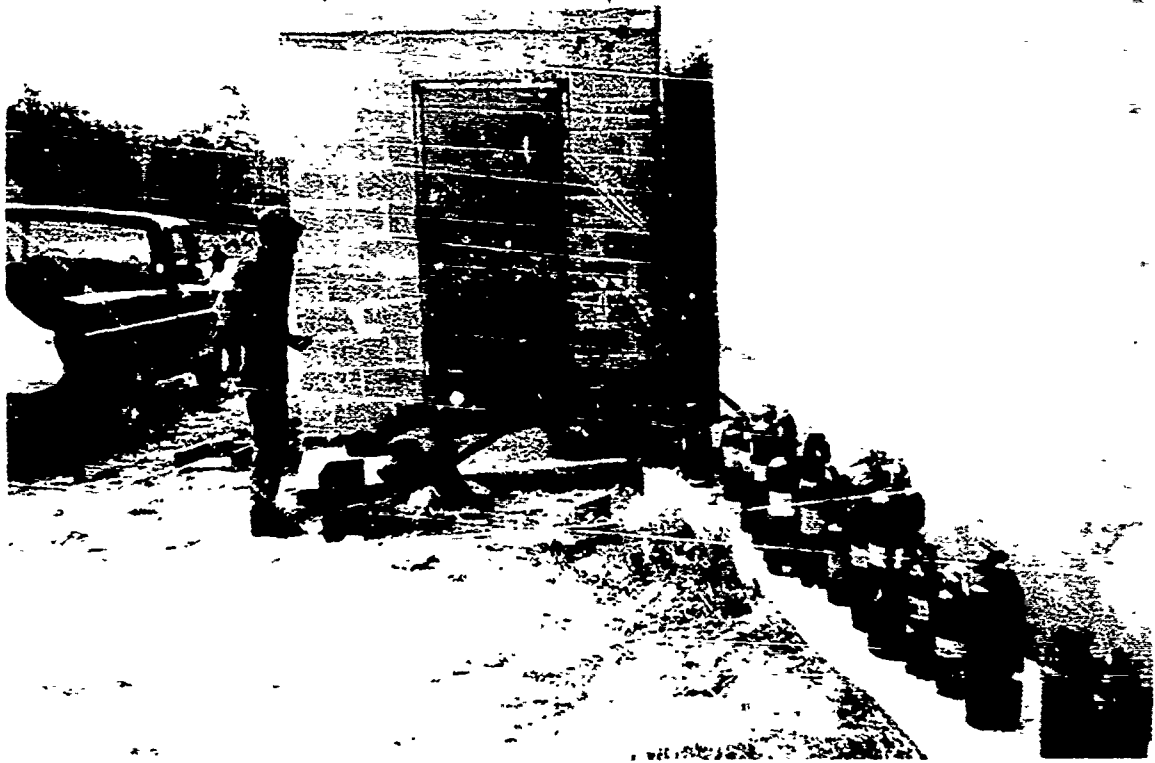
Figure 35. Machine Gun in Test Position

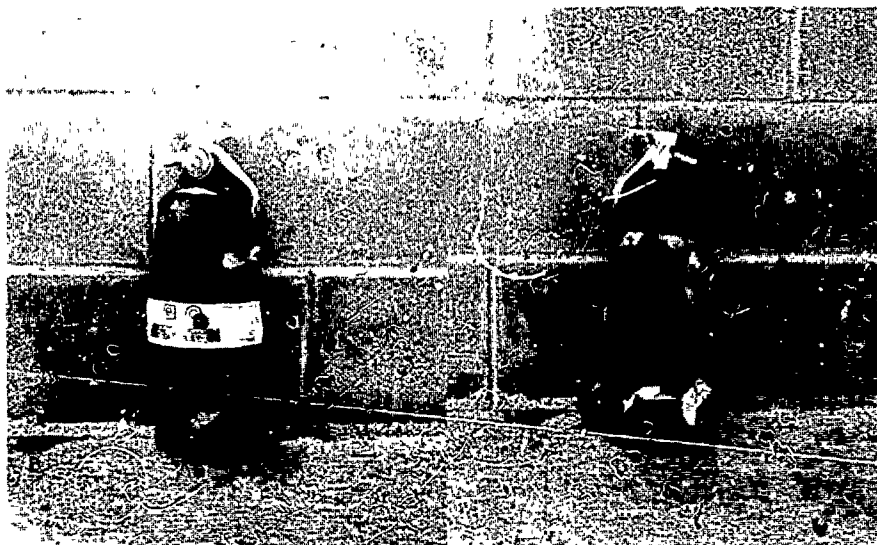
10B:C - Two extinguishers were tested. Projectile entry points were "clean." Both exhibited major deformations at the projectile exit points. The first had a gaping exit hole approximately three-quarters the length of the cylinder. The second extinguisher was split half the length of the cylinder with approximately one-third of the bottom separated. Neither extinguisher showed any evidence of fragmentation (Figure 36).

Figure 36. Amerex 10B:C/Projectile Entry and Exit

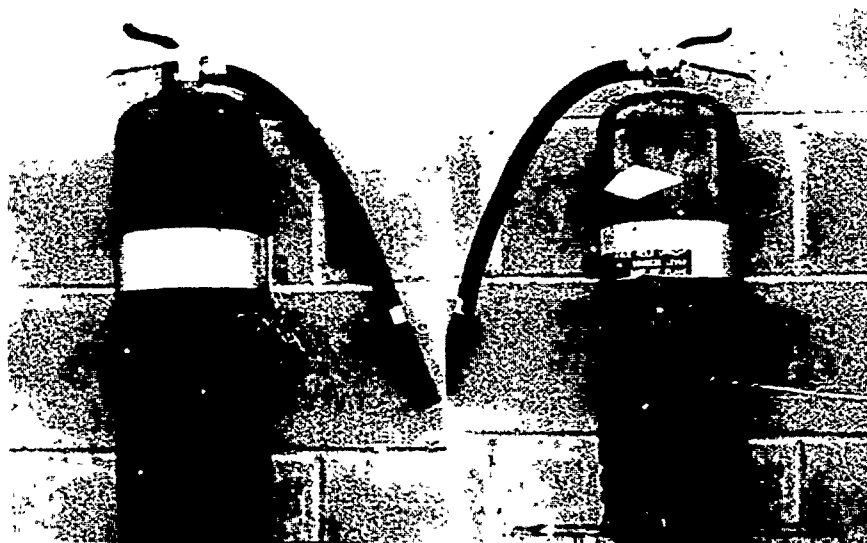
3A:80B:C - One extinguisher was tested; the projectile entry and exit points were clean holes with little or no deformation. There were two exit holes due to the projectile splitting (Figure 39).

Figure 39. Amerex 3A:80B:C/Projectile Entry and Exit

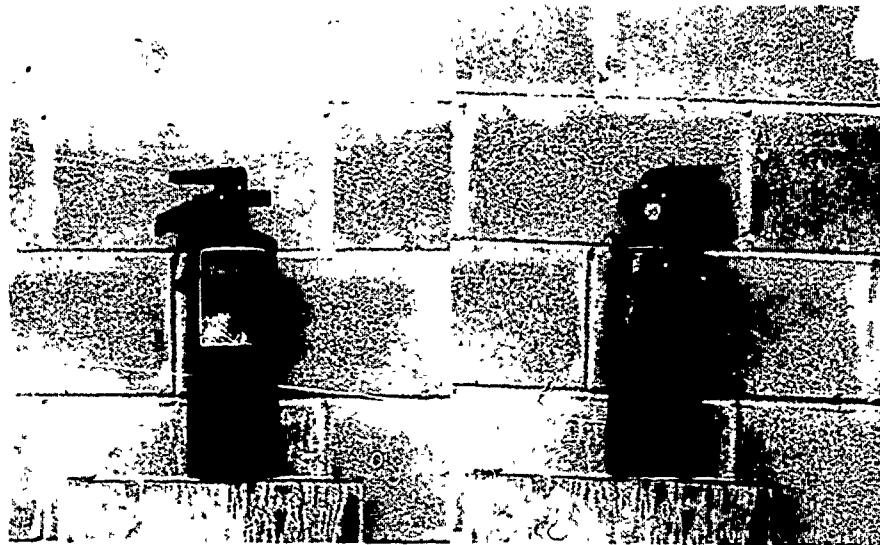
10B:C - Two extinguishers were tested. Both extinguishers had clean projectile entry points. The exit point for the first extinguisher was a gaping hole one-third of the cylinder length, with no evidence of fragmentation (Figure 40). The second extinguisher also displayed a gaping hole one-third the cylinder length with evidence of material loss or fragmentation (Figure 41).

Figure 40. Ansul 10B:C/Projectile Entry and Exit, Extinguisher 1

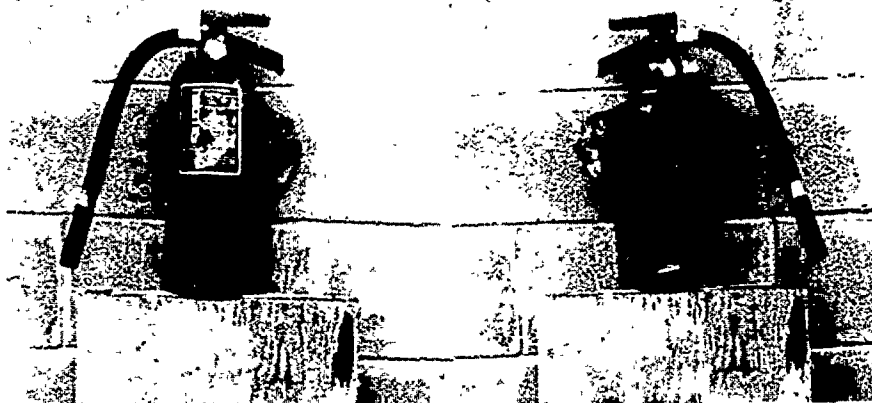
1A:10B:C - Two extinguishers of this size were tested. As with the 10B:C extinguishers, the projectile entry points were clean holes. Both projectile exits split the cylinders top to bottom. One extinguisher was separated from its base, which became a loose fragment (Figure 42).

Figure 42. Ansul 1A:10B:C/Projectile Entry and Exit

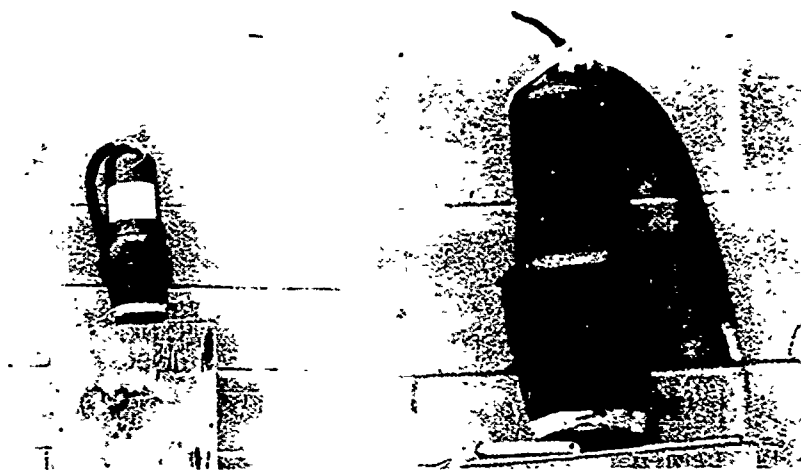
1A:10B:C - Both Pemall 1A:10B:C extinguishers had clean projectile entry points. The first extinguisher had a clean split from the middle seam down to the bottom cap. The other extinguisher had a 4-inch split with the middle seam separated halfway around the cylinder. Neither item showed any evidence of fragmentation (Figure 47).

Figure 47. Pemall 1A:10B:C/Projectile Entry and Exit

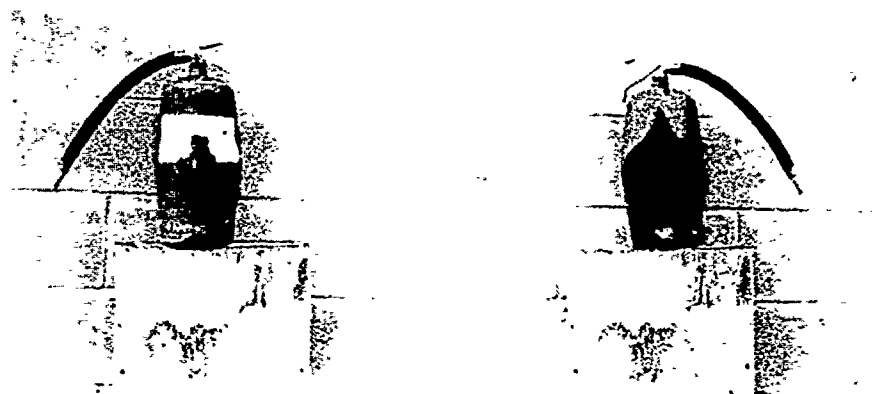
2A:40B:C - Two Pemall extinguishers of this size were tested. Both had slight splits at the projectile entry points. The projectile exits split one extinguisher its entire length and the other three-quarters its length. There was no evidence of fragmentation from either extinguisher (Figure 48).

Figure 48. Pemall 2A:40B:C/Projectile Entry and Exit

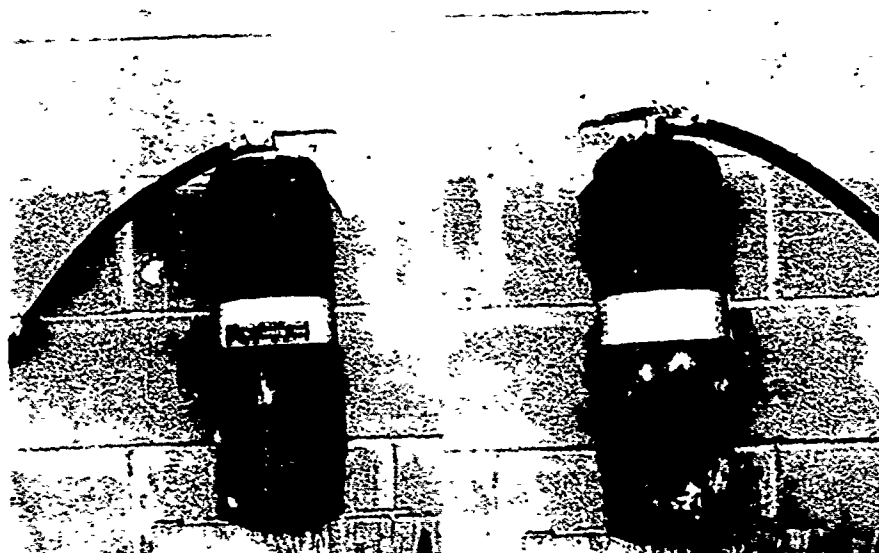
2A:60B:C - One bottle of this size was tested. There was some deformation where the projectile exited the cylinder; a gaping hole approximately one-fourth the length of the cylinder resulted. There was no evidence of fragmentation (Figure 49).

Figure 49. Potter-Roemer 2A:60B:C/Projectile Entry and Exit

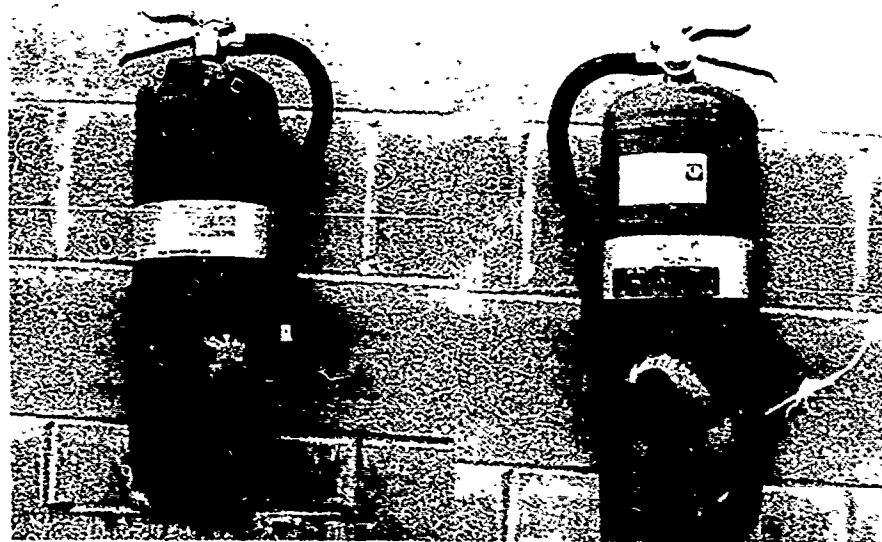
2A:60B:C - One extinguisher was tested. The results were the same as for the 1A:10B:C. The entry and exit points were clean holes (Figure 51).

Figure 51. Protectoseal 2A:60B:C/Projectile Entry and Exit
