**RAPID DAMAGE ASSESSMENT**  
**VOLUME II: DEVELOPMENT AND TESTING**  
**OF RAPID DAMAGE ASSESSMENT SYSTEM**

**NEW MEXICO ENGINEERING RESEARCH INSTITUTE**  
**ALBUQUERQUE, NEW MEXICO 87131**

**FEBRUARY 1981**

**FINAL REPORT**  
**JUNE 1979 - NOVEMBER 1980**

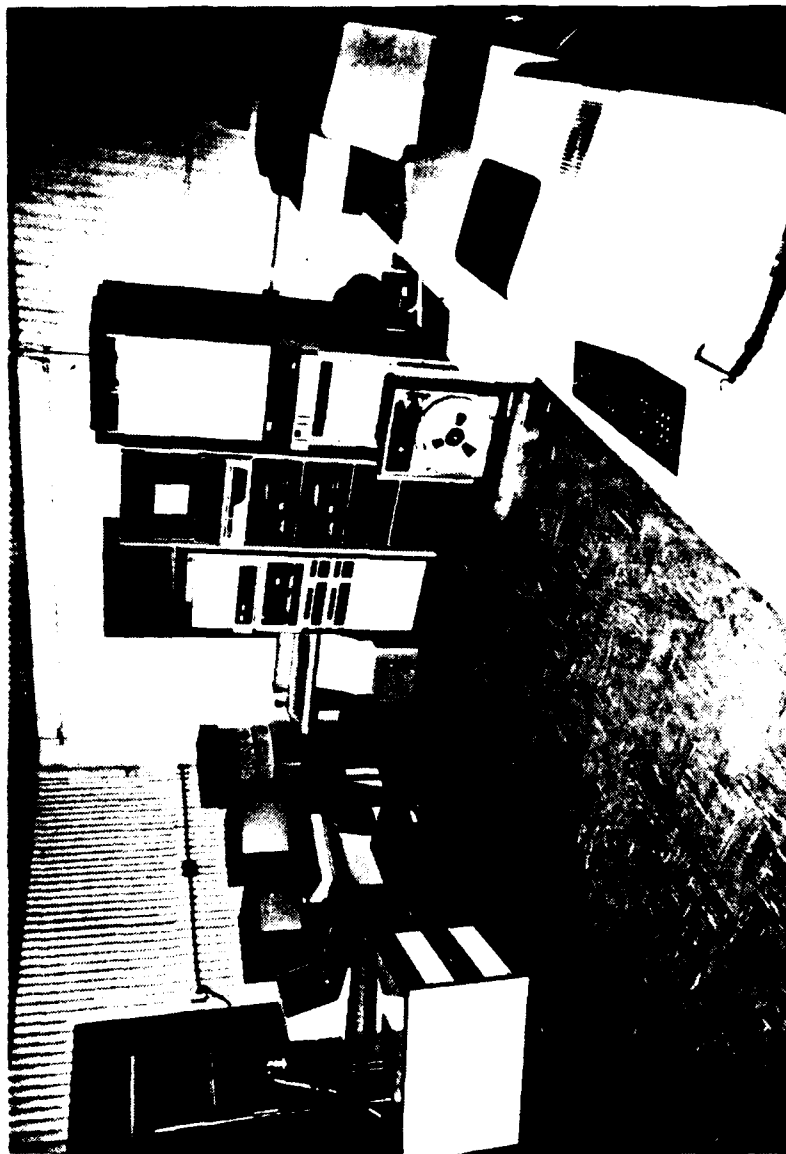
Figure 4. Image Analysis System

The IAS developed by NMERI is essentially a computerized data-processing system. Imagery data from the FSP are first processed to locate, size, and classify damage to a runway surface. The damage data are then processed to determine which MOS could be repaired in the least amount of time. The IAS can be separated into two major subsystems: the Image Controller System (ICS) and the Image Processor System (IPS). The ICS stores and controls the flow of imagery and damage data through the IAS, performs large-scale manipulations of the imagery data, and processes the damage data to select an MOS. The IPS displays the imagery data and interacts with an operator to identify, locate, size, and classify damages. Both the ICS and the IPS can operate as independent, stand-alone systems. Each has its own central processing unit (CPU),

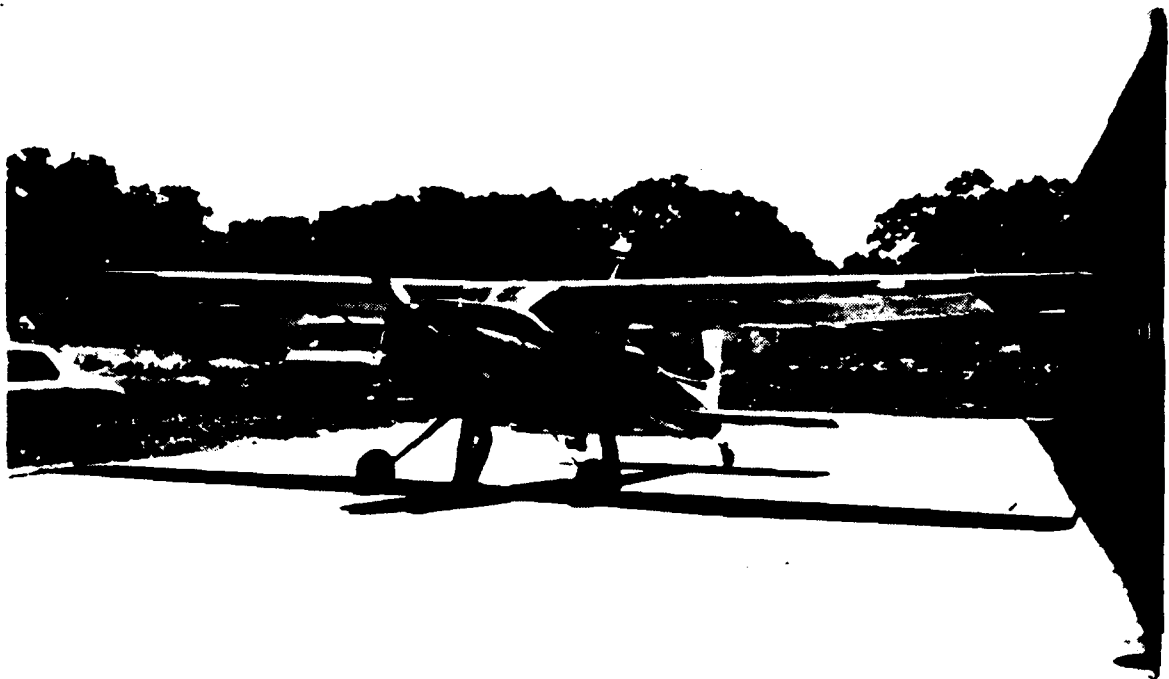
Figure 7. Cessna 180

A Cessna 180 modified for aerial photography was used as the carrier aircraft for concept verification of the DAS. The flying characteristics of the Cessna 180 are similar to those of the T-41, one of the aircraft originally considered as a carrier for the FSP. Attempts to obtain a USAF H-1 helicopter for testing and demonstration were unfruitful. The Cessna 180 is shown in Figure 7. Modifications to the aircraft for testing purposes included the addition of a 16-inch vertical camera port in the floor behind the front seats, reinforcement of the rear floor, removal of rear seats, and addition of batteries and electrical outlets in the rear compartment.

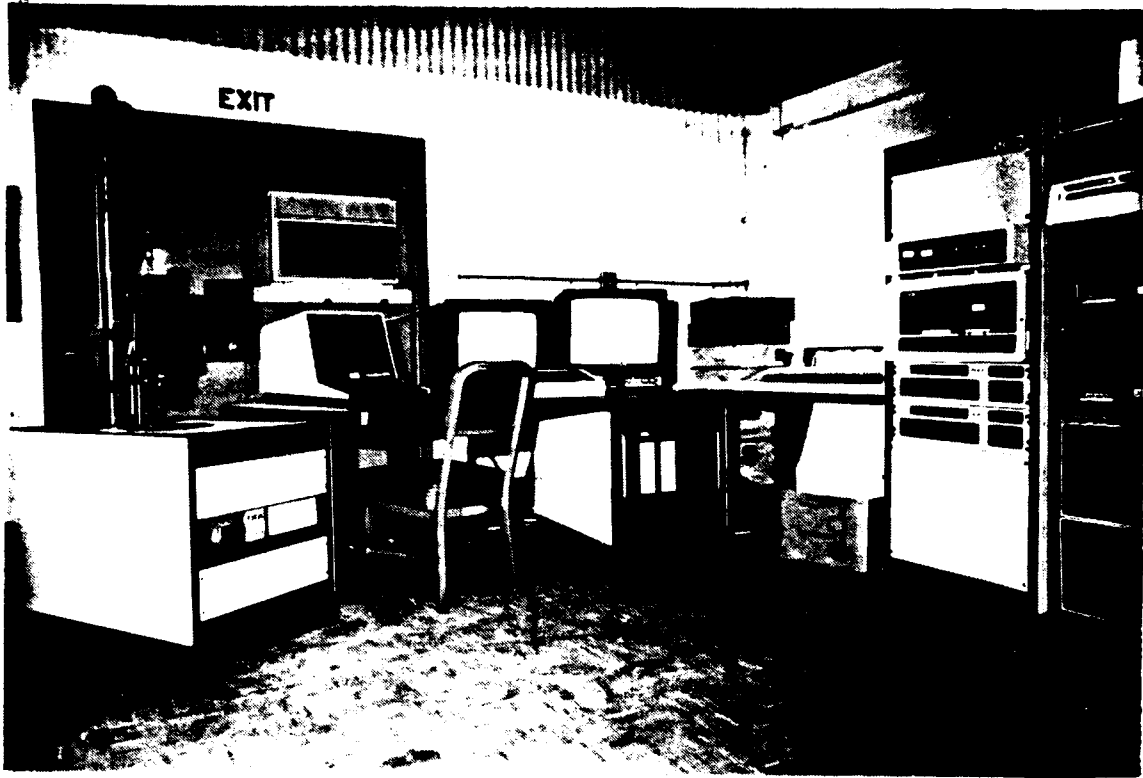
**Figure 12. Image Processor System**

The IPS essentially acts as a terminal to the ICS during damage assessment operations. The IPS receives commands that prepare it to accept imagery data and to assign the desired functions to the programmable function keys by means of the IF-2 parallel interface. Imagery data are transferred to refresh memory by means of the IF-3 DMA interface. The function key/trackball unit is used to interactively enhance the image gray scale, magnify the image, scroll and translate within the image, move the cursor and window, and adjust the size of the window. These standard image capabilities are discussed in detail in Volume I of this report. The programmable function keys are programmed to move the image up and down (low-resolution mode); move the window to the cursor; read cursor location and window corner locations from the video display; mark and assign type values to features; transfer location, size, and type information back to the ICS by means of the IF-2 interface; call for other image sections from the ICS through the IF-2 interface; and terminate IPS operation. Most of the programmable function keys perform several operations at once. The programmable function keys are U1 through U8 and Y1 through Y8. The other function keys are preprogrammed by the VIEWS system. Table 10 lists the programmable function key operations for the low-resolution and high-resolution modes. The IPS is shown in Figure 12.
