ATC REPORT NO.-R-92000/1CR- 63

# The Development of a Low Velocity Impact Methodology for Hybrid Material Systems

JULY 1981

FINAL REPORT FOR PERIOD APRIL 1980 - APRIL 1981

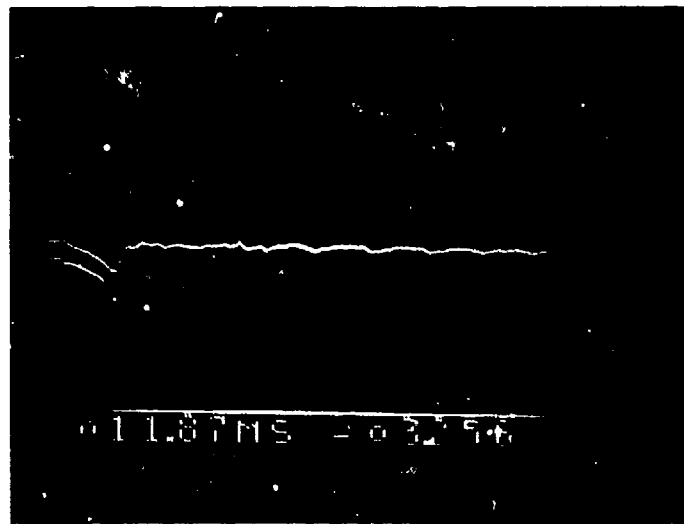
FIGURE 3.5a: THE UPPER AND LOWER TRACES CORRESPOND TO THE RESPONSE OF STRAIN GAGES A AND B, RESPECTIVELY. (SPECIMEN KE2)
