NAVAL MINE ENGINEERING FACILITY YORKTOWN VA
DUKANE SONAR TRANSMITTER MODEL N15F2108; EVALUATION OF. (U)
JUL 76 G J PENNINGTON
NAVMINENGRFAC/TE-9-75

NAVMINENGRFAC/TE-9-75

Subj: Dukane Sonar Transmitter Model N15F210B; evaluation of

20. ABSTRACT (Continue on reverse side if necessary and identify by block number) A corrosive study was conducted at Naval Weapons Station Yorktown. Two aluminum Transmitters DUKANE Model N15F210B were subjected to a 30-day sea water immersion test. Results of the test are presented. The degree of corrosion is analyzed as it would affect reusability of the transmitter. 4

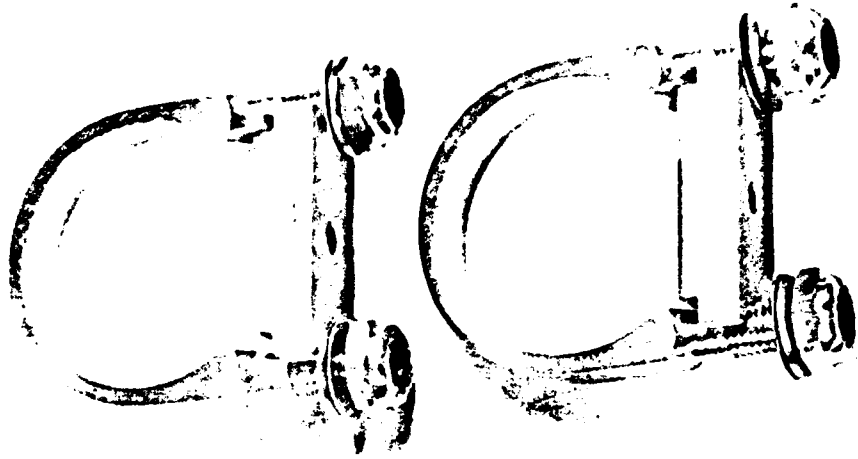
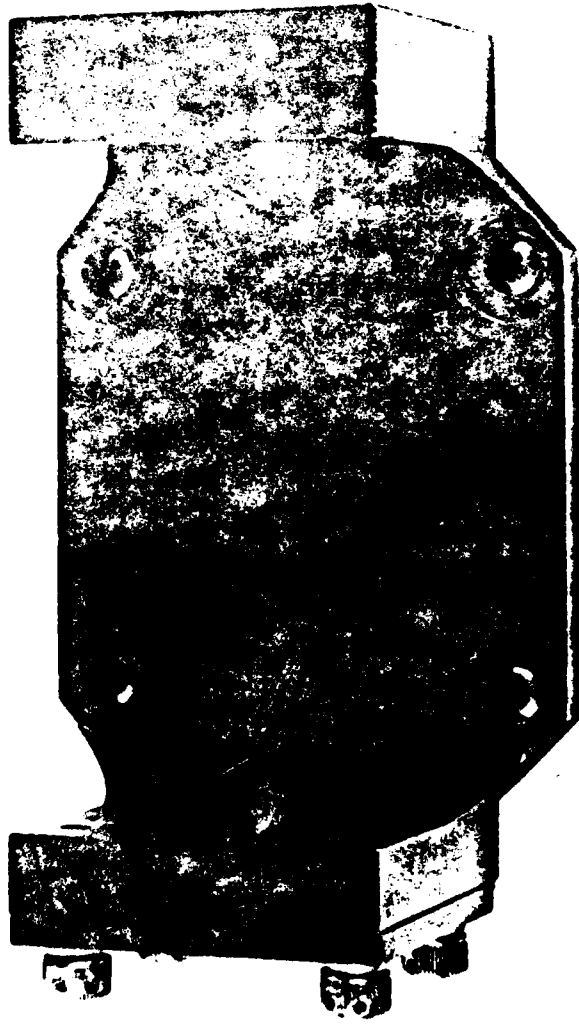
DUKANE'S STANDARD MOUNTING BRACKETS
LEFT - ALUMINIUM BRACKET
RIGHT - STAINLESS STEEL BRACKETS

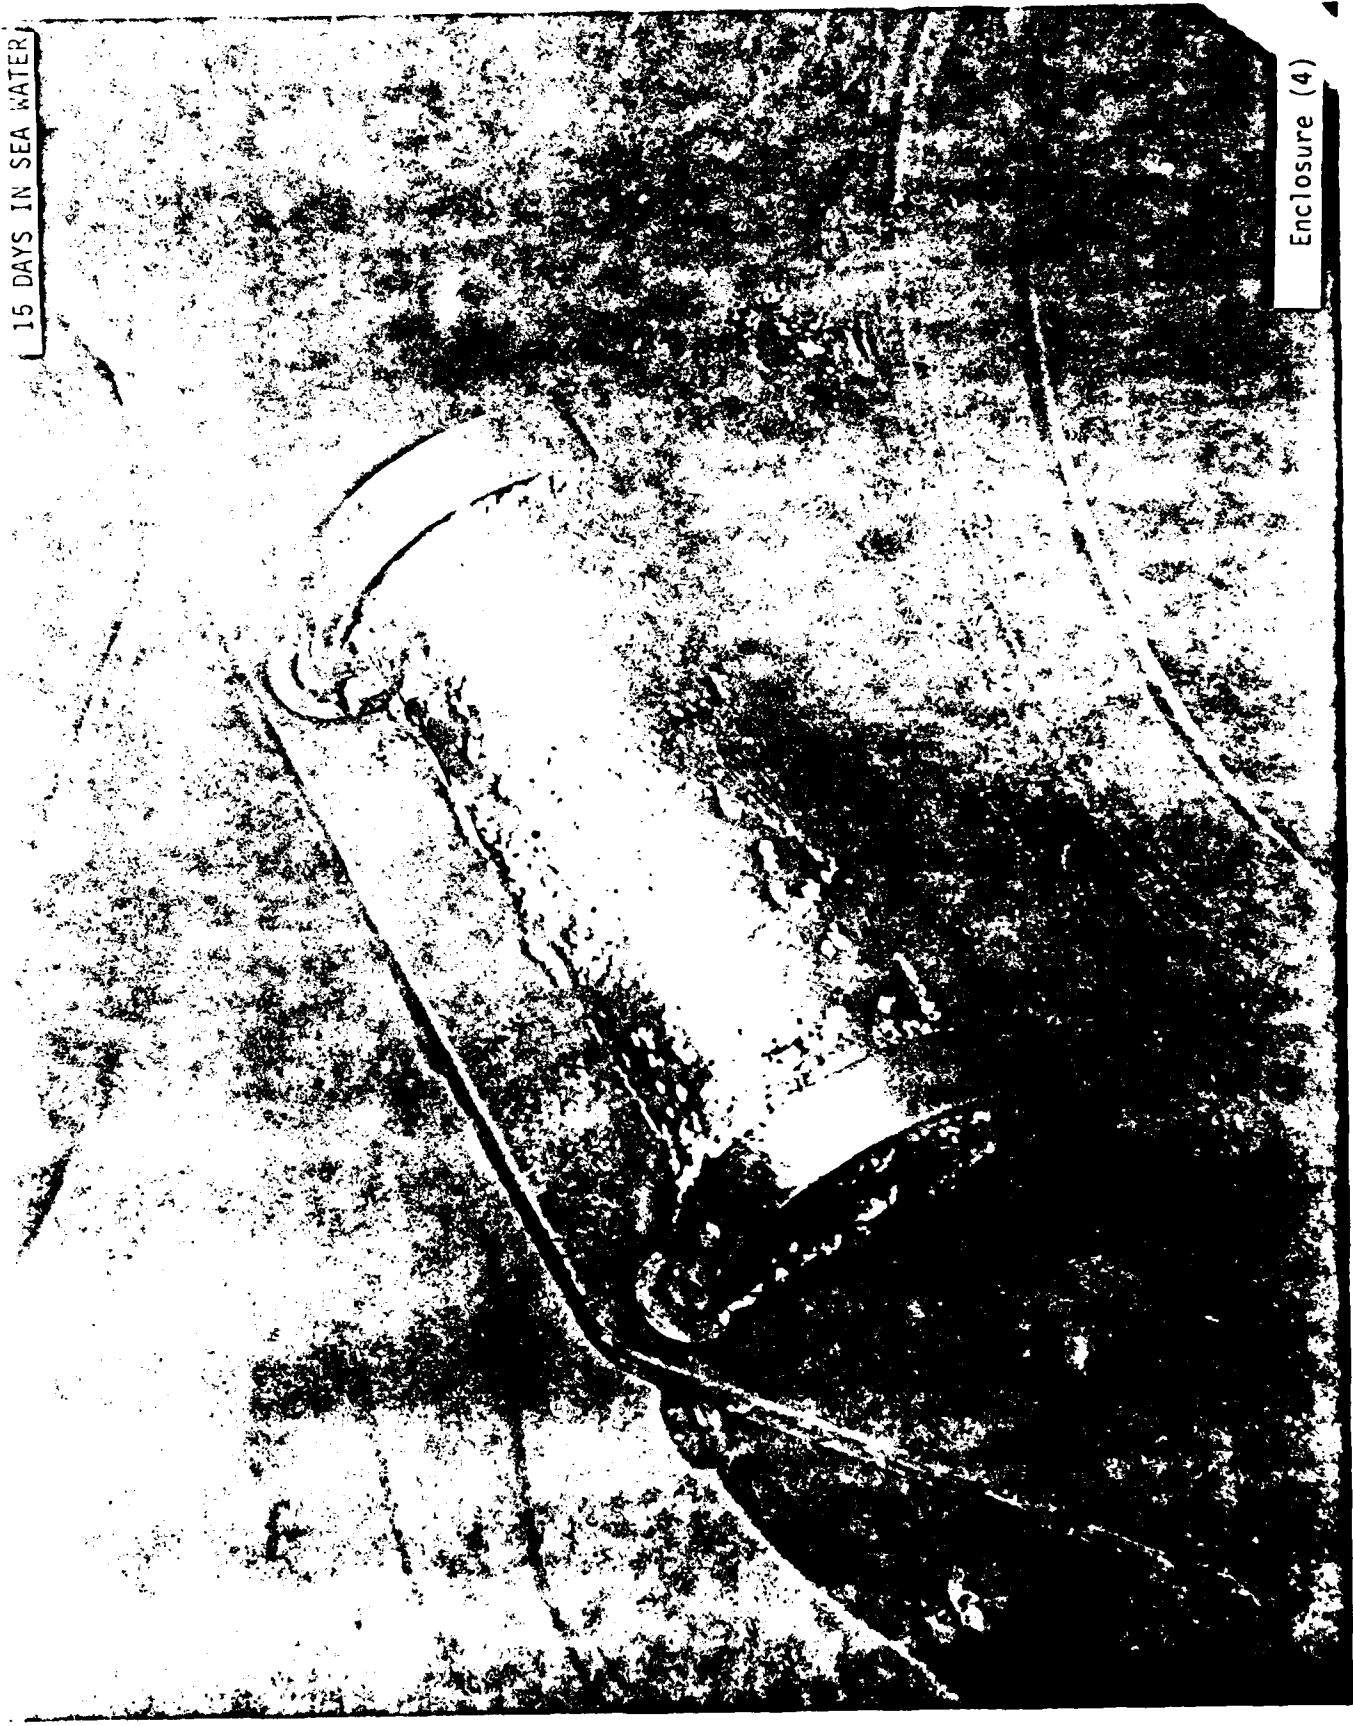
1. Enclosures (3) and (4) show the transmitters at 15 days in sea water. Enclosure (3) depicts the aluminum bracket acting as a sacrificial metal while the transmitter's aluminum case shows very little effect from sea growth and galvanic action. Enclosure (4) depicts little or no corrosion from galvanic action on the stainless steel mounting brackets while the transmitter's case shows a high degree of corrosion.

15 DAYS IN SEA WATER

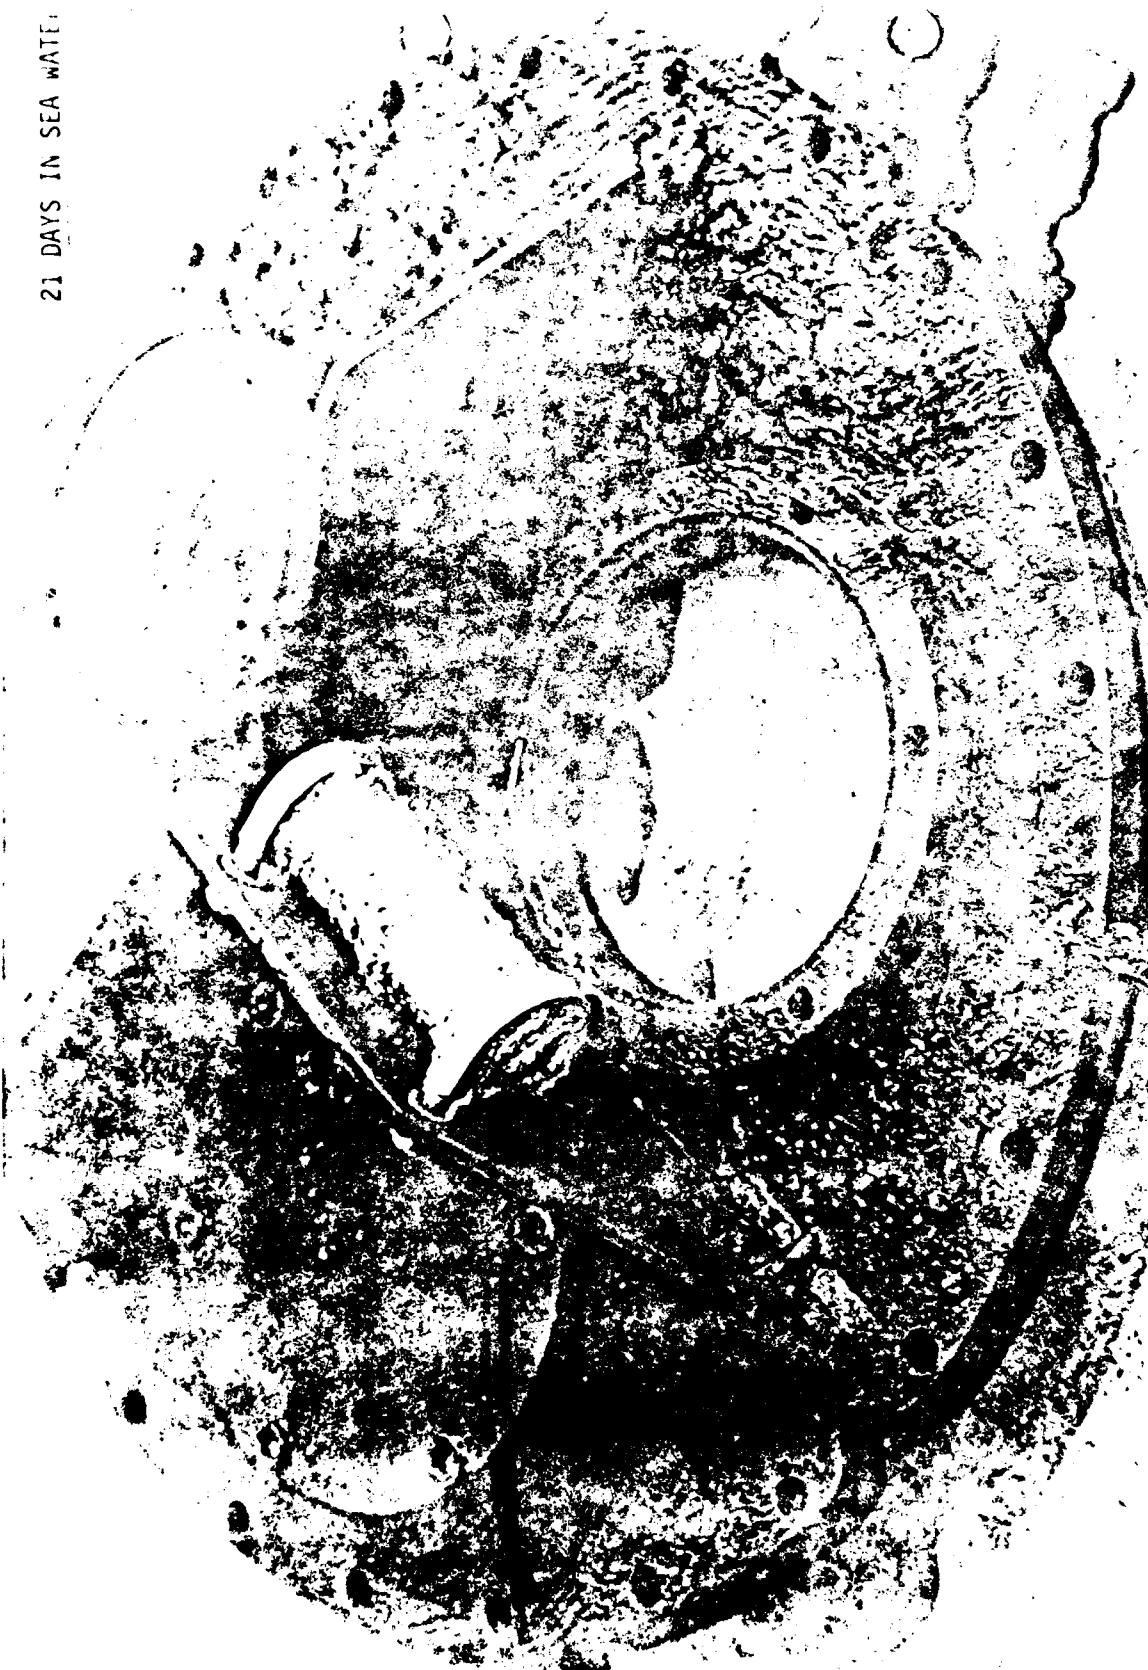
2. Enclosures (5) and (6) show the transmitter at 21 days in salt water. Enclosure (5) shows that the corrosion is increasing rapidly on the aluminum bracket. Enclosure (6) shows that the stainless steel mounting brackets are still resisting the corrosion, but the transmitter's aluminum case depicts a high degree of corrosion.

21 DAYS IN SEA WATER

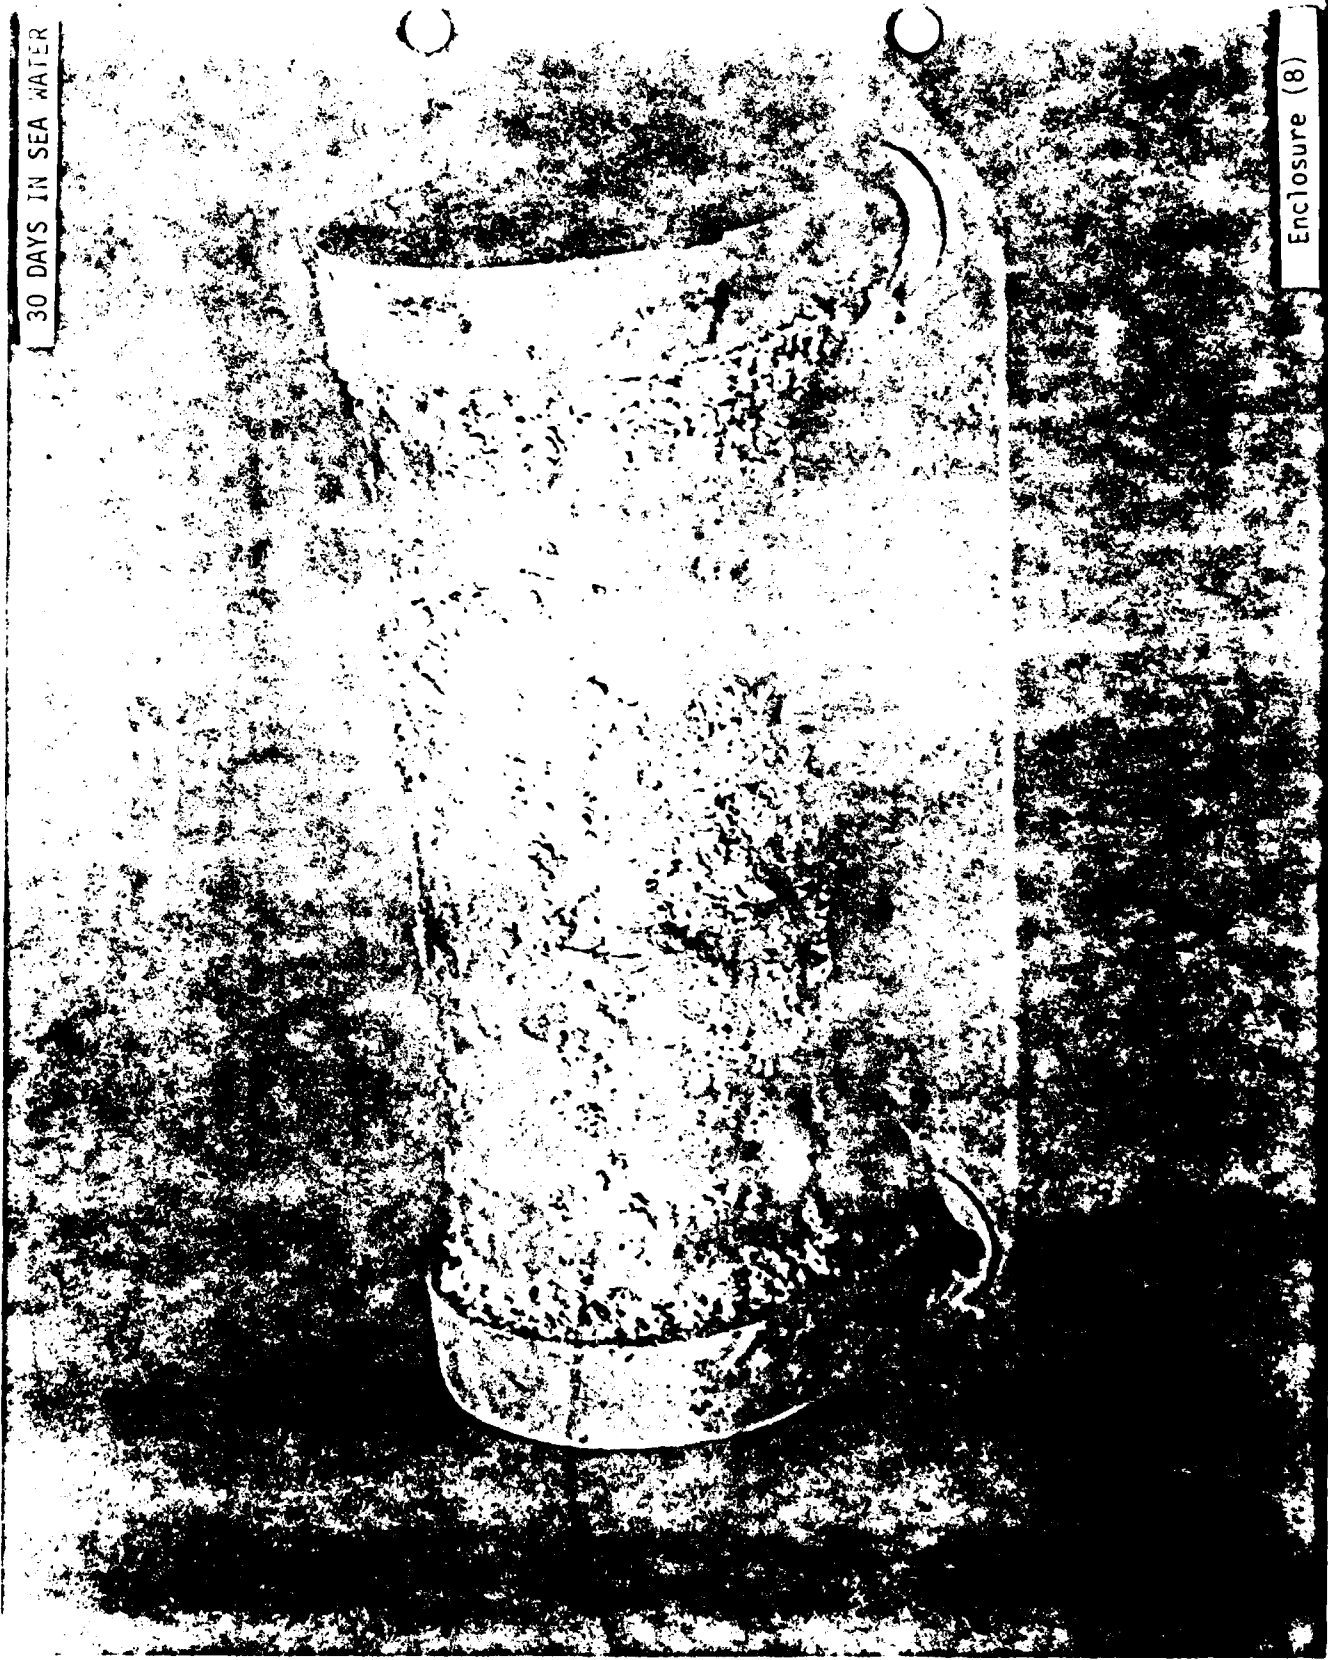
Enclosure (8)

3. Enclosures (7), (8), (9), and (10) show the transmitters after being exposed to sea water for 30 days. Enclosures (7) and (9) depict that the majority of the galvanic action was on the aluminum mounting bracket while enclosures (8) and (10) show that the majority of the galvanic action was upon the transmitter's aluminum case suggesting that the aluminum bracket was acting as a sacrificial anode for the transmitter.

30 DAYS IN SEA WATER
