DAVIDSON LABORATORY

REPORT NUMBER SIT-DL-80-9-2167

November 1980

THE WATER PERFORMANCE OF SINGLE AND
COUPLED LVTP-7's, With and Without
Bow Plane Extensions

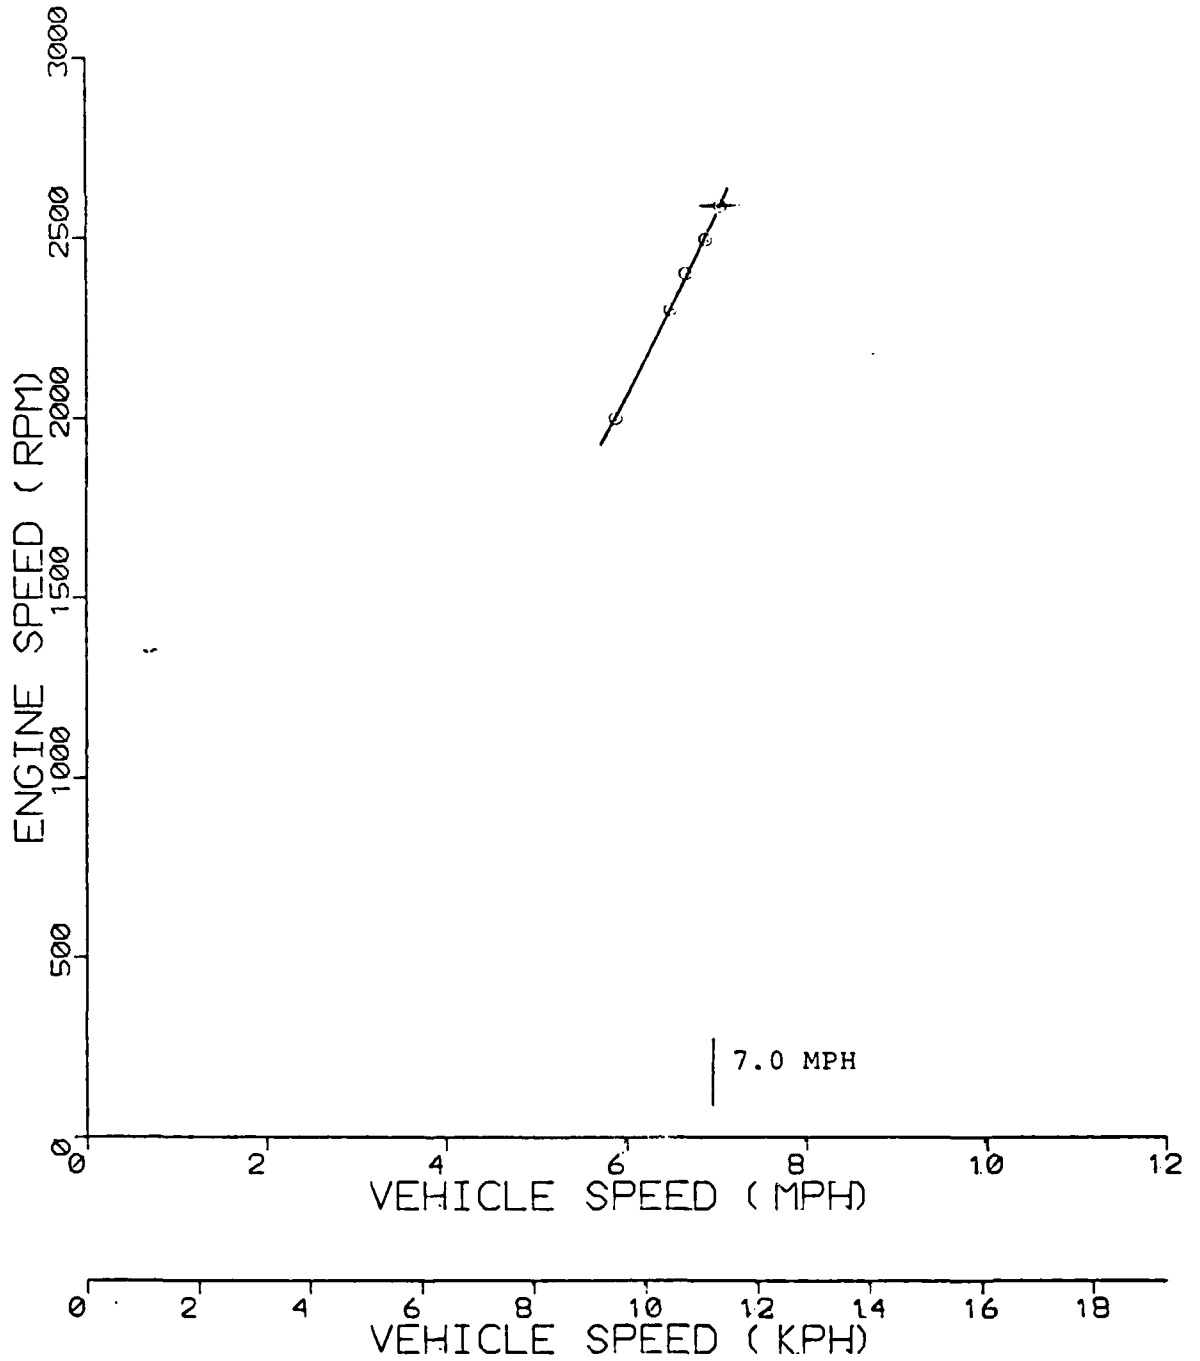
Y15 BASE LINE

FIGURE 7. Vehicle Speed as a Function of Engine Speed (RPM) for the Single Vehicle "Y15" Without Bow Plane

1. Figures 7 through 10 show vehicle speed as a function of engine RPM for the various configurations tested. All tests were performed in the water-jet mode; that is, with the track drive disengaged. Engaging both track and water jet drive tends to lift the bow up, but also reduces the maximum speed attainable.
 - a. Figures 7 and 8 show the standard vehicle performance of "Y15" and "Y18" respectively. Vehicle "Y15" was

1. Comparisons of Figures 7 through 10 show that in still water there is a speed increase of about 0.5 mph possible on the basis of the available power. The maximum engine rpm attainable under all conditions with water jet propulsion, was 2700 rpm at full rack. At that rpm the baseline and unmodified vehicle can attain a speed of 7.0 mph whereas the same vehicle equipped with the bow plane can attain 7.5 mph. Differences in speed due to the various bow plane configurations could not be determined with the simple timing method used.

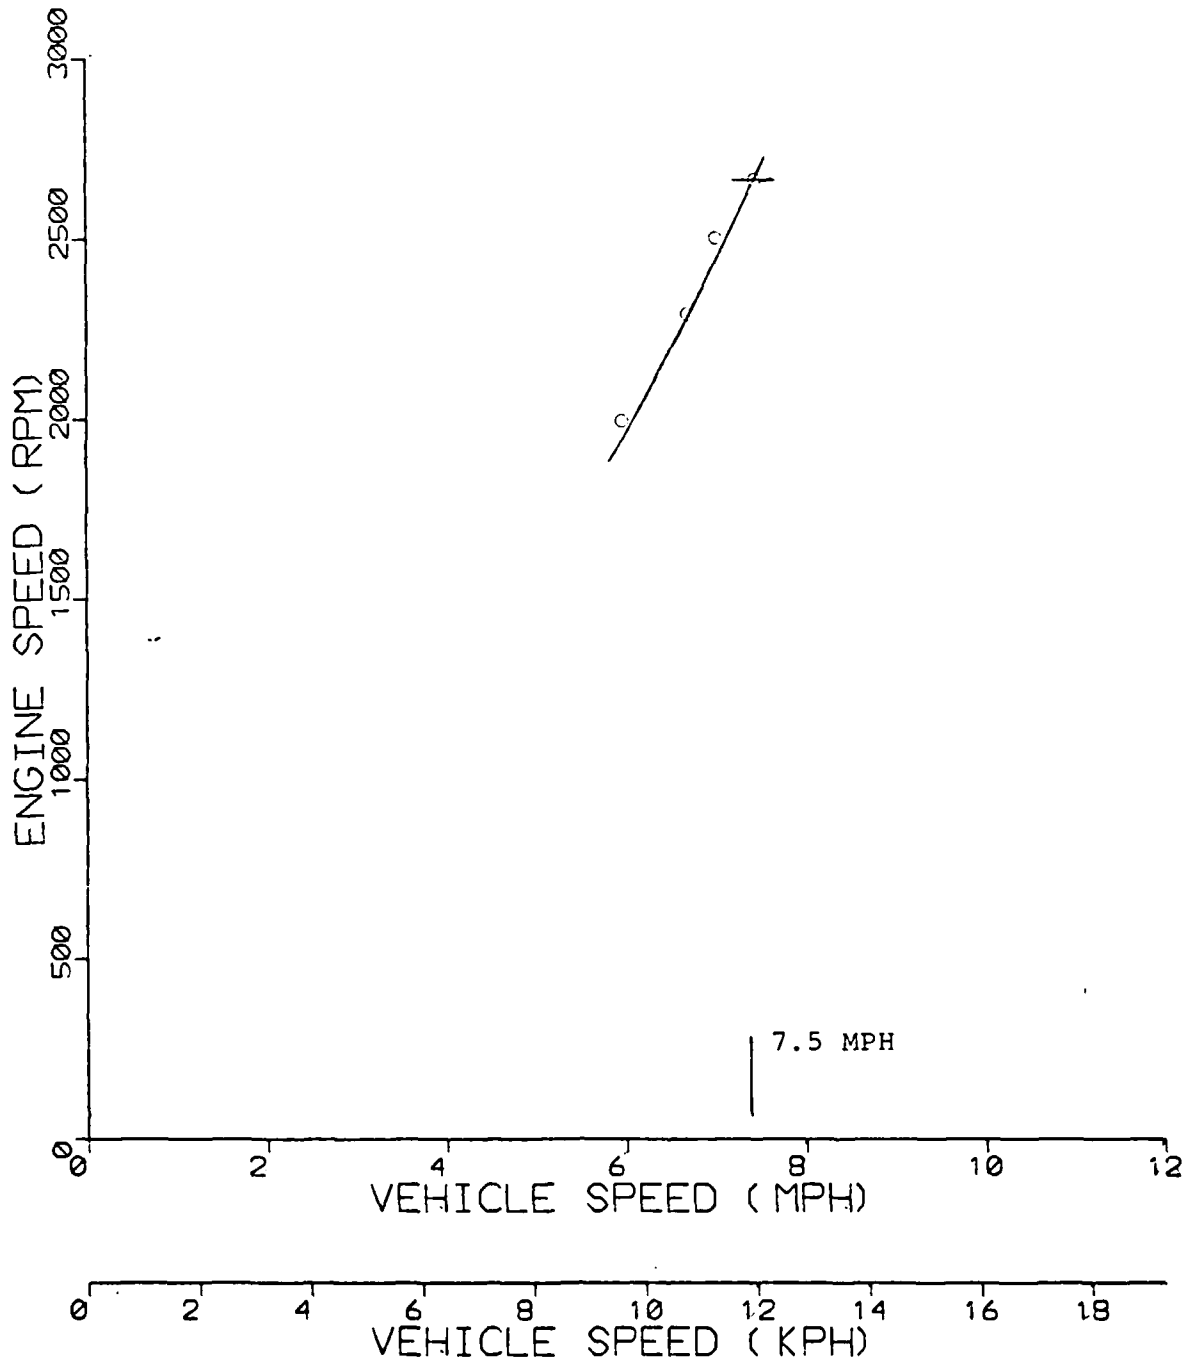
Y15 LARGE BOW

FIGURE 9. Vehicle Speed as a Function of Engine Speed (RPM) for the Single "Y15"

- b. Figure 9 shows the performance of "Y15" with the large bow plane.
- c. Figure 10 shows the performance of "Y15" with the small bow plane with and without lip.

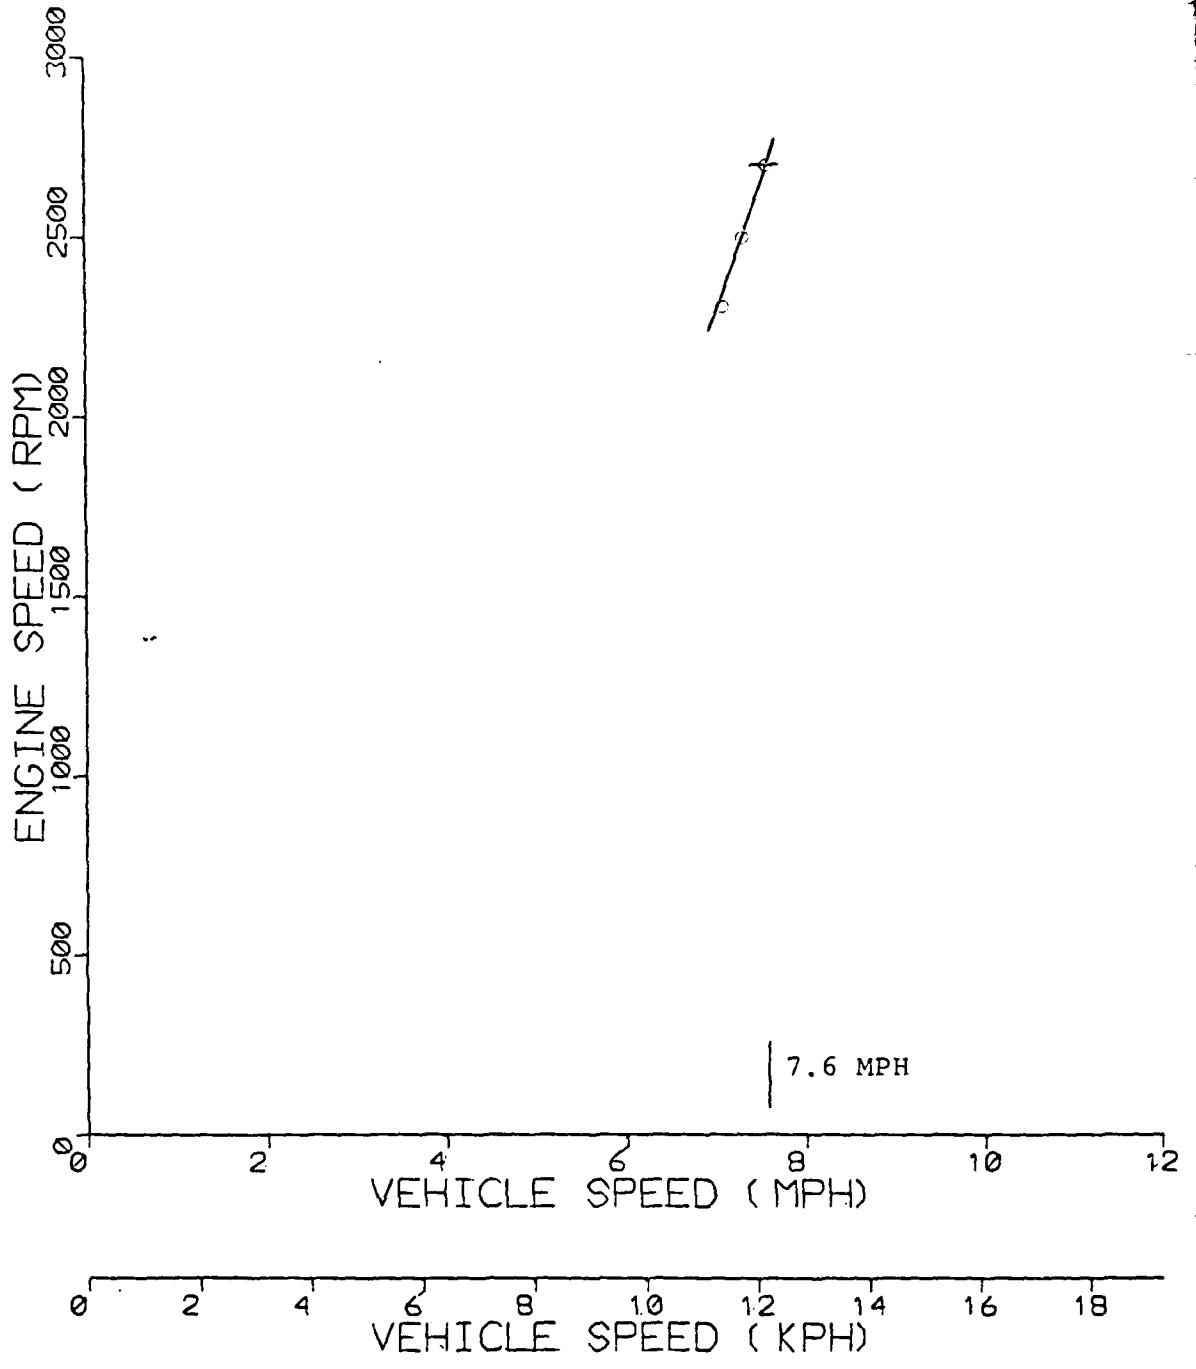
Y15 SMALL BOW

FIGURE 10. Vehicle Speed as a Function of Engine Speed (RPM) for the Single "Y15" With Small Bow Plane

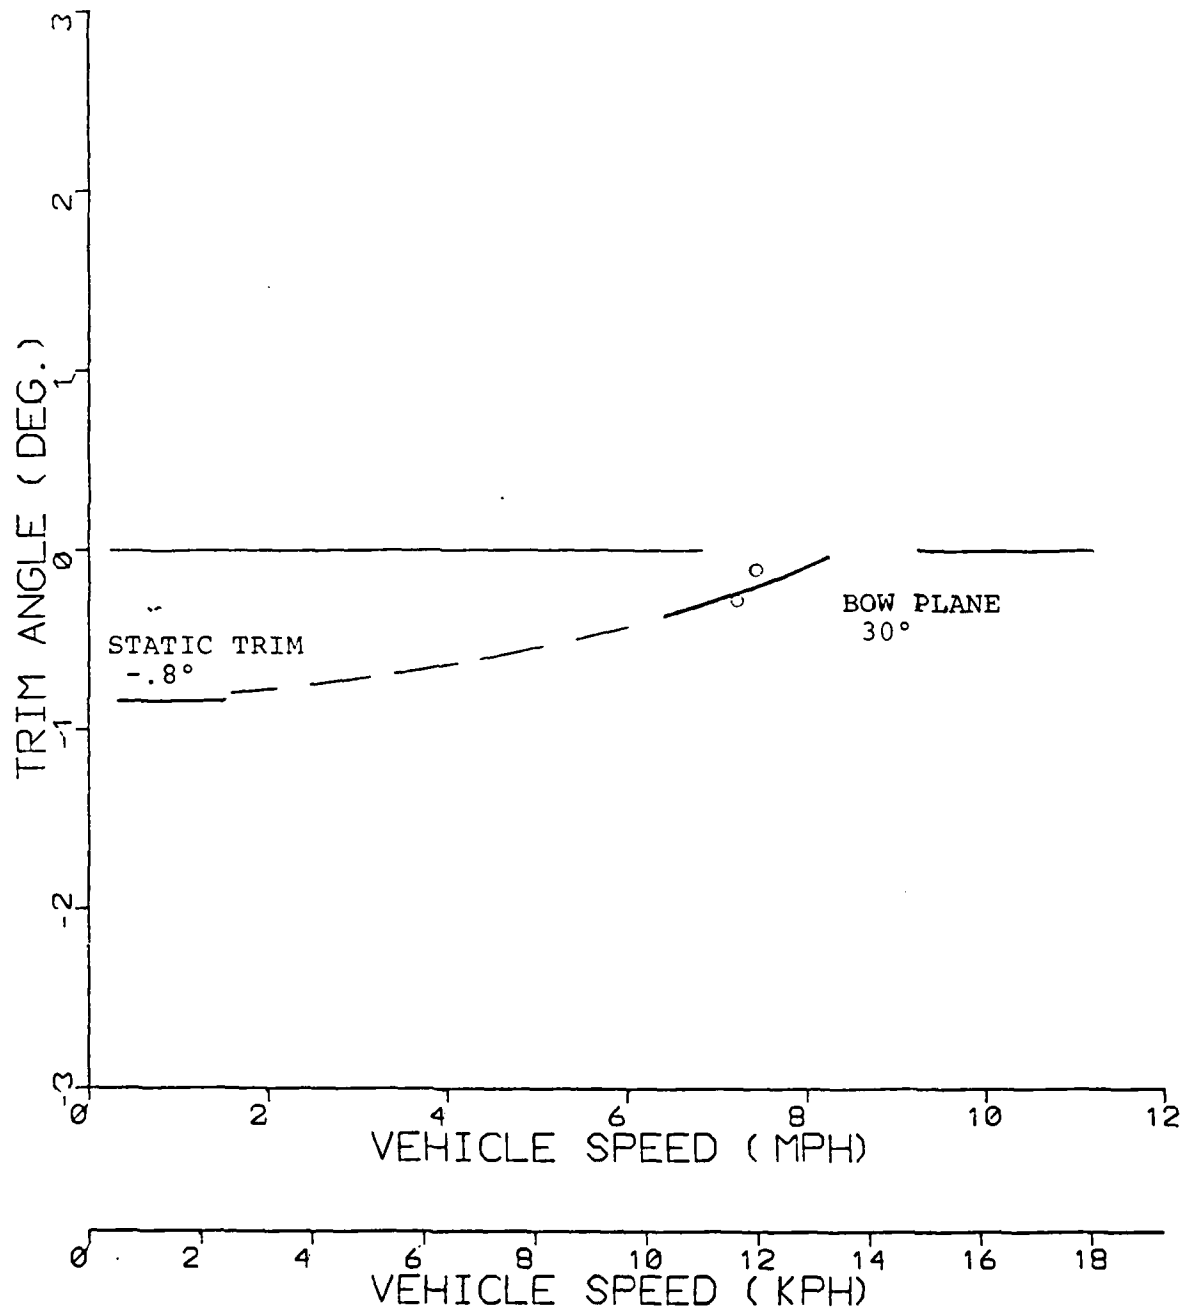
Y15 SMALL BOW

FIGURE 13. Trim Angle (Deg.) as a Function of the Vehicle Speed for the Single "Y15" With Small Bow Plane Adjusted at 30° Angle of Attack. Initial Static Trim -0.8°

- a. Figure 11 shows trim angle for the standard "Y15"
- b. Figure 12 shows trim angles of "Y15" with the large bow plane at three angles of incidence of the bow plane (as defined in Figure 1).
- c. Figure 13 shows the trim angle of "Y15" with the small bow plane at an angle of incidence of 30°.

30° (See Figure 13). The lip on the leading edge of the small plane was so proportioned as to bring the top edge to the same elevation as that of the large plane. In rough water, waves which spill over the leading edge of the plane will drain away in front of the bow. At no time during the smooth water tests and operation off Onslow Beach did a bow wave build up on the vehicle. All operation was possible with an open driver hatch, whereas the comparison vehicle had to be driven with the driver hatch closed, its vision blocks were under water.

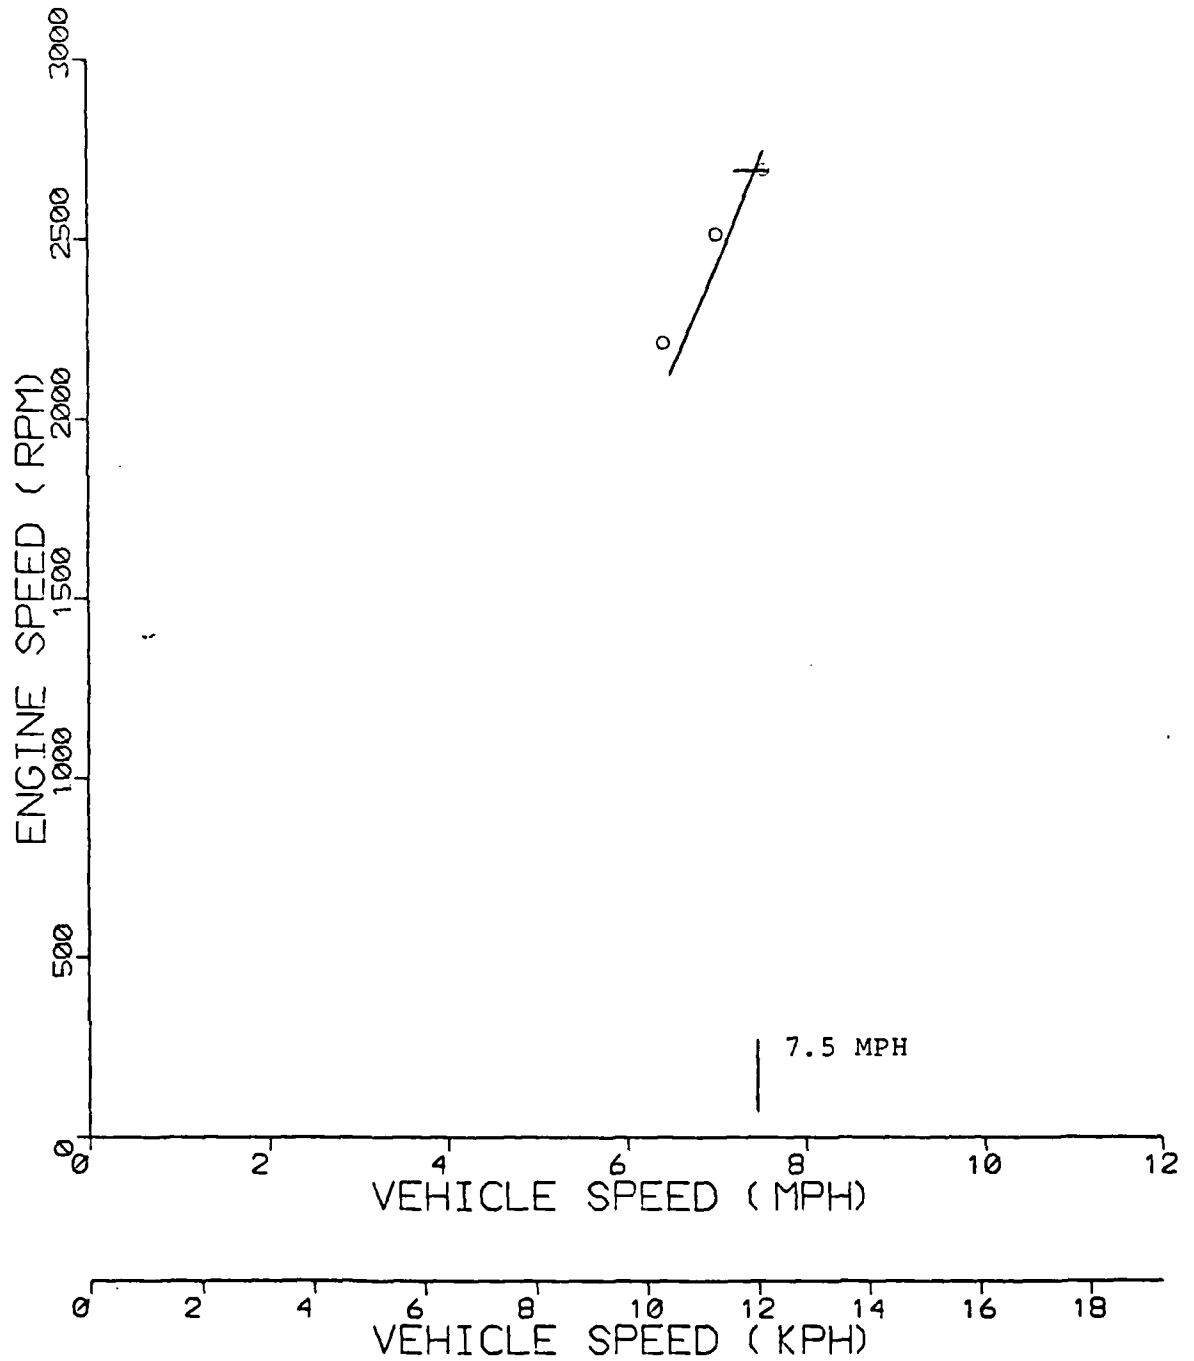
Y15+Y19 COUPLED - NO BOW PLATE

FIGURE 20. Vehicle Speed as a Function of Engine Speed (RPM) for the Coupled Vehicles Without Bow Plane

Data analysis of the coupled vehicle performance shows a small speed increase of about .5 mph, Figures 19 and 20, compared to the baseline unit (See Figures 7 and 8). The coupled vehicles have the same top speed of about 7.5 mph, with or without a bow plane, with full thrust provided by both vehicles. Figures 21

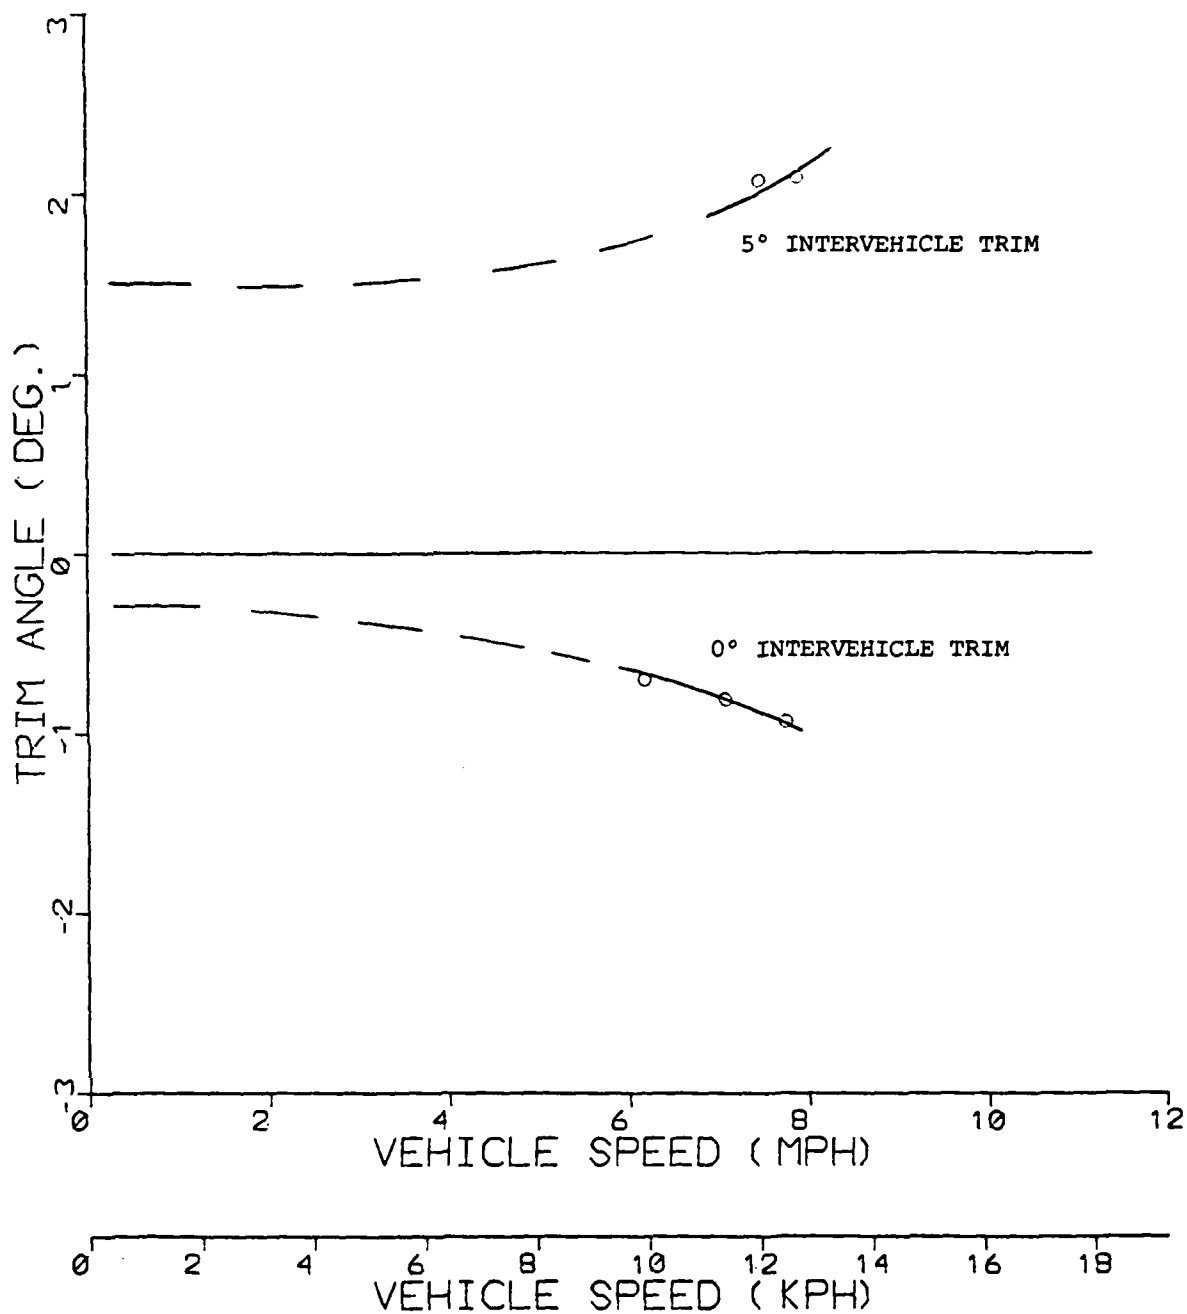
Y15+Y19 COUPLED SMALL BOW AND LIP

FIGURE 21. Trim Angle (Deg.) of the Forward Vehicle as a Function of the Vehicle Speed for the Coupled Vehicles With Small Bow Plane and Lip at Two Interverhicle Angles

and 22 show the trim angles of the forward vehicle as a function of vehicle speed at various intervehicle angles, with and without bow plane.

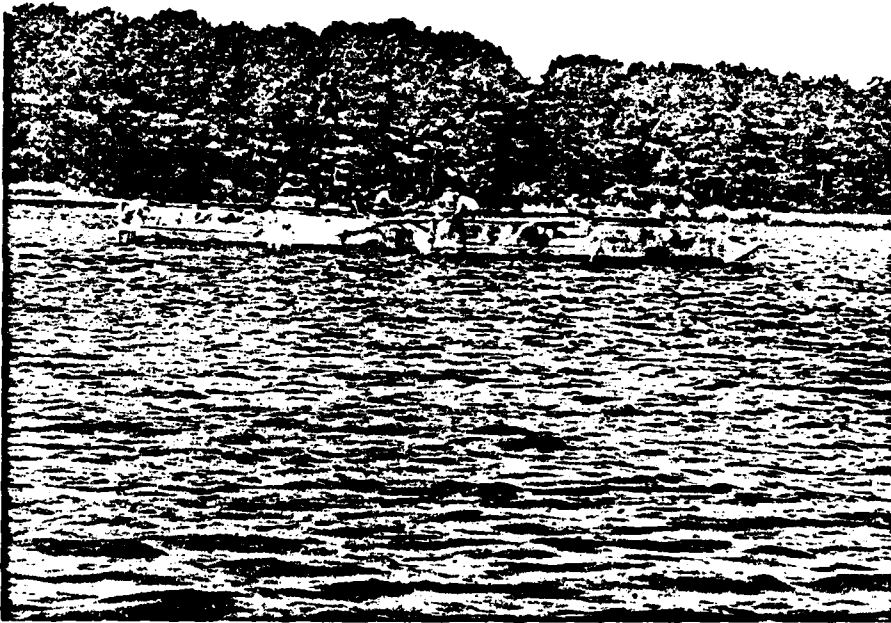
FIGURE 23. Side View of Coupled Vehicles
at Static Condition

Figure 23 shows the coupled vehicles, with the short bow plane and lip, in the static condition at 0° intervehicle trim. Figures 24, 25, and 26 show the water jet flow pattern at full speed.

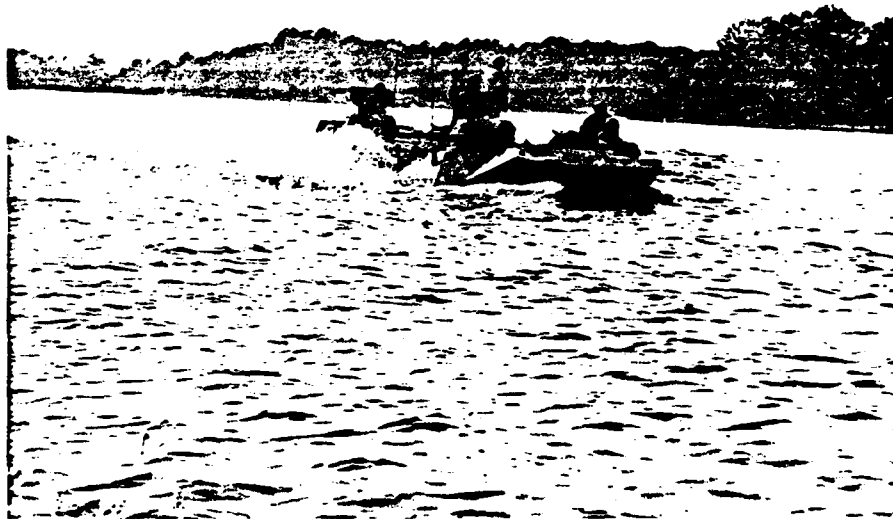
FIGURE 24. Coupled Vehicles During Speed Test
With Intervehicle Trim Angle of 5°
