TAE No. 463

# Repeated Buckling Tests of Stiffened Thin Shear Panels

Scientific Report No. 1

Department of Aeronautical Engineering  
Technion - Israel Institute of Technology  
Haifa, Israel

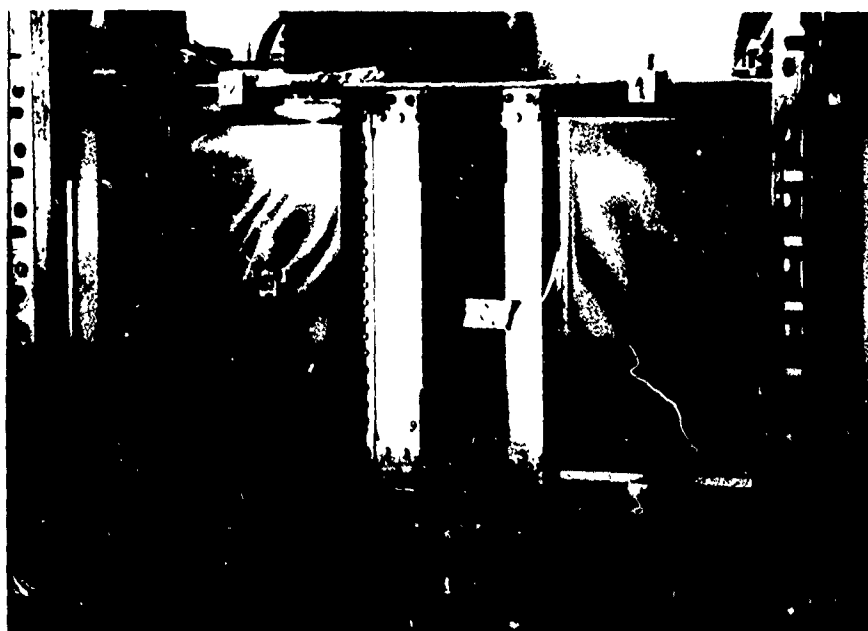
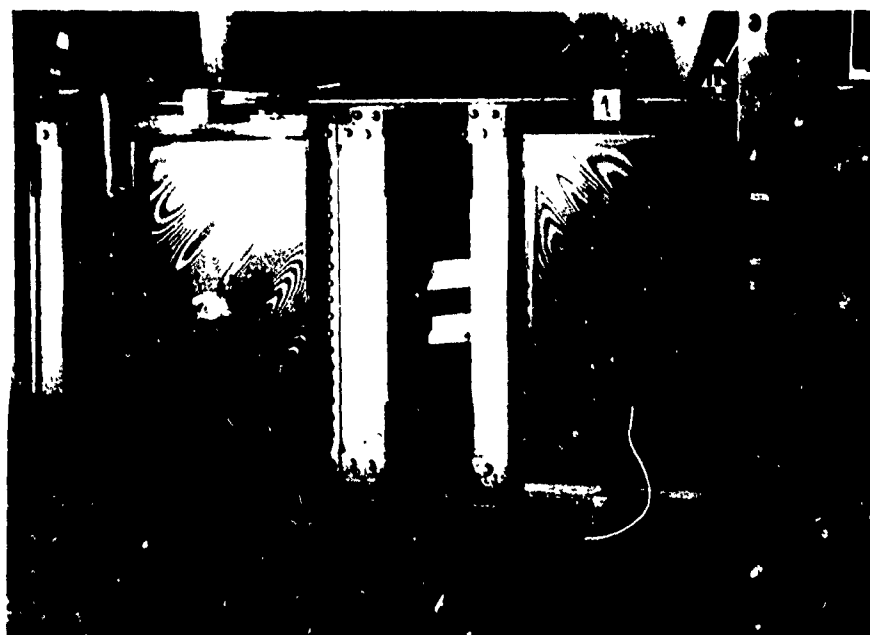
a.  $V = 1.27 \text{ kN}$

b.  $V = 21.58 \text{ kN}$

Fig. 11 Moire fringes with the two different grid densities at two load levels.

- a) A diagonal buckling wave pattern became visible in panel 2 (the sensitive moiré grid) at  $V \approx 0.9$  kN, and at  $V \approx 1.20$  kN more waves appeared (see Fig. 11a).
- b) Relatively large residual deformations appeared already after the first loading ( $V = 13.73$  kN). The growth of residual deflections after each static loading level is presented in Fig. 12. The largest residual strains appeared at the corner of the diagonal of tension near the compression flange. Their values after each loading and release are presented in Table 1. All these strains are in the direction of compression, perpendicular to the direction of diagonal tension.

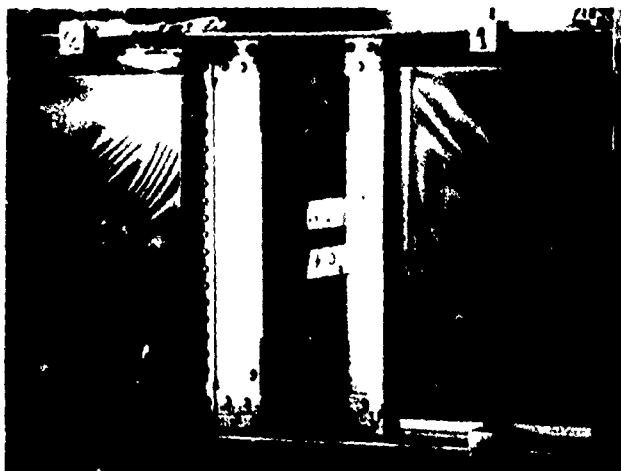
a. after  $V = 13,73 \text{ kN}$

b. after  $V = 19,62 \text{ kN}$

c. after  $V = 21.58 \text{ kN}$

Fig. 12 Residual deflections after release of static loading.
