**DEPARTMENT OF DEFENCE
DEFENCE SCIENCE AND TECHNOLOGY ORGANISATION
AERONAUTICAL RESEARCH LABORATORIES**

MATERIALS NOTE 130

**AN ASSESSMENT OF THE CORROSIVE POTENTIAL
OF THE CHEMICALS USED IN PENETRANT TESTING
TOWARDS AIRCRAFT STRUCTURAL MATERIALS**

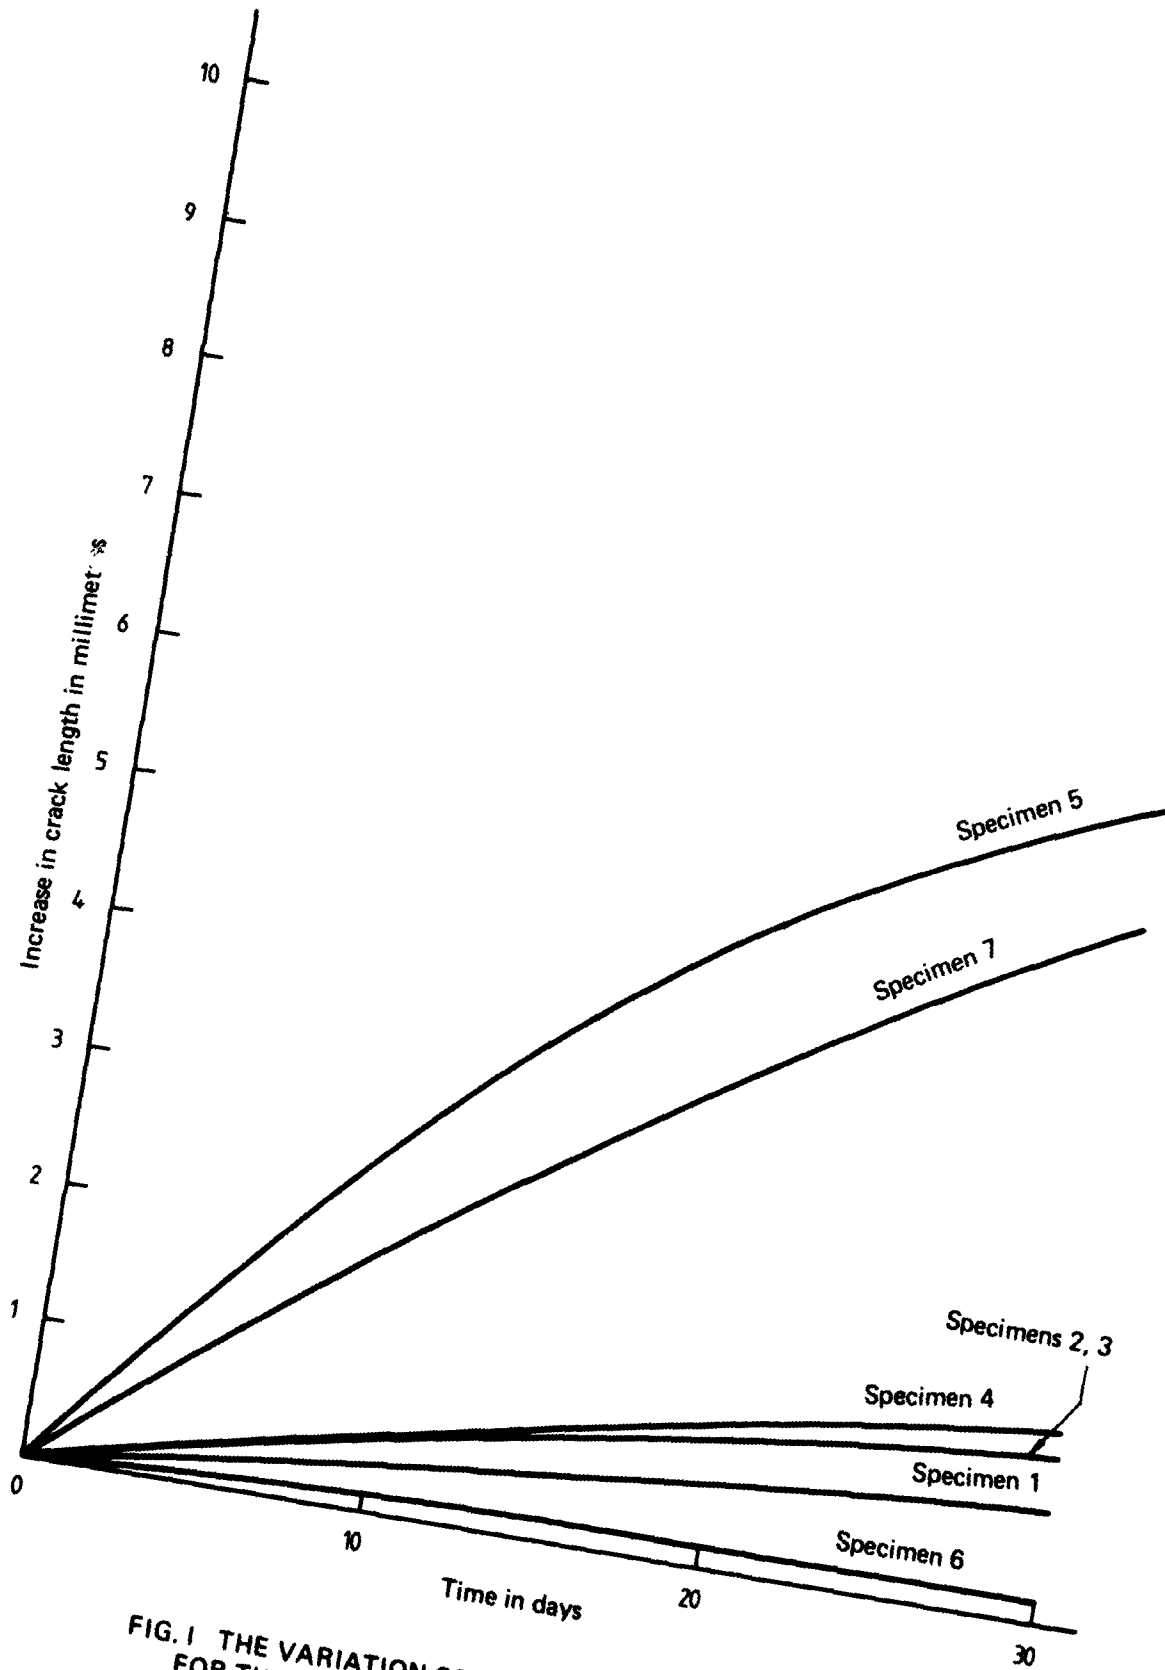
FIG. 1 THE VARIATION OF CRACK LENGTH WITH TIME FOR THE STRESS CORROSION TEST SPECIMENS

Aluminium alloy 7075-T651 was chosen for these tests because of its known susceptibility to stress-corrosion cracking. Seven Double Cantilever Beam (DCB) specimens¹ manufactured from 76 mm plate, containing "pop-in" pre-cracks were bolt-loaded in the short transverse direction. The lengths and opening displacements of the cracks introduced into the specimens were measured and the specimens treated as follows:

The length of crack in each specimen was measured every 24 hours for 46 days. Figure 1 shows the plots of increase in crack length versus time for each of the specimens. The only specimens with significant increases in crack length were numbers 5 and 7; both of these were washed in tap water at some stage of their preparation.
