## Technical Report 691

# REMOTE MEDICAL DIAGNOSIS SYSTEM (RMDS) ADVANCED DEVELOPMENT MODEL (ADM) LABORATORY TEST RESULTS

WT Rasmussen  
I Stevens  
PD Hayes  
(NOSC)

January 1982

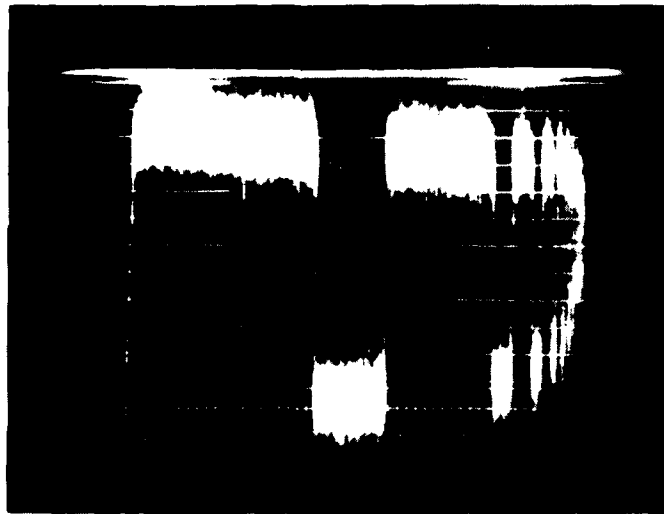
(a) Without low pass filter between camera and oscilloscope

Figure 104 shows photographs taken during the testing of the TV camera and lens system. The top photograph shows the signal obtained directly from the TV camera, while the bottom photograph shows the same signal with a low pass filter between the camera and the oscilloscope. The low pass filter decreased the amount of noise on the signal without distorting the signal's shape. As can be seen in the lower photograph (figure 104), little to no overshoot occurs. The values for rise time and fall time are 0.8 and 0.3 microsecond, respectively. This indicated that under the worst condition (black-to-white, rise time) approximately 1.5 % of the active sweep time will possess smear. This appeared to be within tolerance.
