Evaluation of the Engineering Properties of A Commercially Produced Aluminum Alloy 2020-T651 Plate

**R.G. Malcolm
A.K. Vasudevan
R.J. Brook
P.E. Bretz
Aluminum Company of America**

**Prepared for
Department of the Navy:
Naval Air Systems Command
Washington, D.C. 20360**

1981 December 18

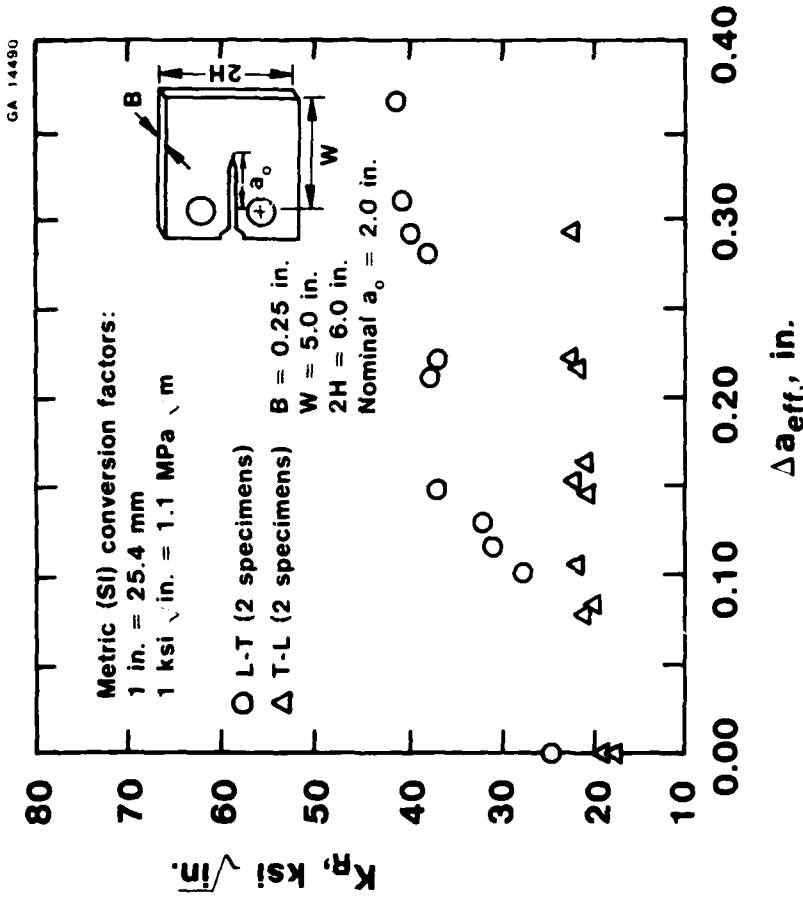
Figure 6

R-Curve Toughness Data for Commercially Produced 2020-T651 Plate (32.54 mm Thick) in the Longitudinal (L-T) and Long-Transverse (T-L) Orientations

R-curves were developed from tests of specimens taken in the L-T and T-L orientations and only from plate piece "B". The data are shown in Fig. 6. Each curve is composed of data established from duplicate tests which were very reproducible. Out of plane fractures occurred in both the L-T oriented specimens, however not with the T-L oriented specimens. The data points recorded in Fig. 6 represent only those values where the plane of crack growth remained normal (to within $\pm 5^\circ$) to the applied loading direction. For the higher toughness L-T orientation, out of plane fractures occurred at Δa_{eff} values which correspond approximately to the point of maximum test load.

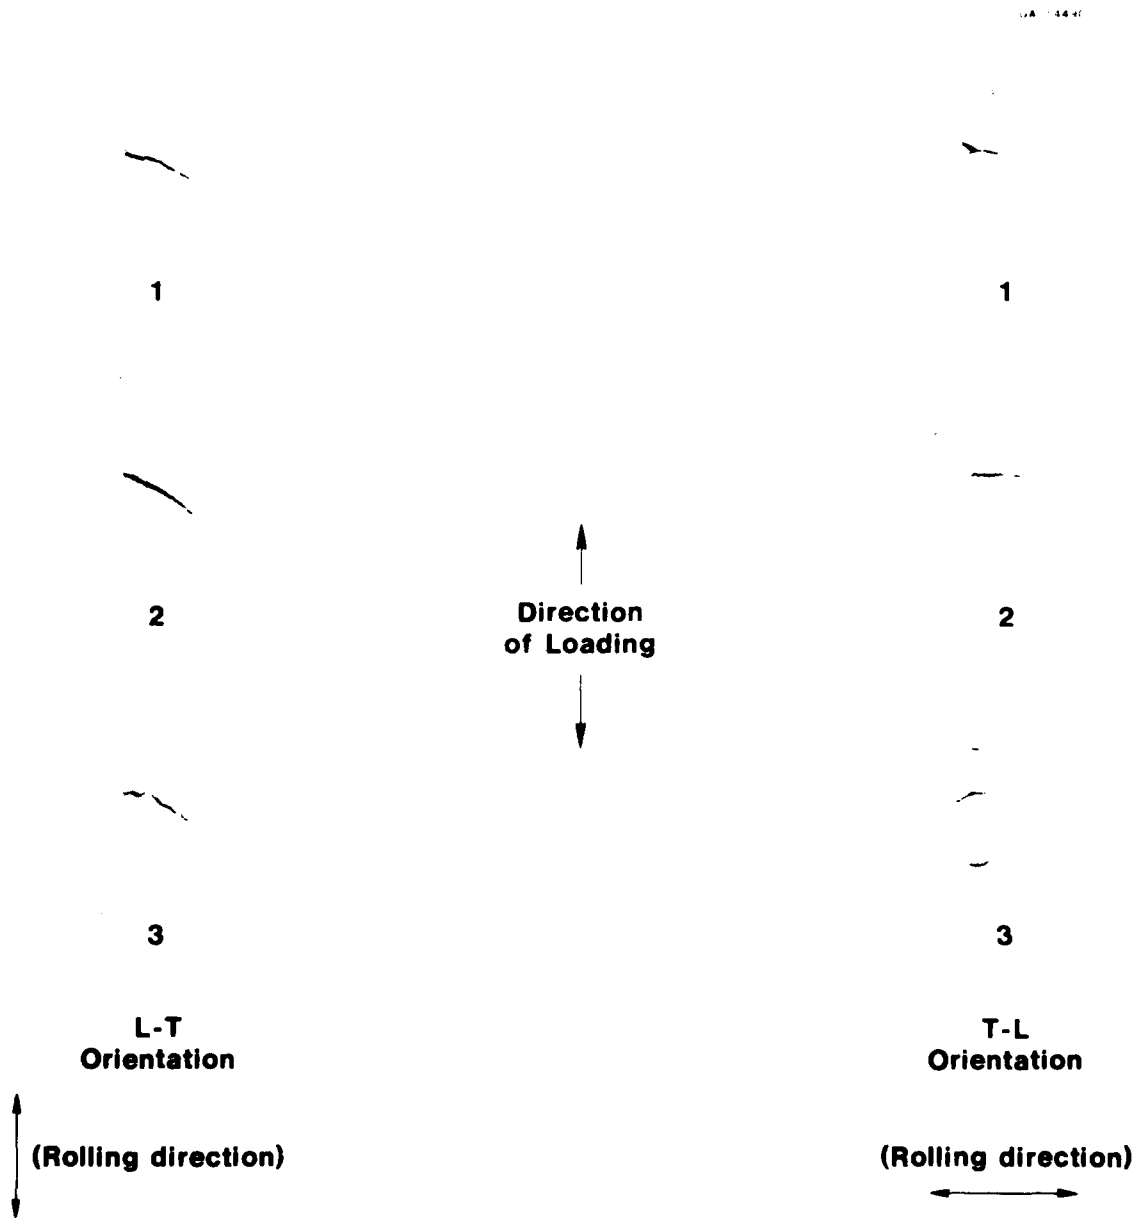
Figure 10

**Effect of Specimen Orientation on the Fracture Path of
 Triplicate Kahn-Type Tear Specimens from a Sample
 (523713-A-2) of 2020-T651 Aluminum Alloy Plate
 (32.54 mm Thick)**

The tear properties of plate piece "A" are slightly higher than those of piece "B". All of the L-T oriented tear specimens from both plate pieces fractured diagonally, as shown in Fig. 10, whereas the fracture path of each of the T-L oriented specimens is normal. The tear properties in the L-T orientation of both pieces of plate are significantly higher than those properties in the T-L orientation.
