RADC-TR-82-2
Final Technical Report
March 1982

ADVANCED ELECTRICAL TEST TECHNIQUES FOR LSI MICROCIRCUITS

Hughes Aircraft Company

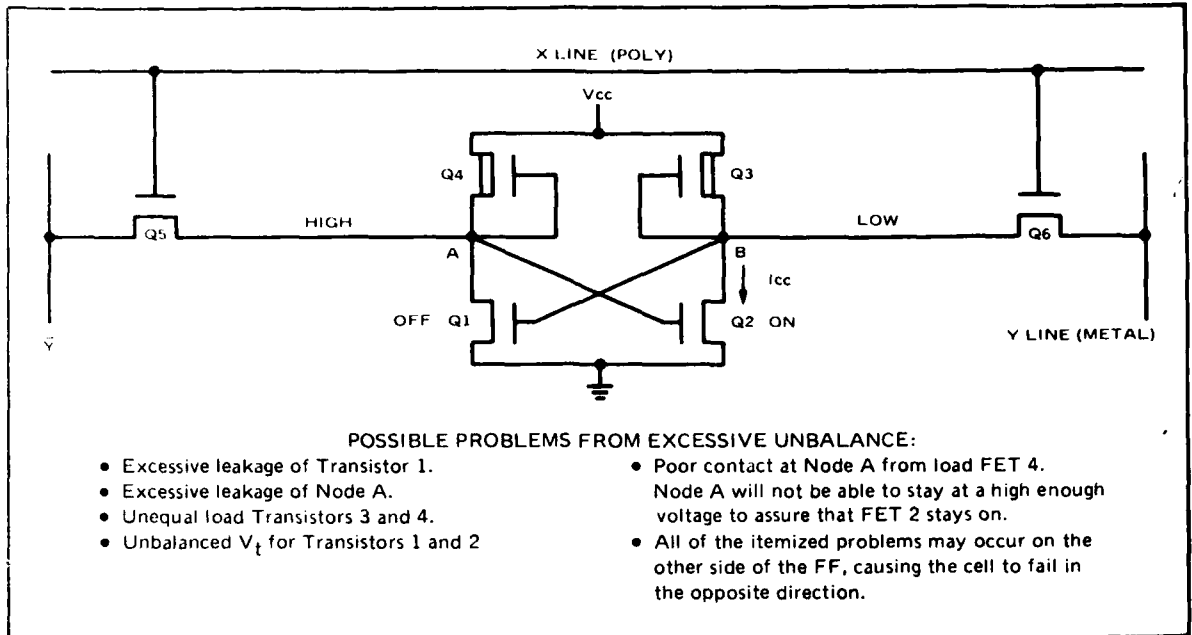
Figure 2. FF Memory Cell Unbalance Factors.

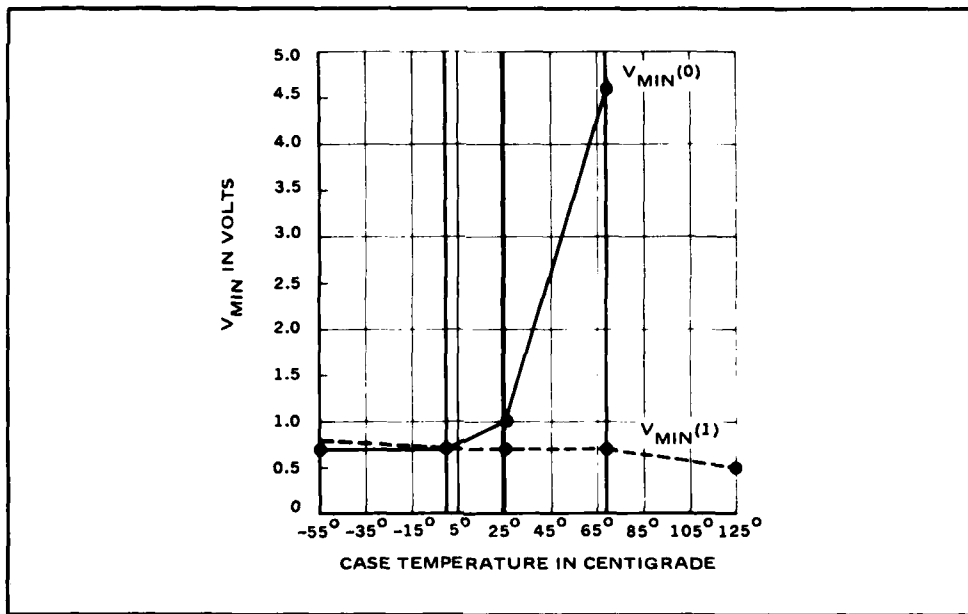
Figure 11. V_{min} Characteristics of Device No. 274. The V_{min} test at elevated temperatures can easily detect this type of TDF.

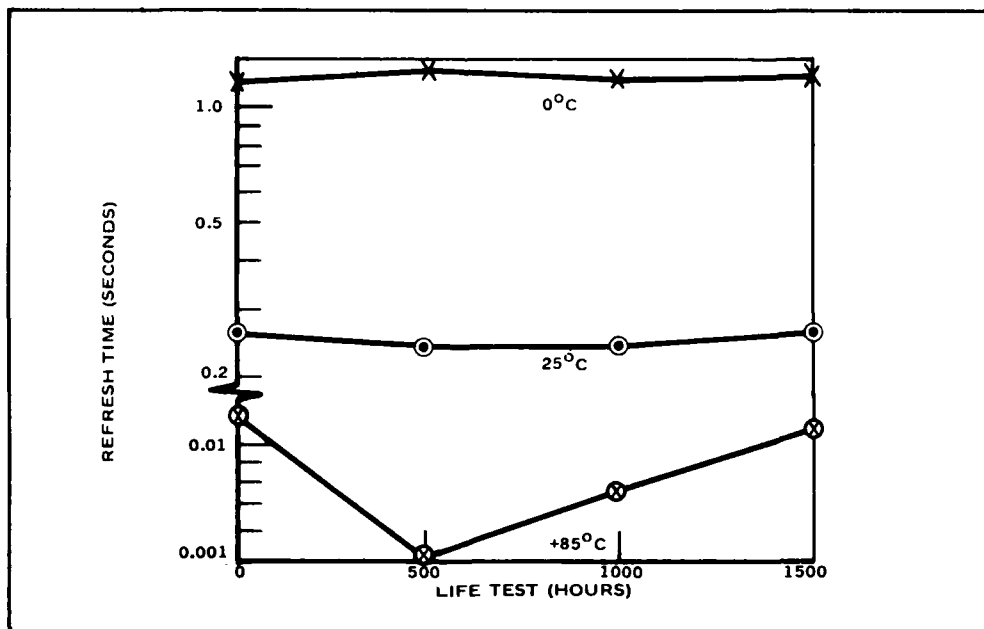
19143-26P

Figure 26. Refresh Time for 9050, 4050 Dynamic RAMs - Non-Suspect Devices. Low temperature data is stable but high temperature data is marred by instrumentation error at 500 hours causing abnormally low readings.

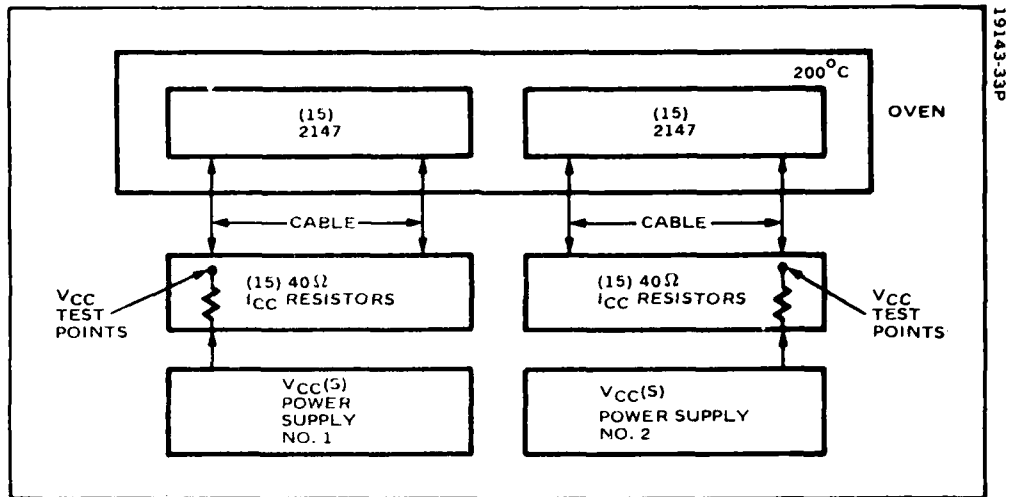
Figure B-1. 2147 Block Diagram of Static RAM Life Test.
