GENERAL ELECTRIC CO PITTSFIELD MA ORDNANCE SYSTEMS
METAL CORE EPOXY GLASS CIRCUIT BOARD EVALUATION PROGRAM. (U)
DEC 81 B E INPYN

Metal Core Epoxy Glass Circuit Board Evaluation Program

FINAL REPORT

**ORDNANCE SYSTEMS
ELECTRONIC SYSTEMS DIVISION
PITTSFIELD, MASSACHUSETTS 01201**

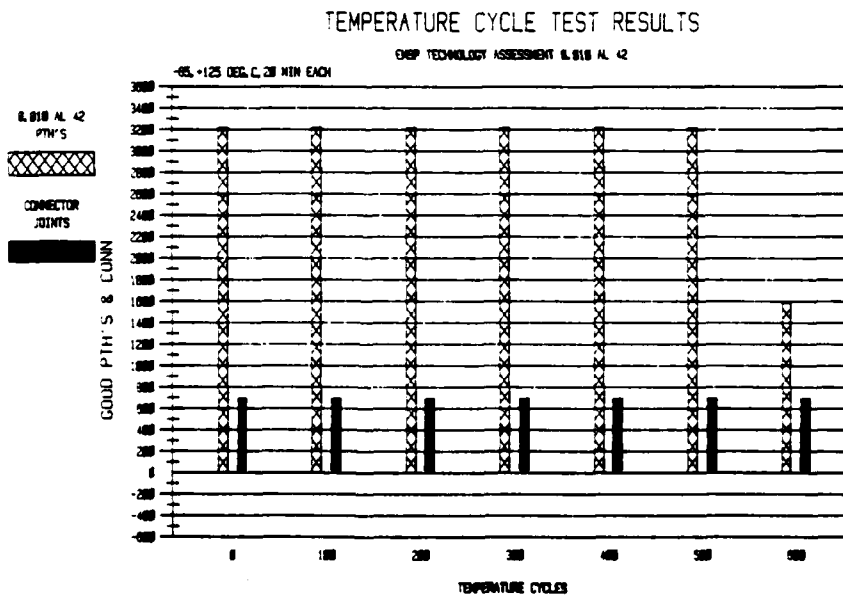
Figure 3. EMSP Temperature Cycle Test Results (Plated-Through Holes & Connector)

Signal Processor (EMSP) technology assessment proposal. The latter program utilized seven metal core PWB's which were accelerated life tested from -65°C to $+125^{\circ}\text{C}$ for 600 cycles. The test results of this EMSP program are shown in Figures 2 and 3.

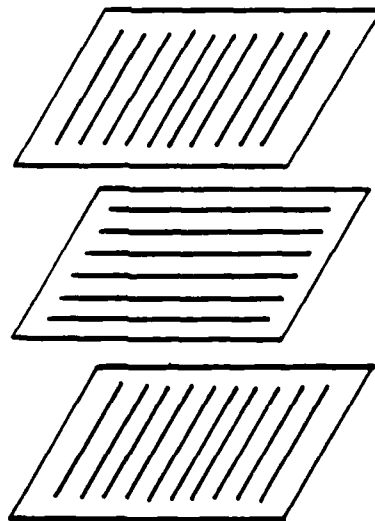
Figure 24. Glass Cloth Weave Grain Direction of Epoxy Glass Prepreg

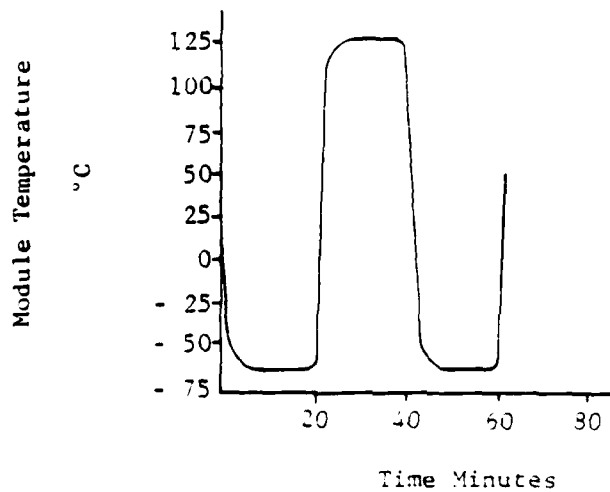
Figure 30. Module Temperature Response

Temperature cycle testing has been established as the best means for thermal stressing the solder joints. This testing was comprised of automatically moving the modules from a high-temperature chamber, +125°C, to a low-temperature chamber, -55°C, dwelling at each extreme for 20 minutes. The time/temperature curve for module temperature response is depicted in Figure 30.

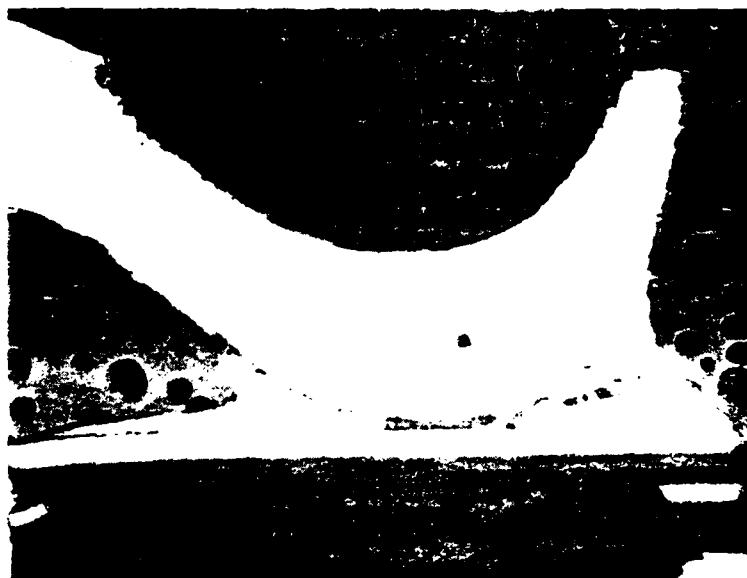
Figure 46. Failed Connector Solder Joint

The connector failures started at 300 cycles. The two failures were located near the end of the row of connector joints. Though the substrate directly below the connector joints was not stabilized, allowing it to expand and contract along with the connector, the end connector joints still failed. A greater distance between the Alloy 42 stabilizing planes and the connector interface is expected to resolve the connector failures. Figures 46 and 36 show a failed connector joint and a good connector joint, respectively.

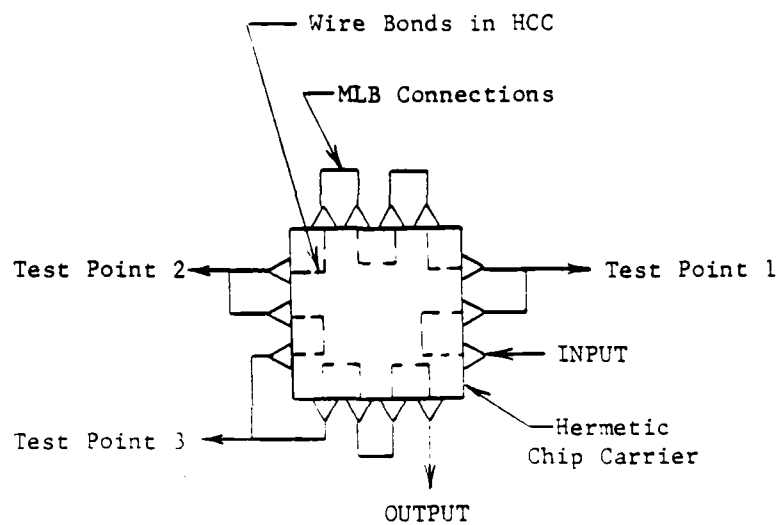
Figure A-10. Typical Chip Carrier Interconnection

- 6.5 Failures will be located by utilizing the design characteristics of the PWB circuitry. Each chip carrier has terminals interconnected as defined in Figure A-10. Each chip carrier is connected to the connector by means of 5 circuit paths (1 in, 1 out, and 3 test points). Electrical shorting of selected test points facilitates identifying the failure area. Failure shall be defined as an electrically open solder joint connection. Experience indicates most failures are intermittent. Therefore, failure identifications will be performed in the test chamber.
