AFWAL-TR-82-3035

FLIGHT TEST OF A G. E. AND DCI DIRECT DRIVE  
FLY-BY-WIRE FLIGHT CONTROL SYSTEM

Final Report for Period October 1978 - April 1981

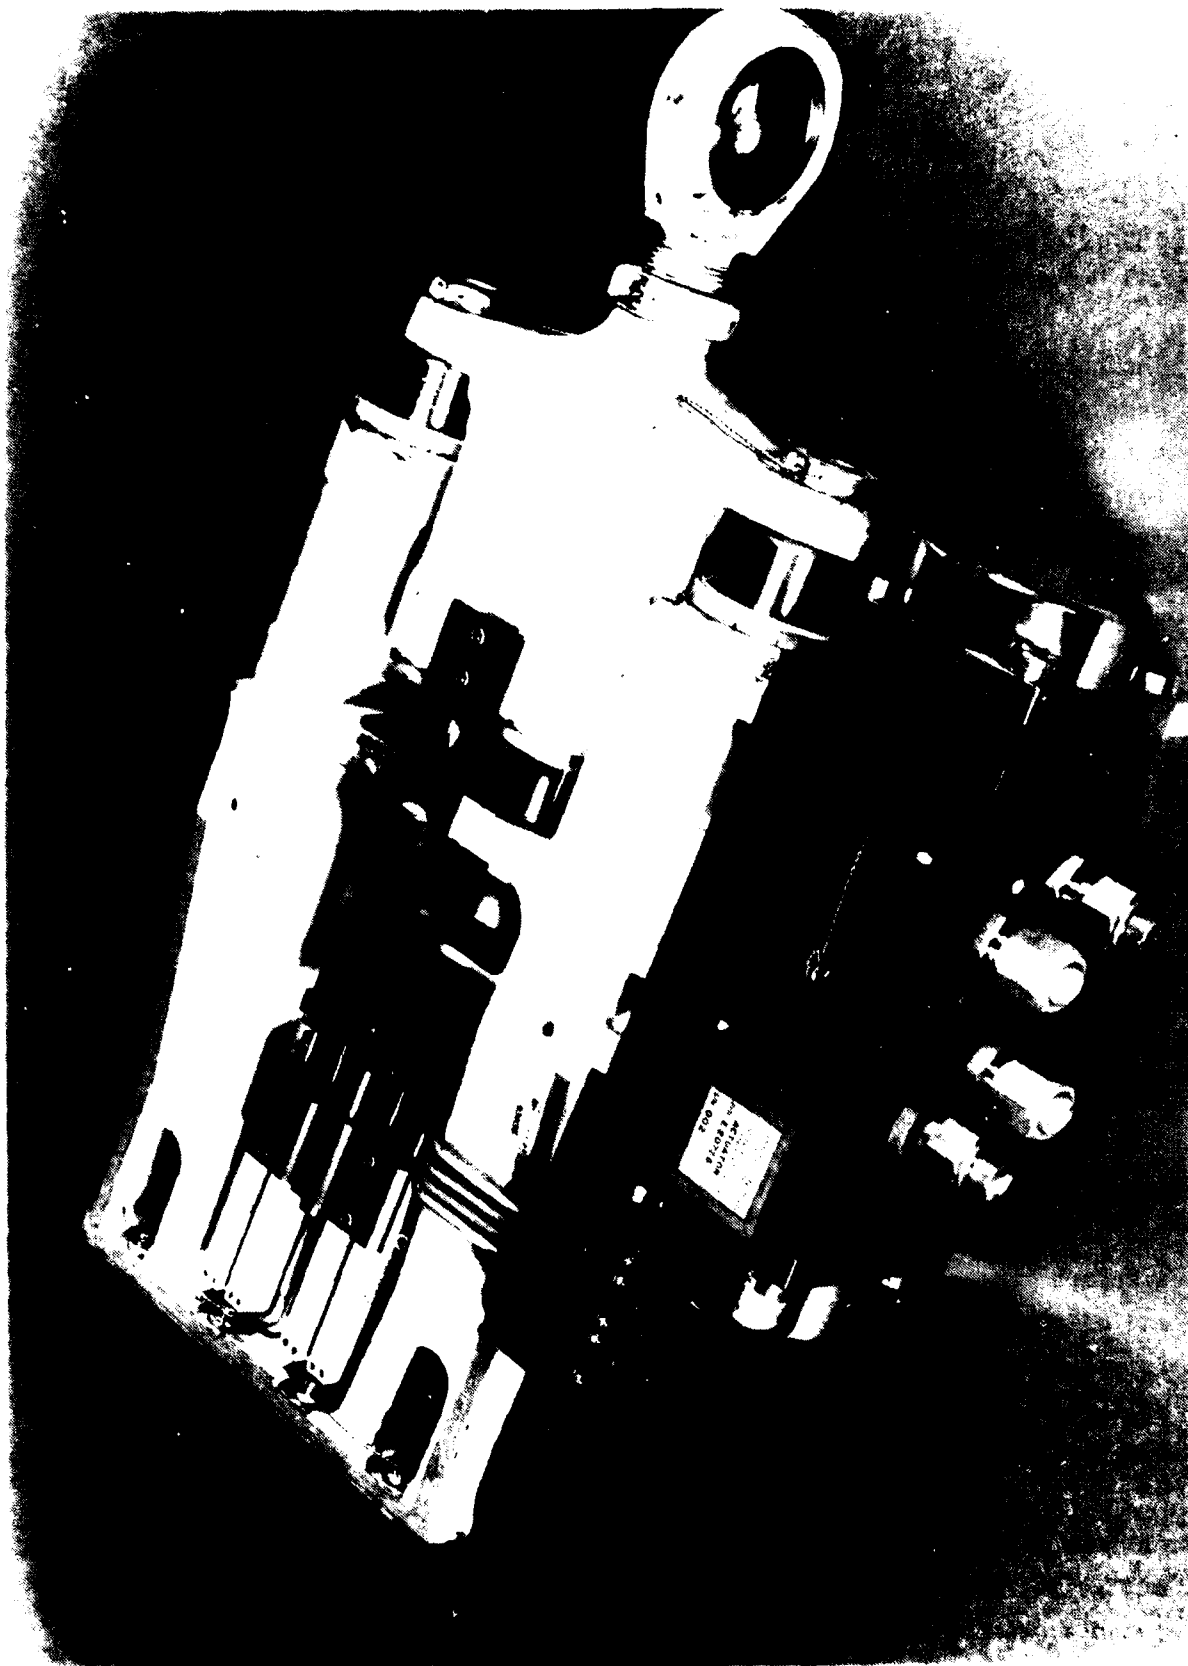
Figure 7 DCI Direct Drive Flight Test Actuator

Figure 7 shows the DCI Direct Drive Flight Test Actuator. The force motors are mounted to a control valve body which replaces the normal manual input control valve. A force motor is used at each end of the control valve. Channel 1 of the control electronics is connected to one force motor and Channel 2 is connected to the other. The position potentiometers are mounted in the center depression of the actuator body.
