INSTALLATION RESTORATION  
PROGRAM RECORDS SEARCH

DAVIS-MONTHAN AIR FORCE BASE, ARIZONA

CH2M HILL  
Gainesville, Florida

August 1982

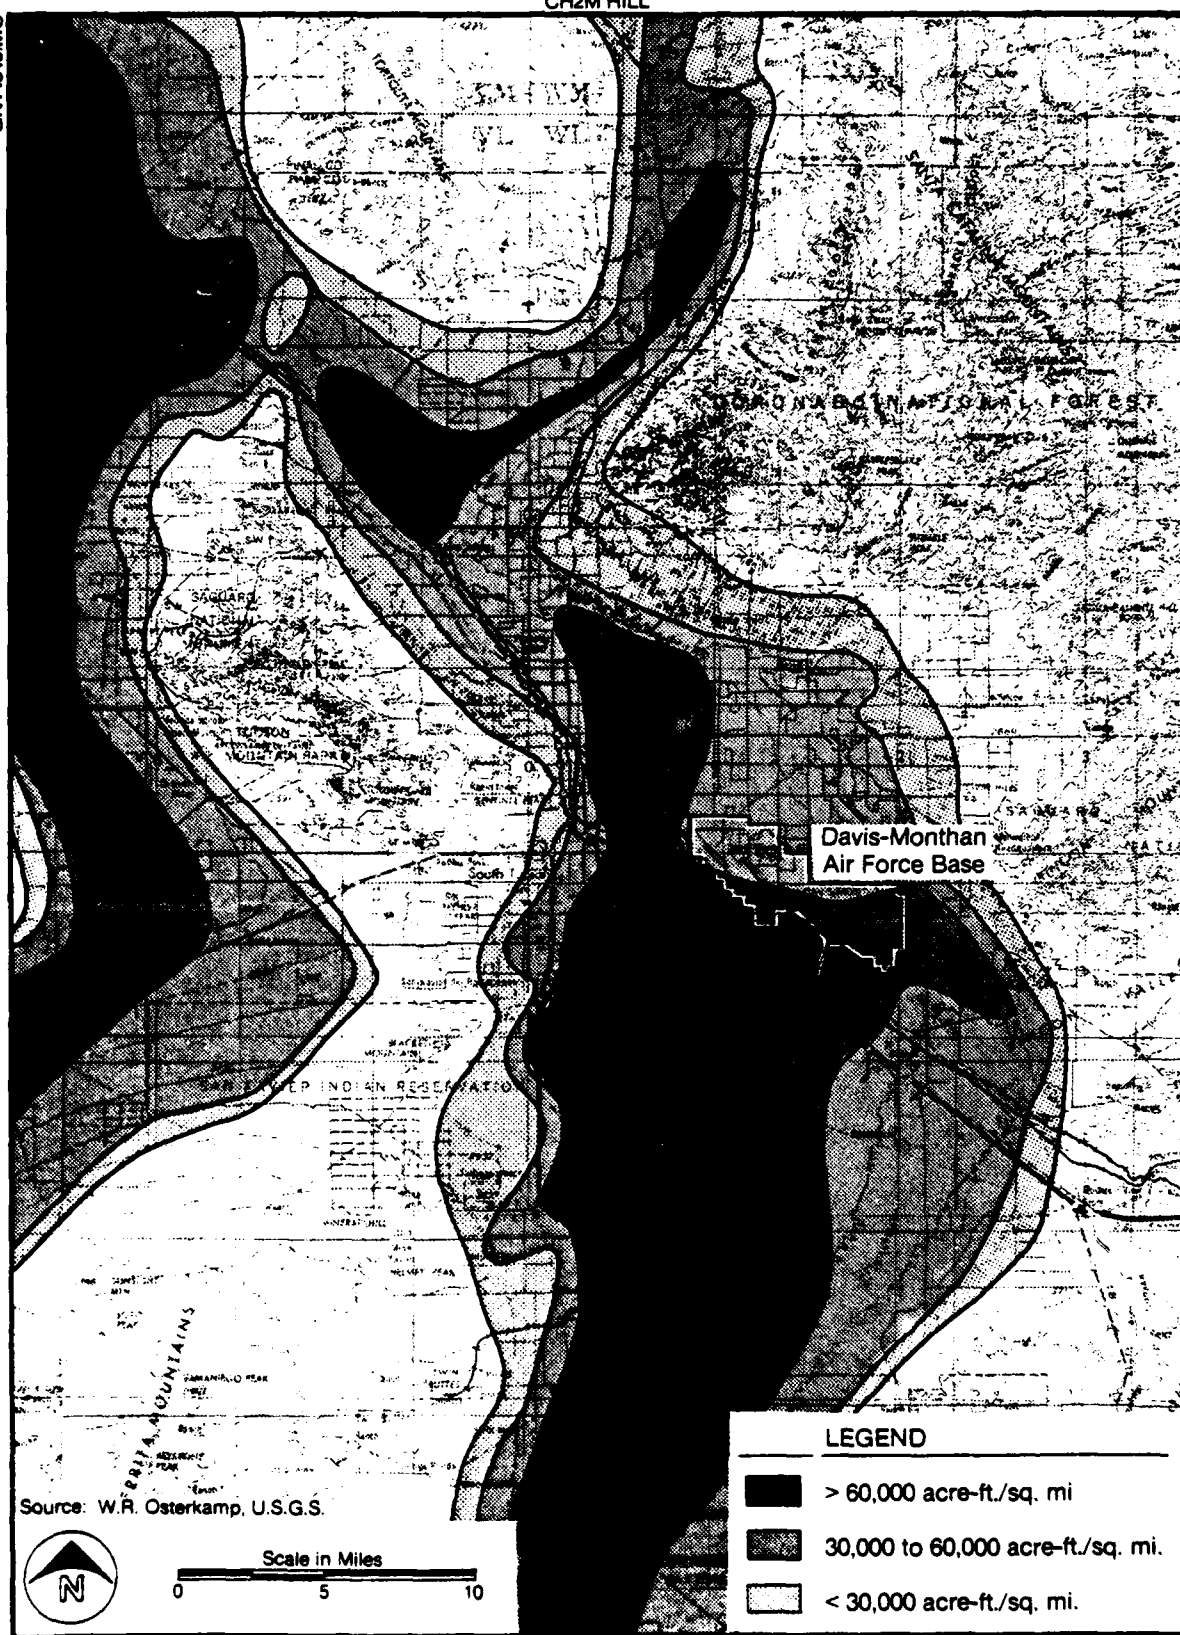
FIGURE 11. Distribution of recoverable ground water.

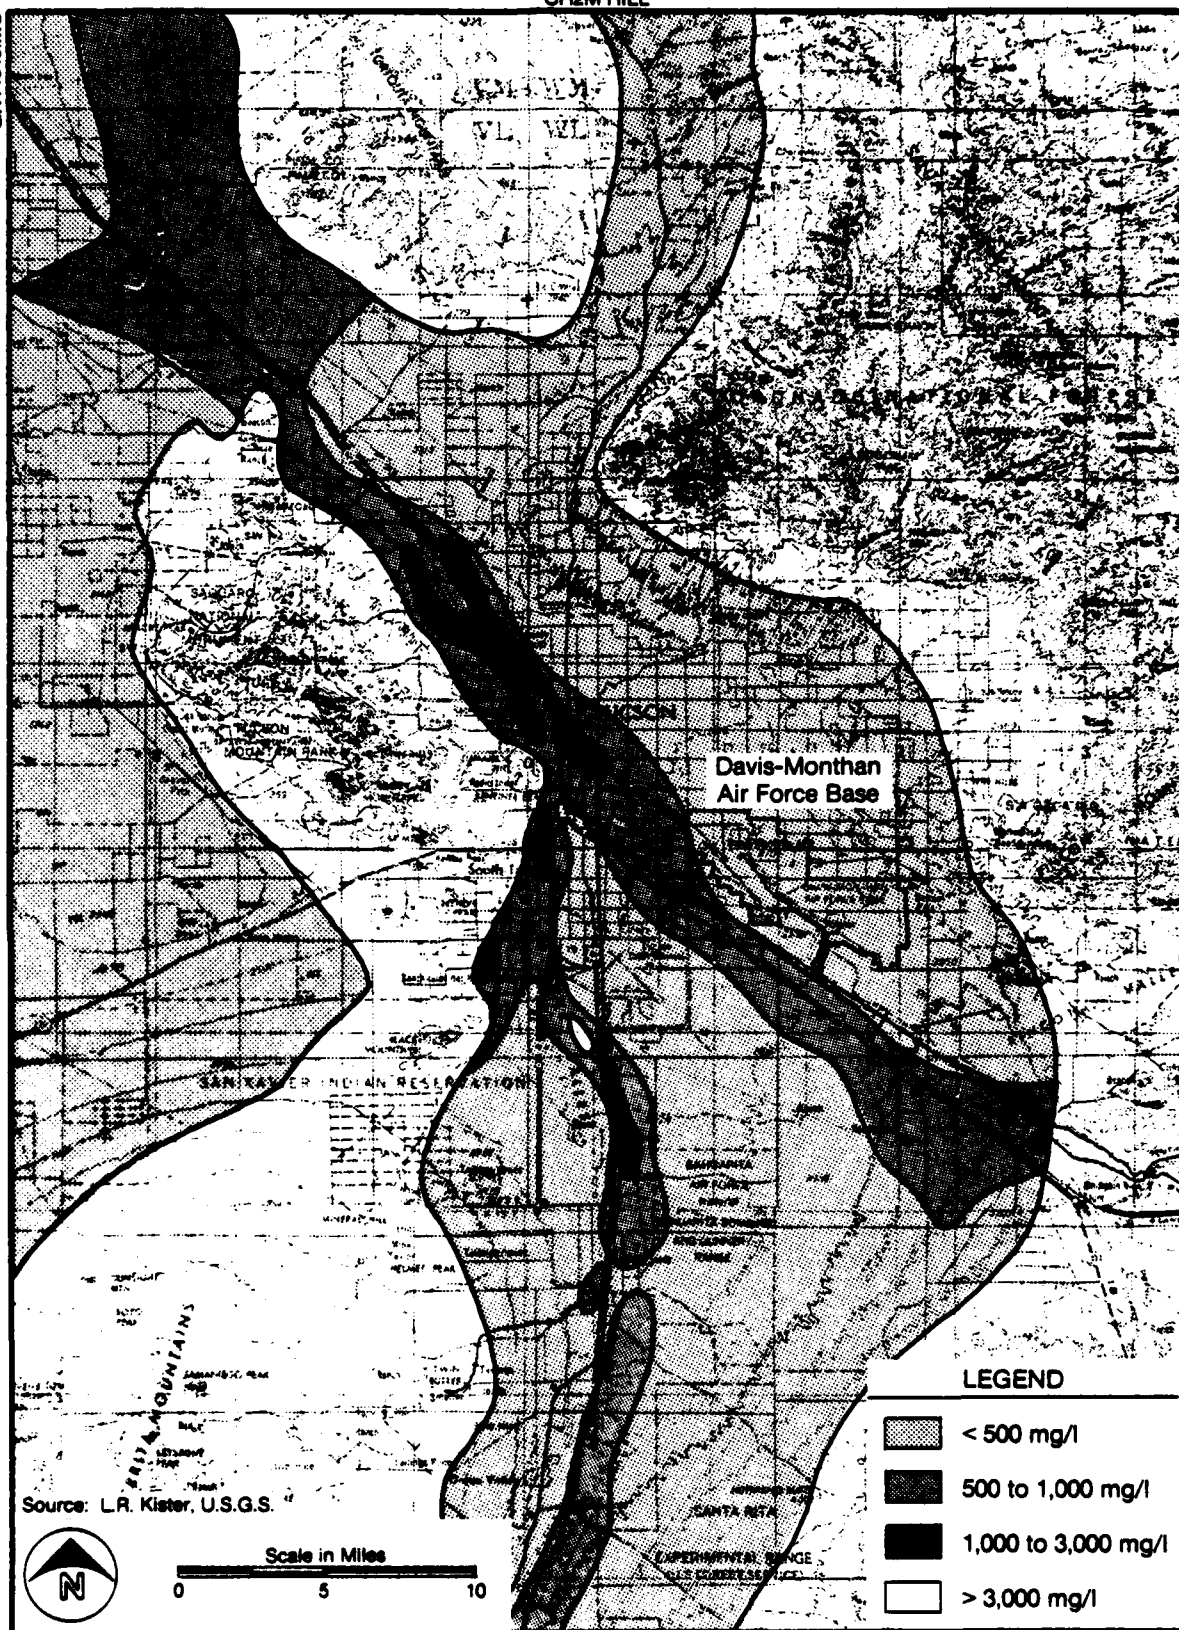
FIGURE 15. Dissolved solids content in ground water.
