CONTRACT NO. N62742-81-C-0006

A-E SERVICES TO PERFORM A CATHODIC PROTECTION SURVEY OF  
THE BULK FUEL TERMINALS AT N.S.C., PEARL HARBOR, HAWAII

JUNE 1982

PACIFIC CORROSION RESEARCH, INC.  
5481 B COMMERCIAL DRIVE  
HUNTINGTON BEACH, CALIFORNIA 92649

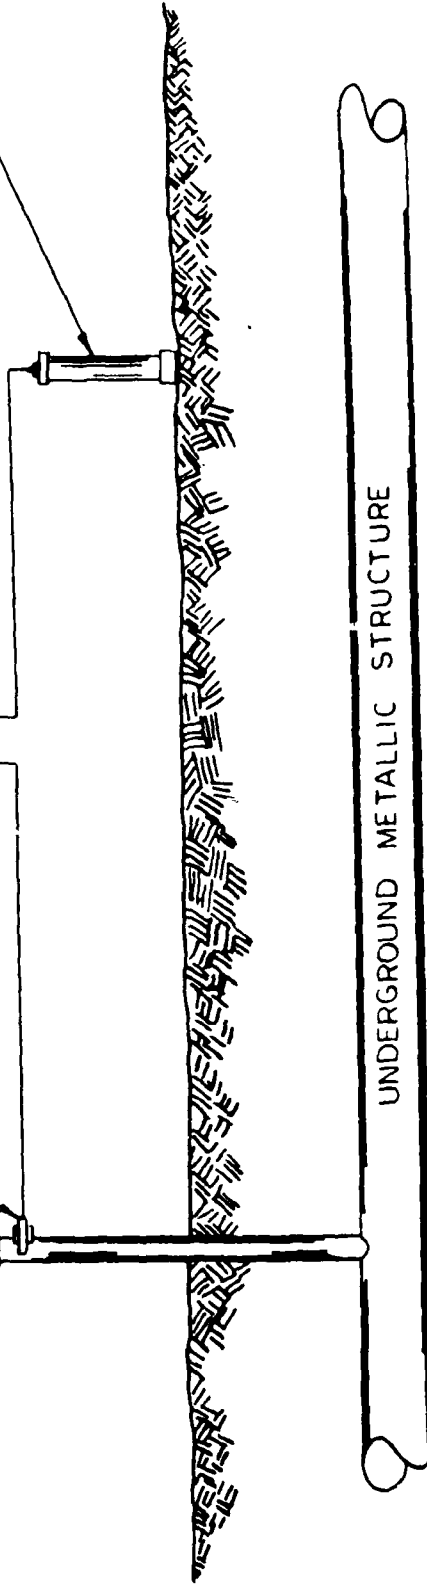
**APPROVED: E L J**      **NUMBER: 5000**

The term pipe-to-soil potential refers to a measurement commonly used to determine the degree of corrosion activity on an underground metallic structure. Pipe-to-soil potential is basically a measure of the emf or voltage of an underground metallic structure with respect to a reference electrode, such as the copper-copper sulfate half-cell. The soil serves as an electrolyte to provide a potential reference.

When a measurement is taken with the copper-copper sulfate half-cell, a potential of approximately -550 millivolts is the normally accepted noncorroding potential of an uncoated steel pipe. Potentials which are more negative than -550 millivolts are indicative of corrosion activity. If potentials taken at various locations along an uncoated underground structure are not uniform, and there are a number of readings less negative than -550 millivolts included with some readings that are more negative, "concentrated" corrosion will be active at the more negative locations.

CONNECTION MADE TO  
STRUCTURE VIA PIPING,  
HOSE BIBB, SPRINKLER  
HEAD, ETC. (NEGATIVE)

COPPER-COPPER  
SULPHATE HALF - CELL  
PLACED OVER  
STRUCTURE. (POSITIVE)

UNDERGROUND METALLIC STRUCTURE

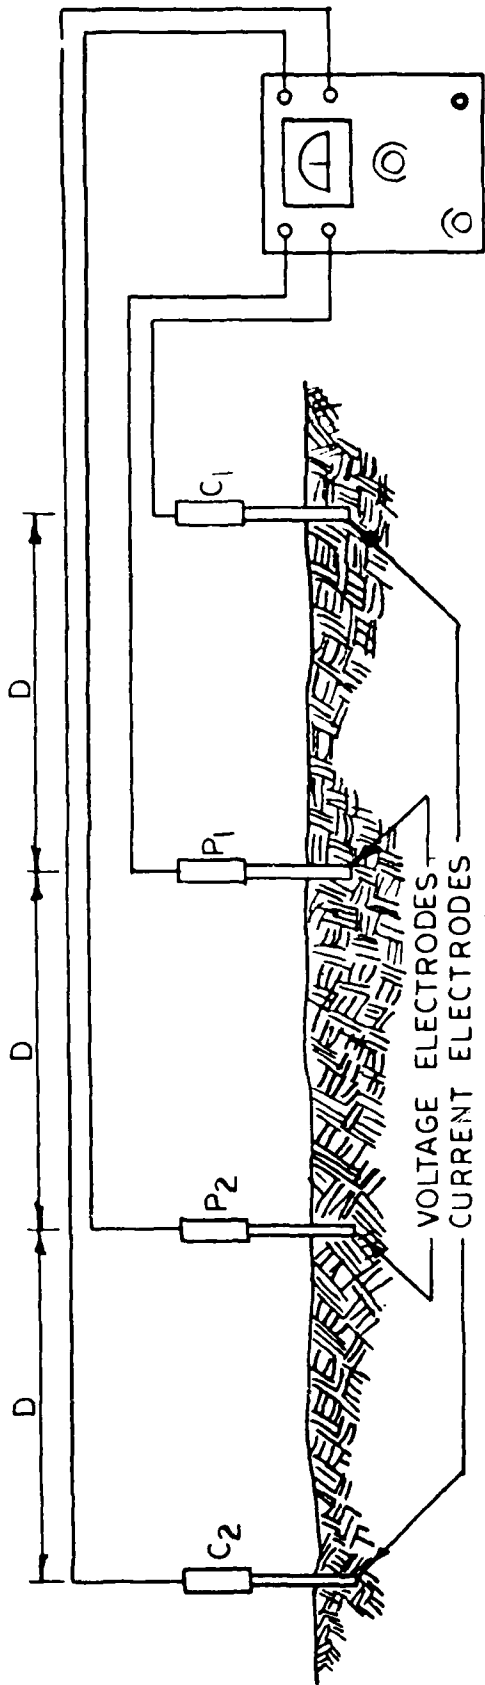
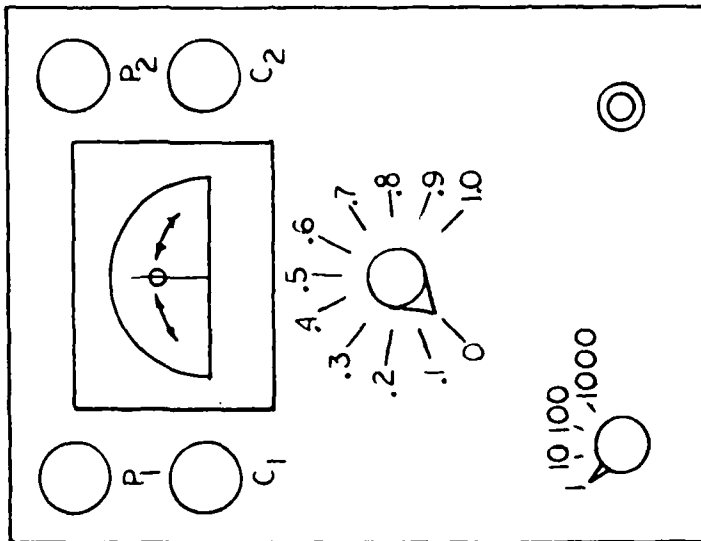
MEASUREMENTS  
OF  
SOIL RESISTIVITY

When testing soil for its relative corrosiveness, measurements of soil resistivity are an invaluable aid to the corrosion engineer. Soil resistivity, which can be considered inversely proportional to soil corrosivity, is a measure of the resistance to the flow of electric current through the soil.

FORMULA FOR CALCULATING SOIL RESISTIVITY

$$R = \frac{191.5 DE}{I}$$

- P = SOIL RESISTIVITY OHM-CENTIMETERS
- D = DISTANCE BETWEEN ELECTRODES IN FEET
- E = VOLTAGE CHANGE, MILLIVOLTS
- I = CURRENT MILLIAMPERES

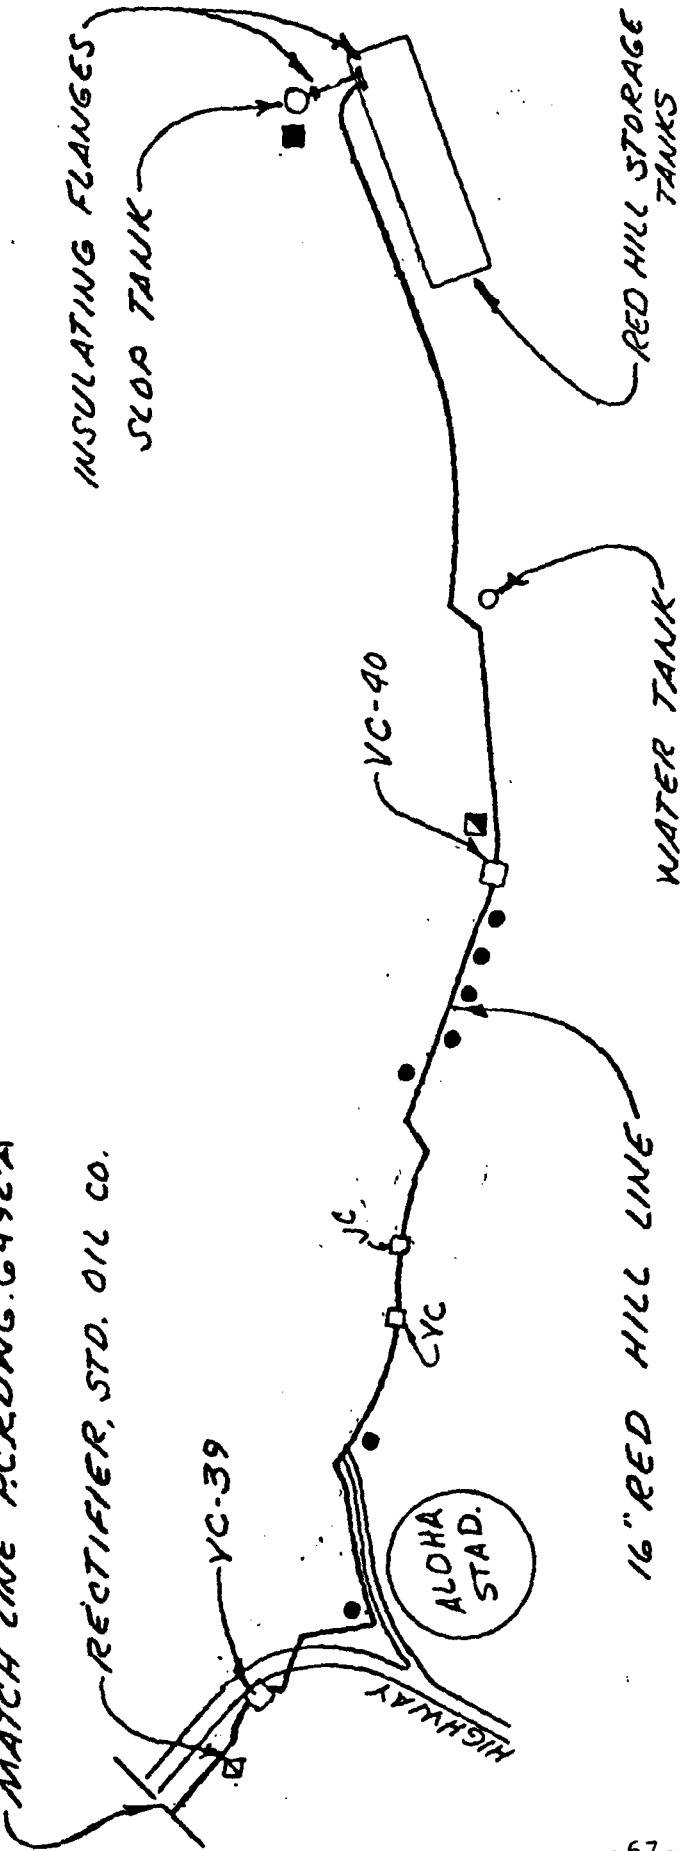
PACIFIC CORROSION RESEARCH CONSULTING CORROSION ENGINEERS HUNTINGTON BEACH, CALIFORNIA	
BULK FUEL TERMINALS NSC, PEARL HARBOR, HAWAII	
CORROSION SURVEY	
PROPOSED CP SYS.	SECTION: A-1
DRAWN: R.E.F.	DATE: 2-16-82
APPROVED: A.T.E.	NUMBER: 6491-A

- ▣ REPLACE EXISTING RECTIFIER R-13 WITH A NEW OIL COOLED RECTIFIER AND INSTALL GRAPHITE ANODES.
- INSTALL NEW OIL COOLED RECTIFIER AND INSTALL HIGH SILICON IRON TUBULAR ANODES.
- INSTALL NEW TEST BOX AND INSTALL PREPACKAGED MAGNESIUM ANODES.

- (1) Replace the existing seven rectifiers, R-3, R-5, R-8, R-9, R-11, R-12 & R-13 with seven new oil cooled rectifiers with a D.C. current output rating from 30 A. to 60 A.
- (2) Install eighteen (18) new oil cooled rectifiers with a D.C. current output rating from 40 A. to 60 A.
- (3) Install one-hundred-sixty-six (166) 4'x40" graphite anodes, twenty-four (24) 4"x80" graphite anodes, eighty seven (87) 4½"x60" high silicon iron anodes, twenty (20)

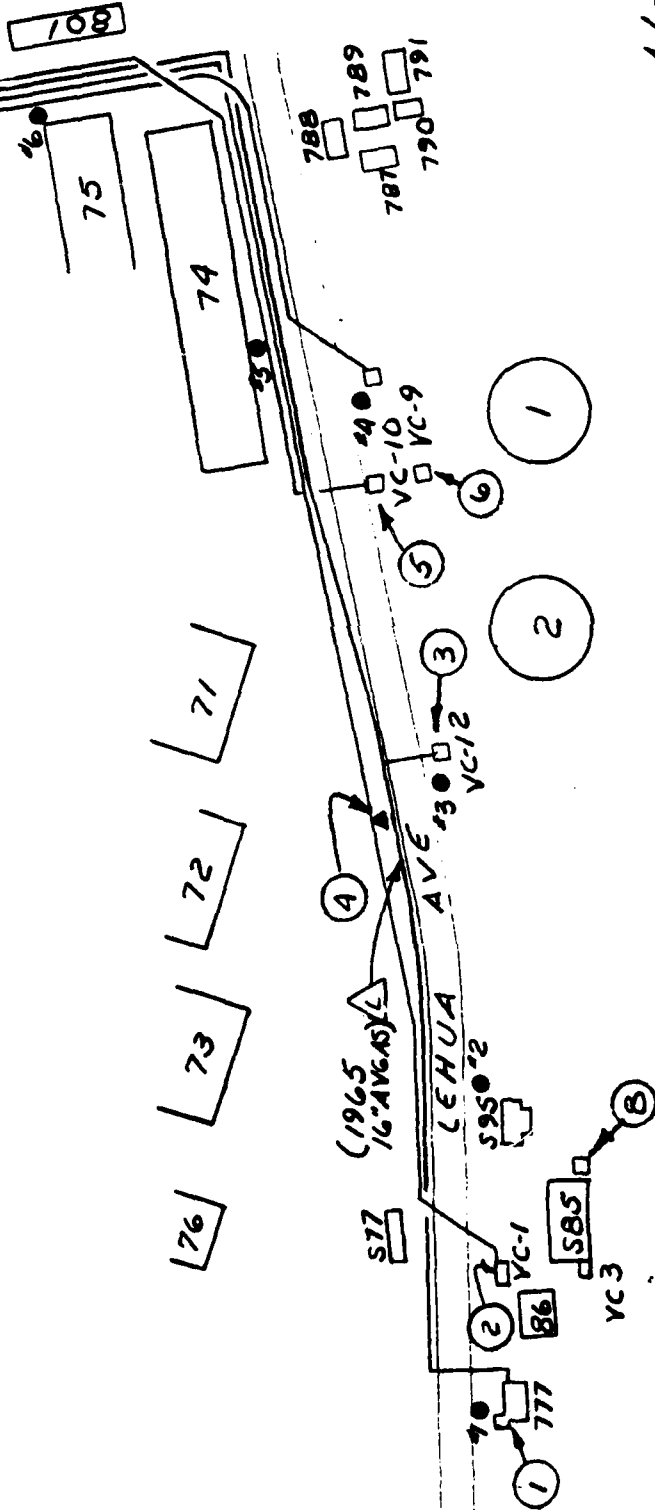
<b>PACIFIC CORROSION RESEARCH</b> CONSULTING CORROSION ENGINEERS HUNTINGTON BEACH, CALIFORNIA	
BULK FUEL TERMINALS NSC, PEARL HARBOR, HAWAII	
CORROSION SURVEY	
FIELD DATA	SECTION: A-2
DRAWN: R. E. F.	DATE: 2-15-82
APPROVED: [Signature]	NUMBER: 6493

- #1 SOIL RESISTIVITY LOCATION
- #1 PIPE-TO-SOIL POTENTIAL LOCATION
- CURRENT TEST LOCATION
- UNDERGROUND POL LINE
- ▲ LEAK LOCATION OR TEST BOX
- EXISTING ANODE BED
- ⊠ EXISTING RECTIFIER

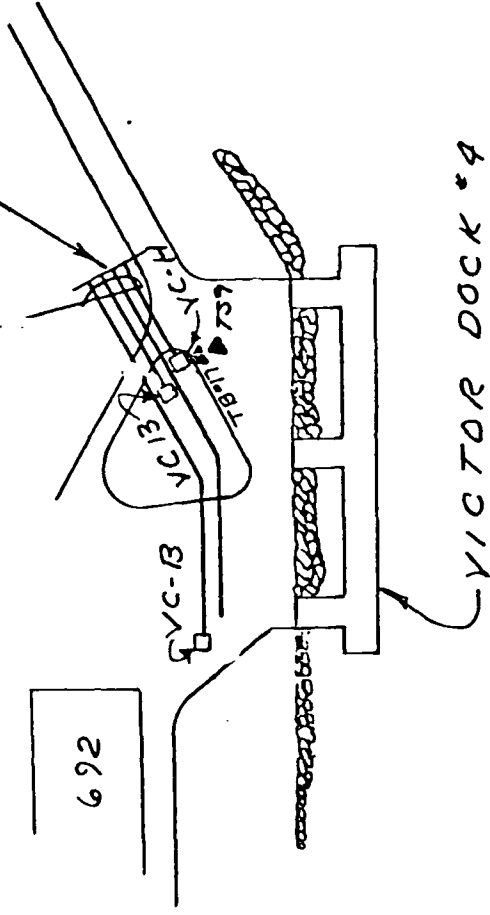
<b>PACIFIC CORROSION RESEARCH</b> CONSULTING CORROSION ENGINEERS HUNTINGTON BEACH, CALIFORNIA	
BULK FUEL TERMINALS NSC, PEARL HARBOR, HAWAII	
CORROSION SURVEY	
PR:	SYS. SECTION: A-2
DRAWN: R.E.F.	DATE: 2-15-82
APPROVED: <i>[Signature]</i>	NUMBER: 6495A

■ INSTALL A NEW OIL COOLED RECTIFIER AND INSTALL HIGH SILICON IRON TUBULAR ANODES.

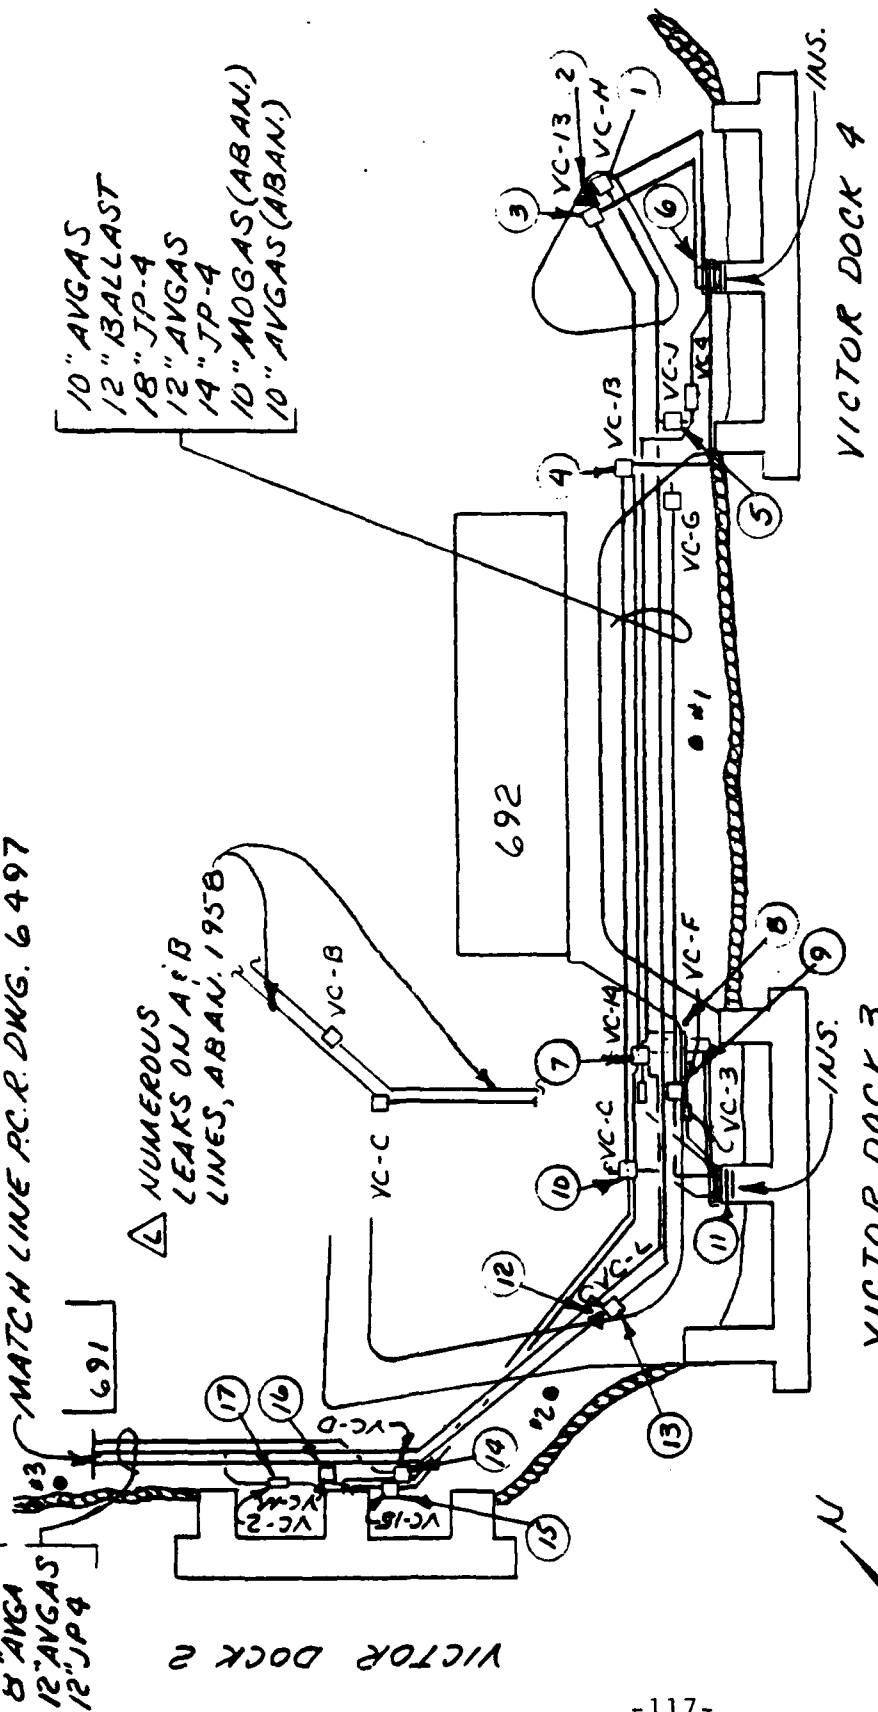
NUMEROUS  
LEAKS ON A & B  
LINES, ABAN. 1958

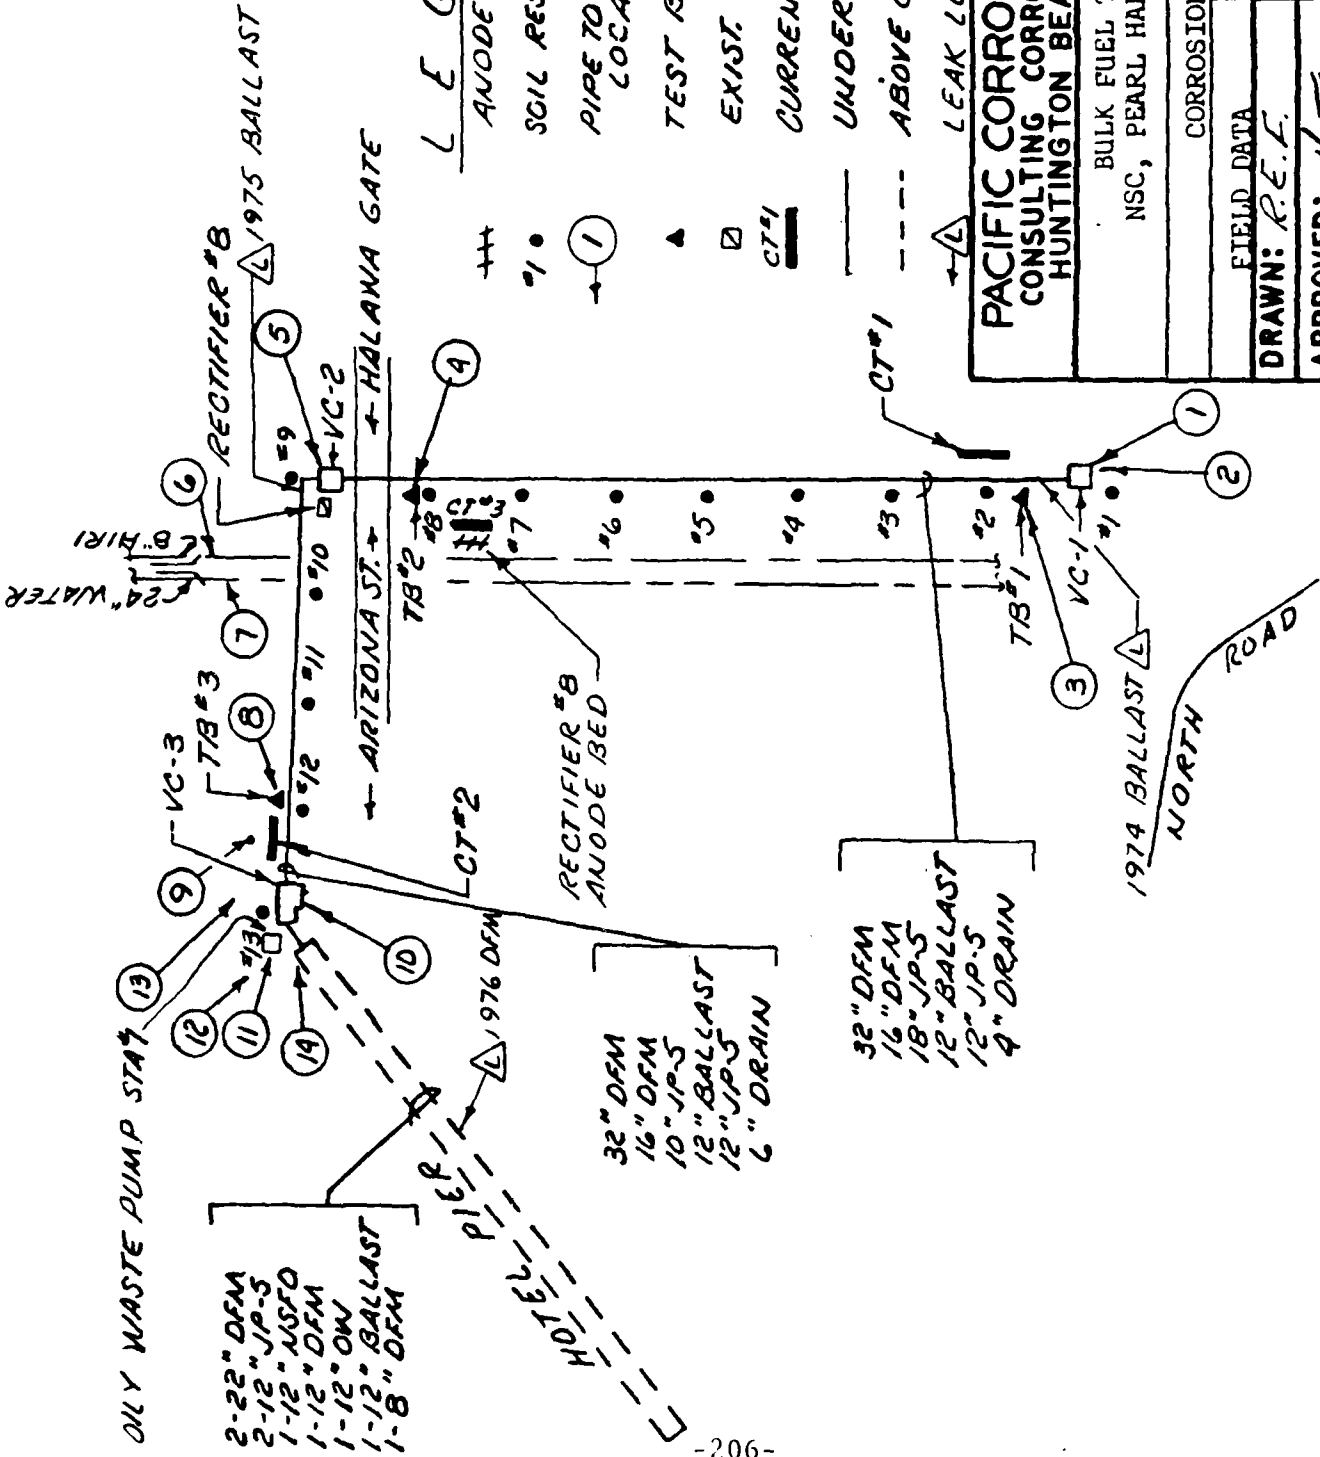
<b>PACIFIC CORROSION RESEARCH</b> CONSULTING CORROSION ENGINEERS HUNTINGTON BEACH, CALIFORNIA	
BULK FUEL TERMINALS NSC, PEARL HARBOR, HAWAII	
CORROSION SURVEY	
PROPOSED C.P. SYS.	SECTION: B-1
DRAWN: R.E.F.	DATE: 9-30-81
APPROVED: <i>H. Tso</i>	NUMBER: 6477-A

- Ⓜ INSTALL RESISTANCE BOND STA.
- ~ CONTINUITY BOND CAST IRON WATER LINE ACROSS EACH JOINT.
- INSTALL NEW OIL COOLED RECTIFIER AND INSTALL HIGH SILICON IRON TUBULAR ANODES OR GRAPHITE ANODES.
- ▣ REPLACE EXIST. RECTIFIER #8 WITH A NEW OIL COOLED RECTIFIER AND INSTALL GRAPHITE ANODES.

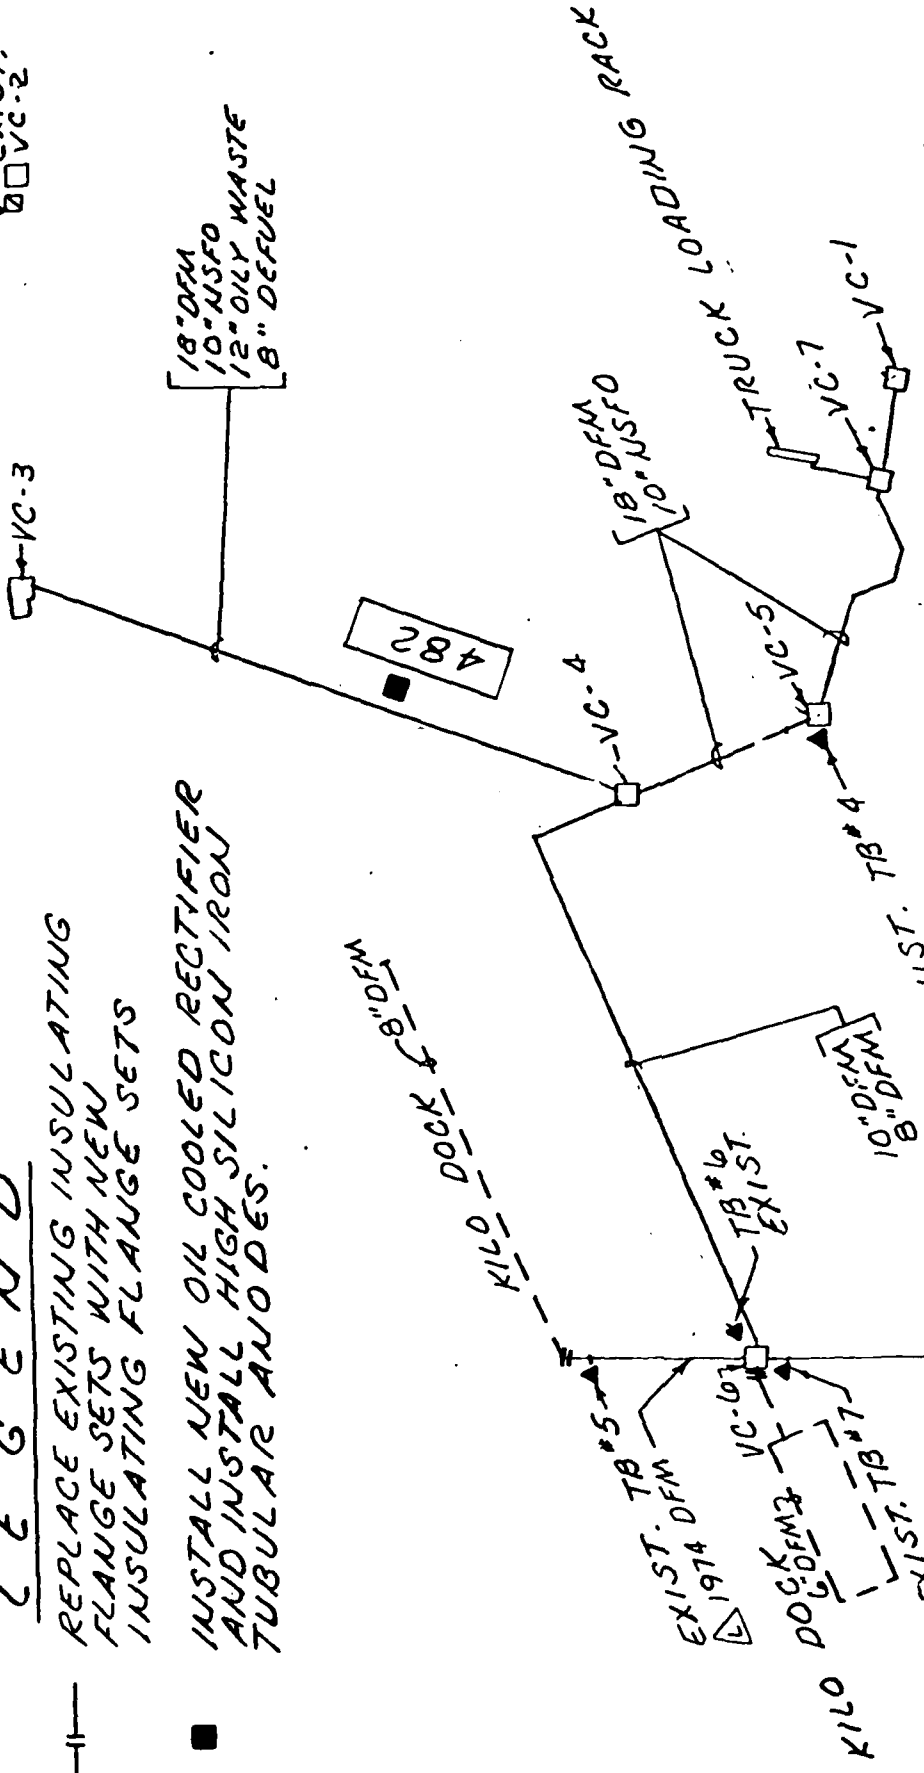
<b>PACIFIC CORROSION RESEARCH</b> CONSULTING CORROSION ENGINEERS HUNTINGTON BEACH, CALIFORNIA	
BULK FUEL TERMINALS NSC, PEARL HARBOR, HAWAII	
CORROSION SURVEY	
PROPOSED CP SYS.	SECTION: B-2
DRAWN: R.E.F.	DATE: 10-1-81
APPROVED: <i>R.E.F.</i>	NUMBER: 6478-A

INSTALL NEW OIL COOLED RECTIFIER AND INSTALL HIGH SILICON IRON TUBULAR ANODES.

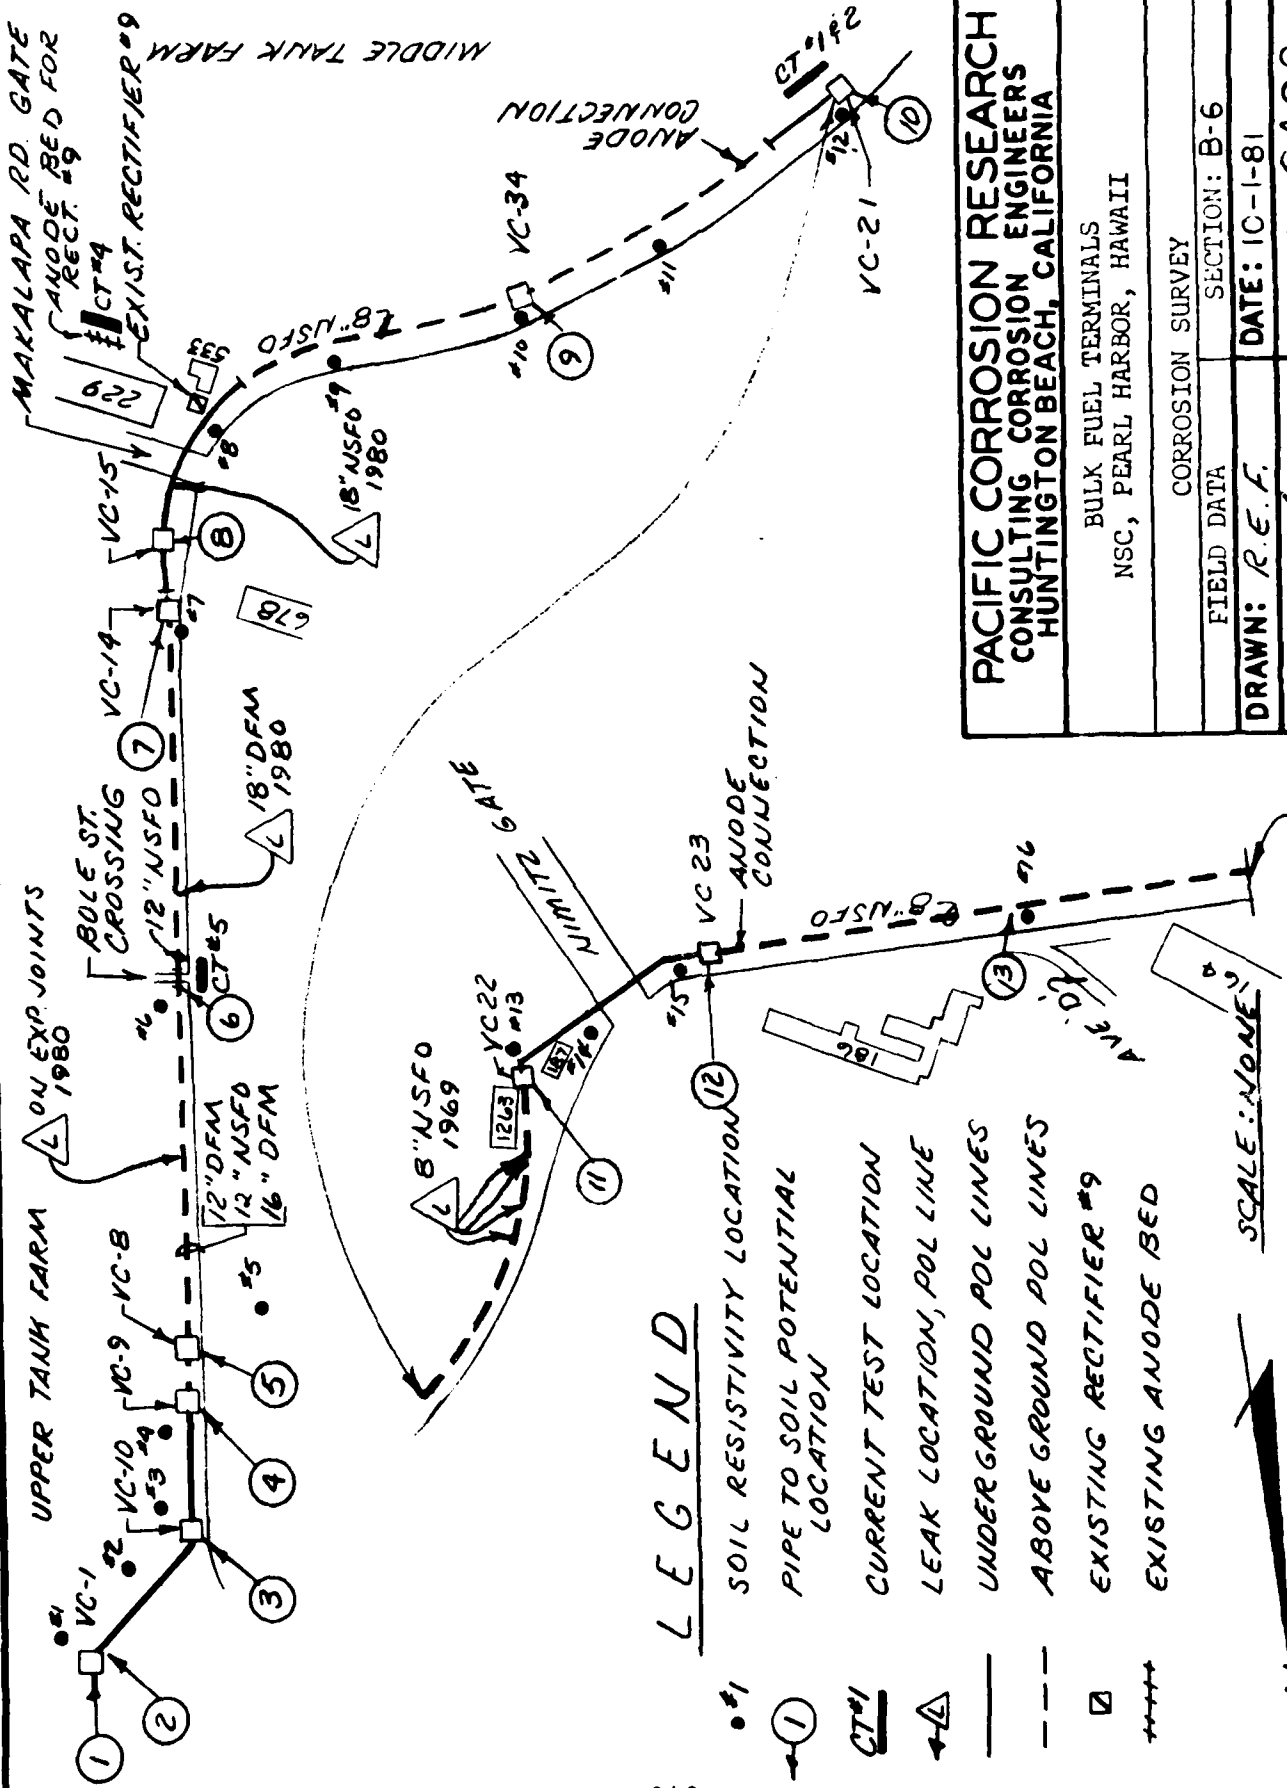
<b>PACIFIC CORROSION RESEARCH</b> CONSULTING CORROSION ENGINEERS HUNTINGTON BEACH, CALIFORNIA	
CORROSION SURVEY	
BULK FUEL TERMINALS NSC, PEARL HARBOR, HAWAII	SECTION: B-6
FIELD DATA	DATE: 10-1-81
DRAWN: R.E.F.	NUMBER: 6482
APPROVED: <i>H. TSO</i>

Rdg. No.	Location	D.C. Current I (ma)	Pipe to Soil Potentials (mv)		
			I (Off)	I (On)	Change
1.	Casing #1 (abandoned)	8	-420	-920	500
2.	Casing #2 (abandoned)	6.5	-465	-890	425
3.	Casing #3, 12" NSFO	97	-280	-940	660
4.	Casing #4, 12" NSFO	30	-290	-890	600
5.	Casing #5, 16" DFM	7.2	-315	-1090	775

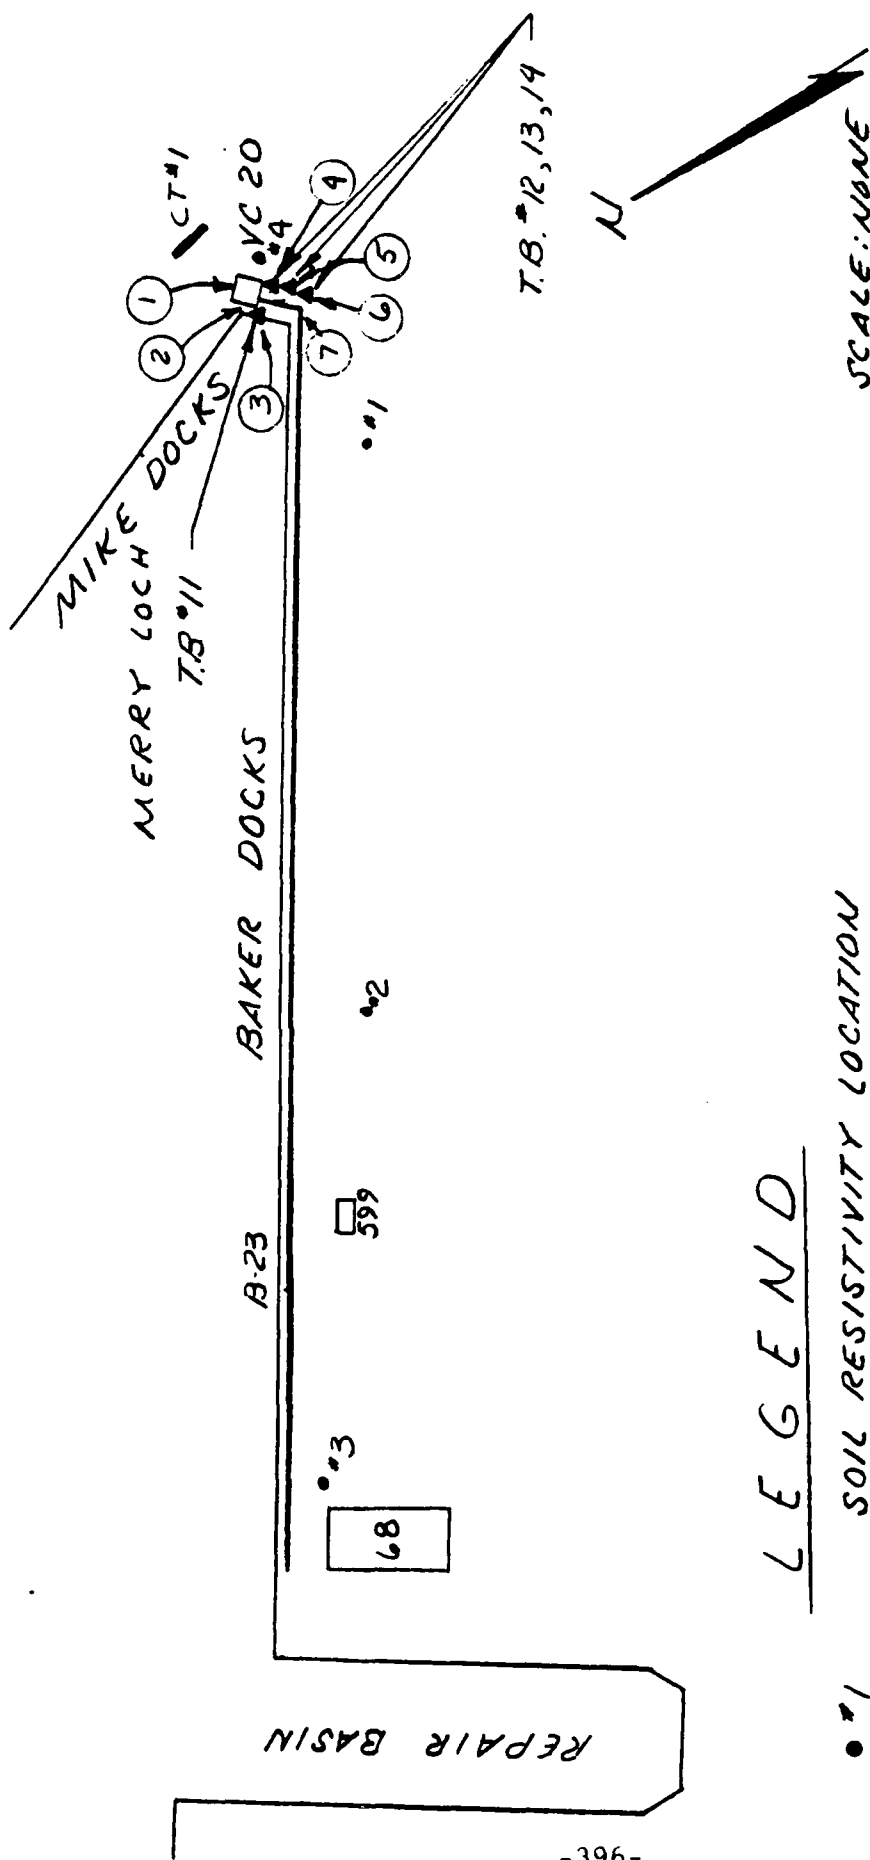
<b>PACIFIC CORROSION RESEARCH</b> CONSULTING CORROSION ENGINEERS HUNTINGTON BEACH, CALIFORNIA	
BULK FUEL TERMINALS NSC, PEARL HARBOR, HAWAII CORROSION SURVEY	
FIELD DATA	SECTION: B-9
DRAWN: R E F	DATE: 2-12-82
APPROVED: <i>H. TS</i>	NUMBER: 6503

Rdg. No.	Half Cell Locations 12" Off Sheet Piles & 6" below water level	Pile-to-Seawater Potentials (mv)		
		I(Off)	I(On)	Change
1.	15' N. of Baker Docks	-700	-705	5
2.	30' N. of Baker Docks	-695	-705	10
