DISPOSAL OF CHEMICAL AGENT IDENTIFICATION SETS  
AT ROCKY MOUNTAIN ARSENAL, COLORADO

MUSTARD OPERATIONS: PHASE 1  
FINAL REPORT

Prepared By  
William R. Brankowitz  
USATHAMA

JULY 1982

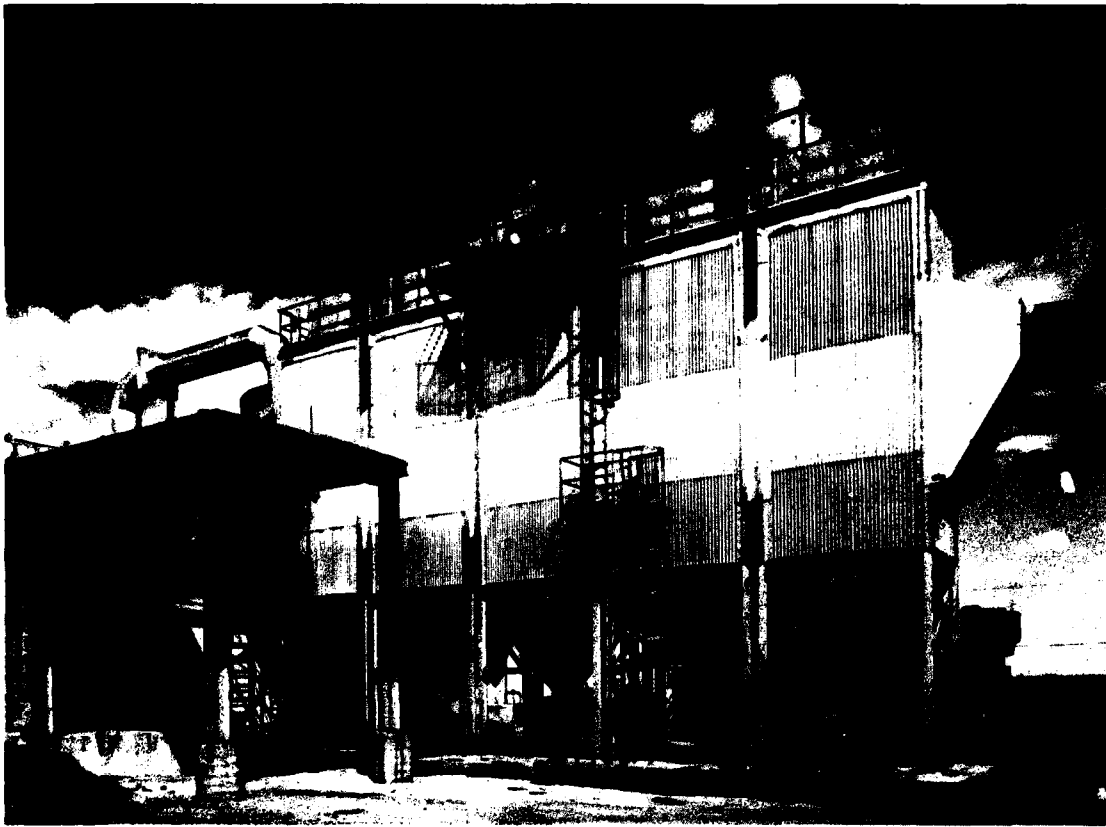
**Figure 13 ELECTROSTATIC PRECIPITATOR**

The waste residue from the CAIS disposal included the furnace trash, electrostatic precipitator (ESP) residue, and the dried salts from spray drying the brines and other liquid industrial wastes (see Figures 12, 13 and 14). The furnace trash, both deactivation and decontamination furnaces, was processed through the residue compactor and placed in 55 gallon drums. The ESP residue was placed in 55 gallon drums directly from the bins at the bottom of the ESP cells. The waste liquid was pumped to the spray dryer holding tanks in Bldg. 1703, dried to salts, and then placed in 55 gallon drums. All drums have been stored in warehouses awaiting determination of final disposition. Refer to Section 2, Paragraph 2.3, for a summary of the wastes generated during mustard operations.
