TECHNICAL REPORT HL-82-22

# SOUTH FORK TILLATOBA CREEK DROP STRUCTURES, MISSISSIPPI

## Hydraulic Model Investigation

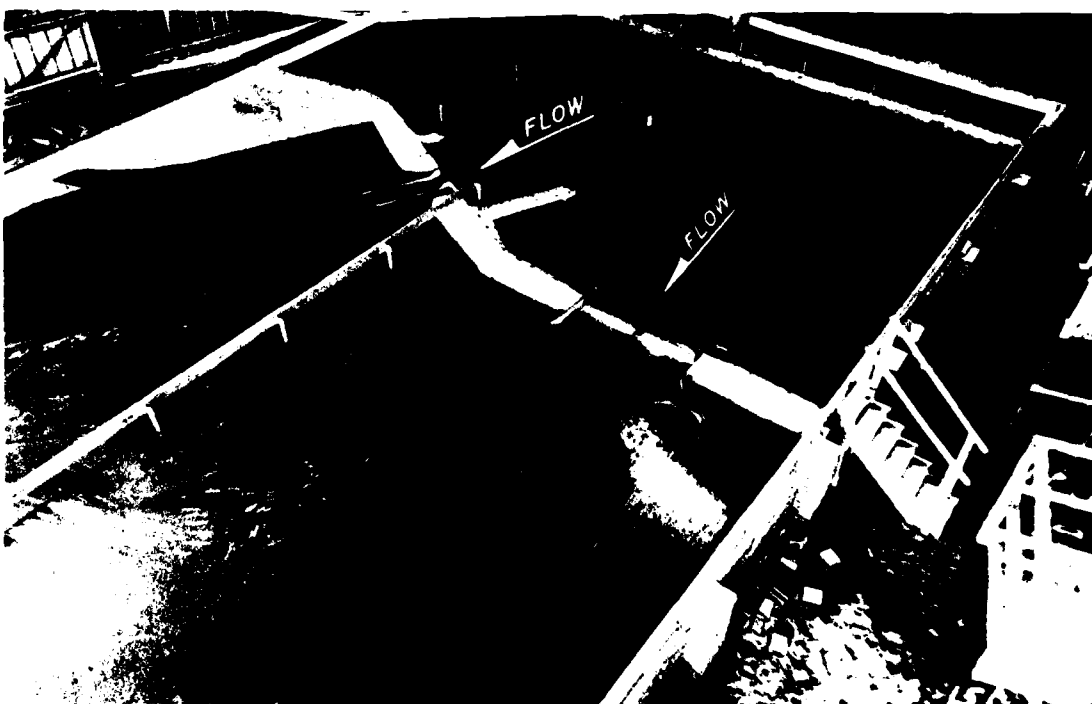
Photo 2. Flow conditions with length of right approach dike reduced; discharge 14,800 cfs, tailwater el 234.3

12. Approach conditions were improved by modifying the right approach dike. Flow conditions were observed as the dike was shortened in 25-ft increments from the original length of 125 ft. A 25-ft-long dike was determined to be the appropriate length that provided a uniform distribution of flow entering the structure. Approach flow conditions with the shortened dike are shown in Photo 2. Eddies present in the entrance channel with the original design approach were eliminated by this modification.

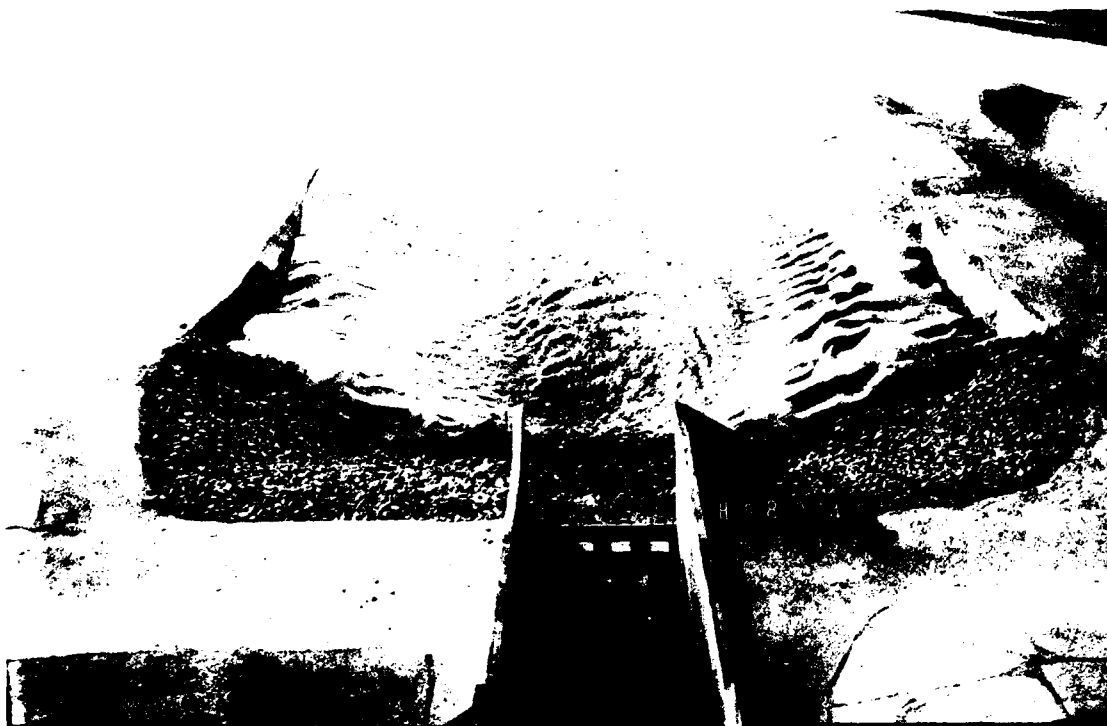
a. Looking downstream

b. Looking upstream

Photo 13. Scour in exit channel of low-stage structure with type 2 abutments and type 4 design crest in stilling basin

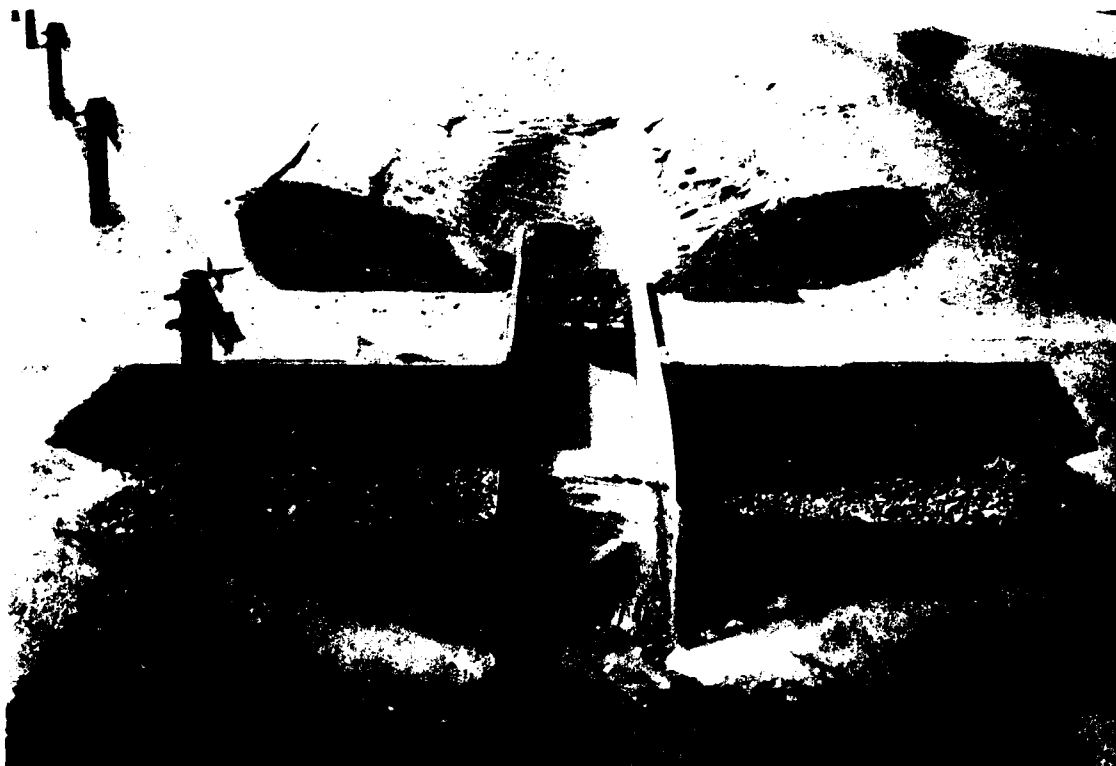
Photo 20. Scour in area between extended entrance walls

27. After all tests of the low-stage structure were completed, the abutments to the drop structure were extended 50 ft upstream from the weir to determine what effect this would have on flow conditions in the stilling basin. Details of this modification (type 3) are shown in Plate 8. This design was not considered applicable for the South Fork Tillatoba Creek site modeled in this study but could possibly be considered for other projects. A structural advantage could be gained by moving the headwall and nonoverflow dike upstream from the weir to reduce the load on the walls of the weir crest. Also, the extended walls would result in more uniform flow passing over the weir. Riprap was placed between the extended walls for the initial tests. However, the riprap in this area failed, as shown in Photo 20, because of the high velocities. This area was then paved with concrete as shown in Photo 21. A scour test was conducted with the extended walls and the original design stilling basin. Results of these tests are shown in Photo 21 and Plate 15. The depth of scour was about the same as that with the type 2 abutments previously tested (compare scour in Plates 10 and 15).

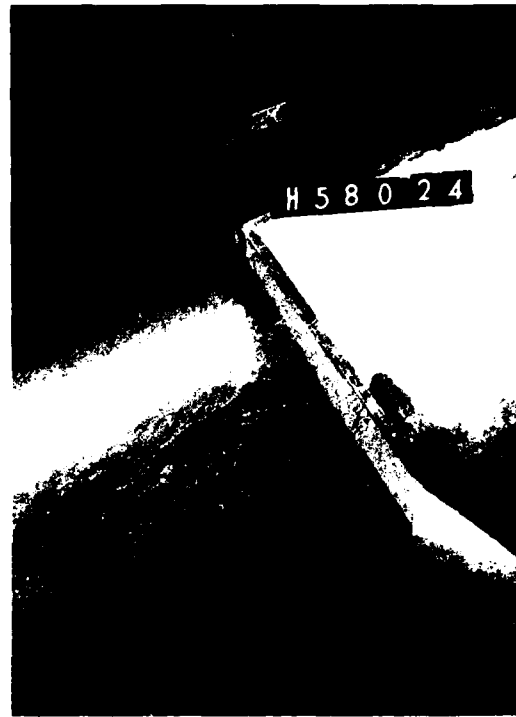
Photo 23. Flow conditions with type 6 design approach wing wall; discharge 14,800 cfs

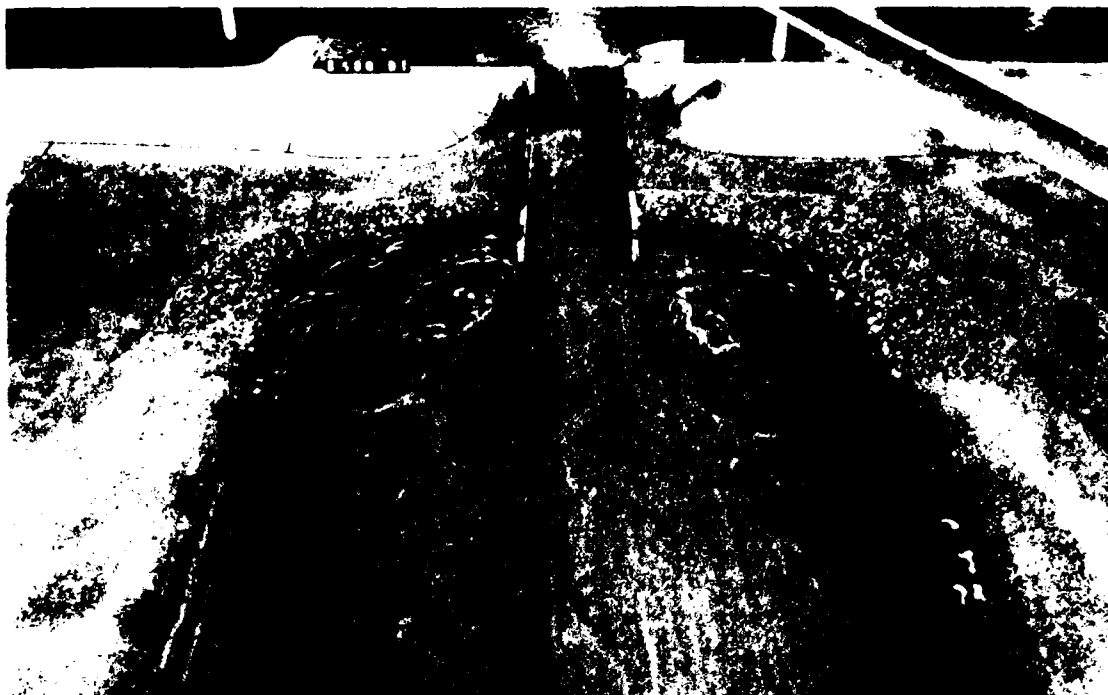
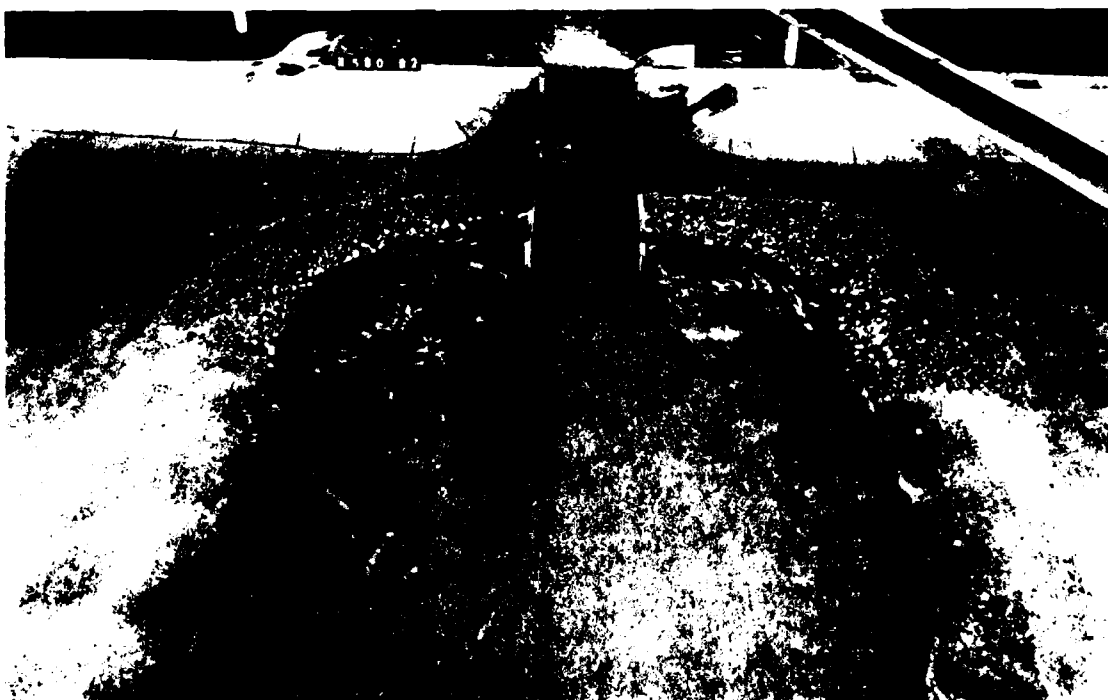
a. Existing tailwater el 230.8

b. Tailwater el 229.2 with ultimate degraded channel conditions

Photo 34. Flow conditions with the type 7 design approach wing walls, type 4 design crest, exit wing walls removed, and reduced bottom width in exit channel of low-stage structure for peak discharge (8,800 cfs) from 50-year storm

40. Velocities measured in the approach and exit areas with the design discharge are shown in Plates 20 and 21. Flow conditions for the peak discharge from the 50-year frequency storm (8,800 cfs) and the design discharge (14,800 cfs) are shown in Photos 6, 32, and 34-37.
