# CRREL Report 82-31

October 1982

## *Bering Strait sea ice and the Fairway Rock icefoot*

A. Kovacs, D.S. Sodhi and G.F.N. Cox

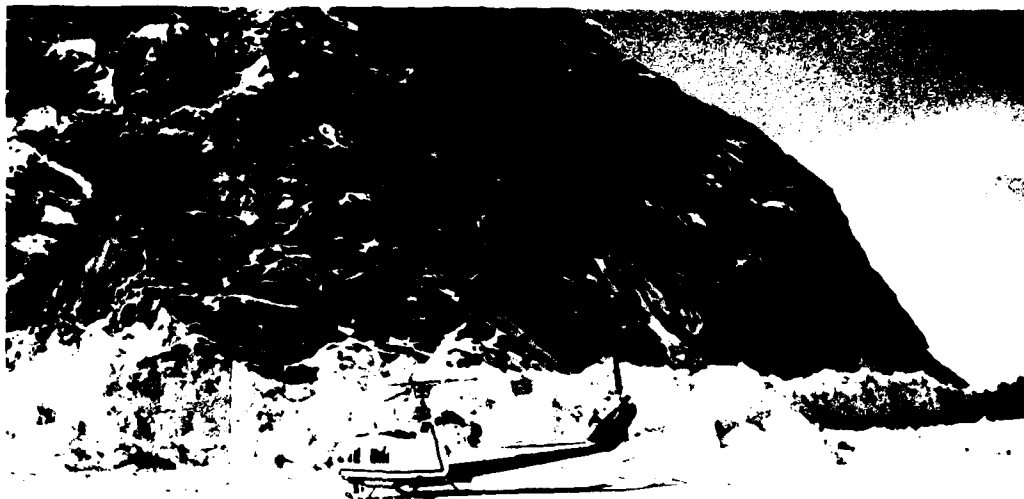
*Figure 30. Icefoot on southeast side of Fairway Rock.*

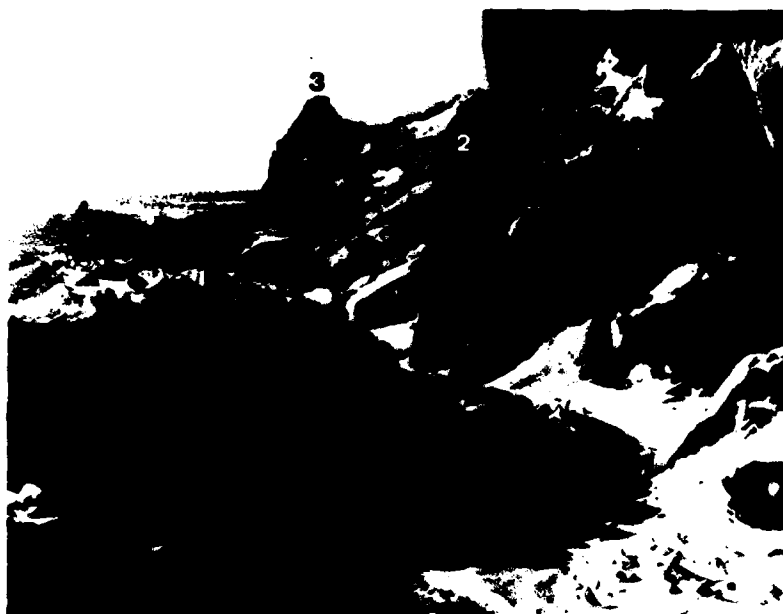
*Figure 31. Icefoot rubble along south side of Fairway Rock.*
