# Braking of an Aircraft Tire on Grooved and Porous Asphaltic Concrete

Satish K. Agrawal

January 1983

Final Report

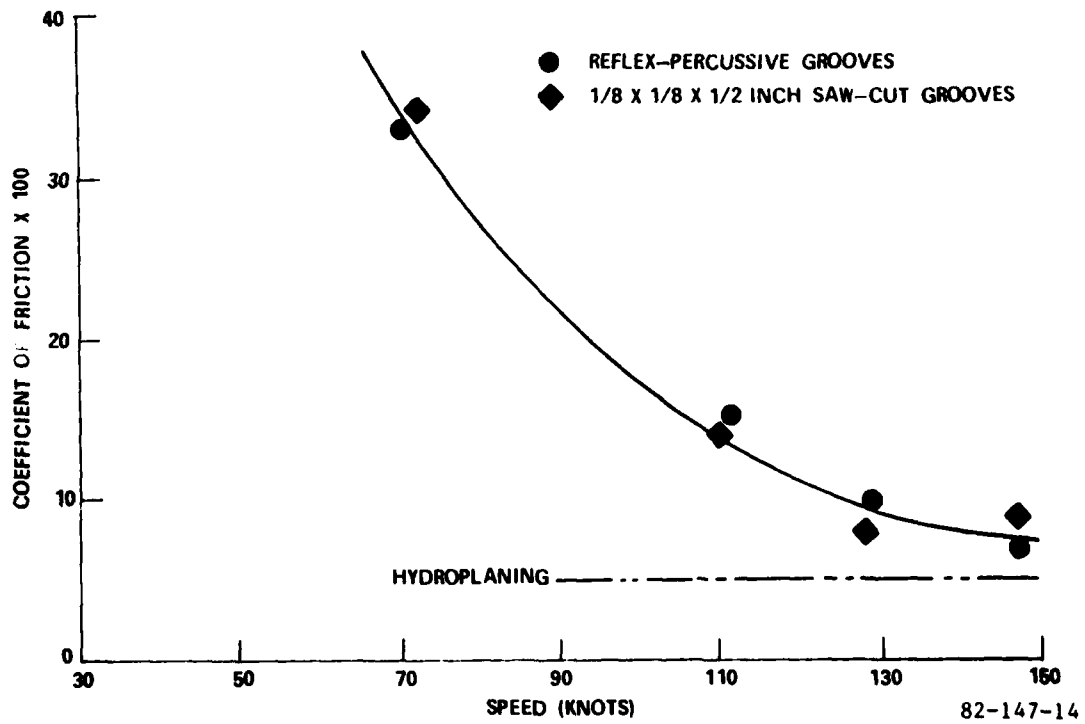
FIGURE 14. BRAKING PERFORMANCE OF A WORN TIRE ON PUDDLED SURFACE

The braking performance of the worn tire on puddled surfaces with saw-cut grooves and reflex-percussive grooves is shown in figures 13 and 14. Figure 13 shows that for the 1/4-inch square grooves, the spacing has a distinct effect on the available friction level, for a given speed, the larger the spacing the smaller the value of available friction level. However, even with the largest groove spacing included in the test program (3 inches), the condition of hydroplaning is not reached within the speed range tested (70 to 150 knots).

The performance on the reflex-percussive grooves, and on 1/8-inch square saw-cut grooves is shown in figure 14. A single curve adequately represents the average performance of the two treatments. Figure 15 shows a composite of figures 13 and 14 to directly compare the braking performance on all the surfaces tested. The shaded area bounded by two light lines show the performance envelope on the saw-cut grooves. The dark line shows the performance on the reflex-percussive grooves and on the 1/8-inch square saw-cut grooves. In all cases, hydroplaning condition is not reached within the speed range employed in the test program. This figure indicates that the saw-cut grooves spaced 1 1/4 inches apart provide the highest levels of available friction on puddled surfaces with worn aircraft tire. The use of new tires will provide even higher levels of friction coefficients.

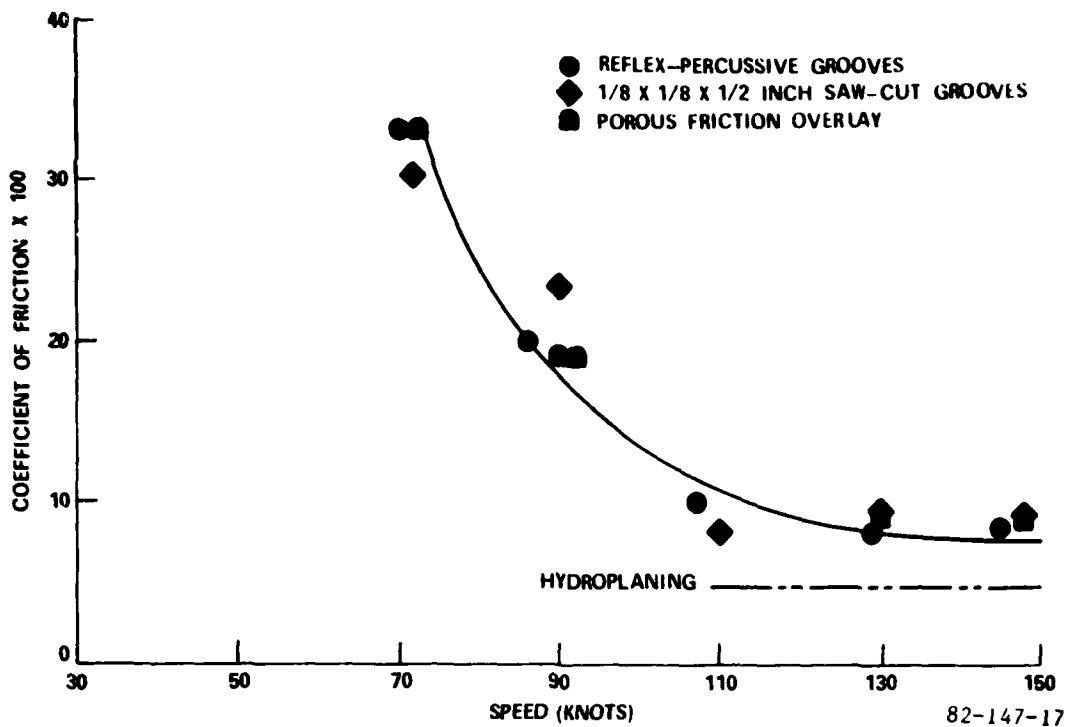
FIGURE 17. BRAKING PERFORMANCE OF A WORN TIRE ON FLOODED SURFACE

Figures 16 and 17 show the braking performance of a worn tire on flooded surfaces. In each case, a single curve shows the average performance on the surfaces tested. Figure 18 is a composite of figures 16 and 17 and clearly show that the performance on all the surfaces tested can be represented by a single curve; however, both curves are shown separately in this figure. In all cases hydroplaning condition is not reached.
