FRACTURE BEHAVIOR OF BORON ALUMINUM COMPOSITES  
AT ROOM AND ELEVATED TEMPERATURES

PROGRESS REPORT

PERIOD: JUNE 1, 1980 - MAY 31, 1981

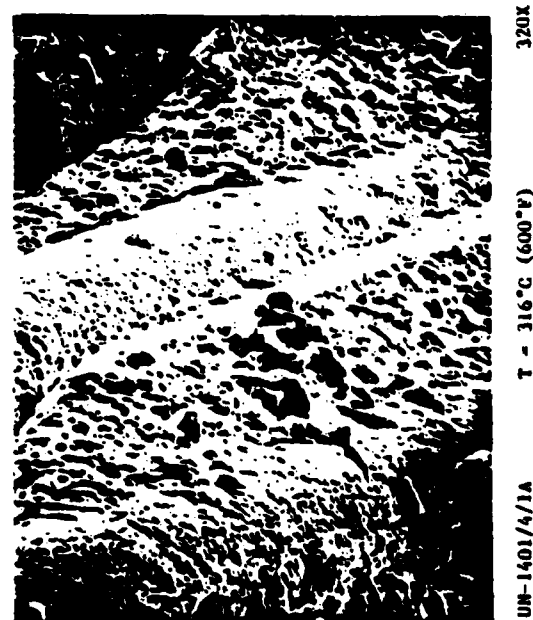
Figure 24. Details of scanning electron microscope micrographs of fracture surfaces shown in Figure 23.
